FACILITY COMPLIANCE INSPECTION REPORT

Division of Waste Management Solid Waste Section

Coastal Environmental Partnership
 7400 Old Hwy 70
 New Bern, NC 28560

2509-20130206INSP

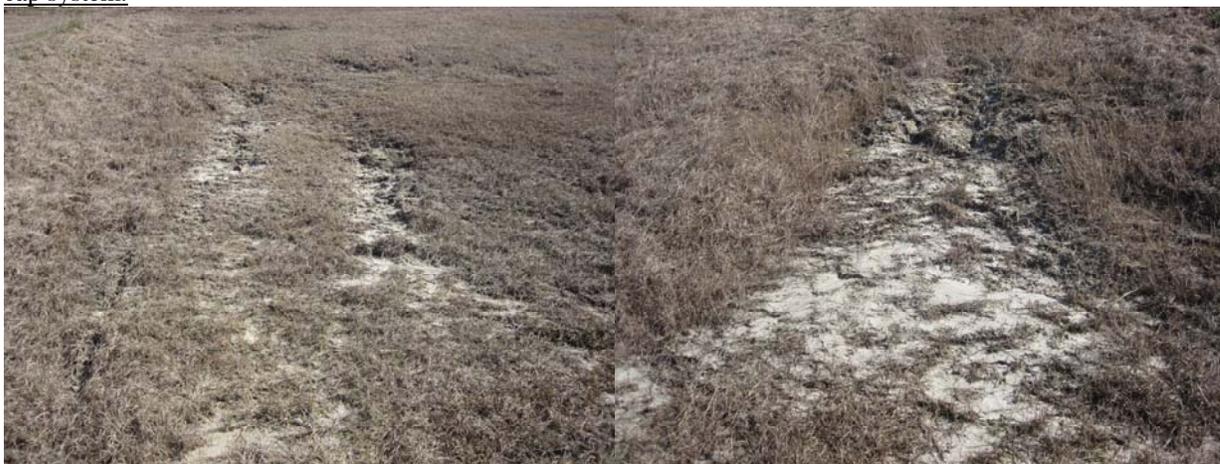
- 20) The inert debris area was reviewed; no unpermitted waste was noted during this Facility Compliance Inspection.
- 21) A cover crop has been well established and maintained on the closed areas of the landfill. Overall, the closed areas of the landfill are well maintained however, several areas of sparse cover and erosion were noted on the western sideslope.
*Please reseed and mulch all areas of sparse cover to establish a cover crop suitable to prevent erosion of your landfill cap system.

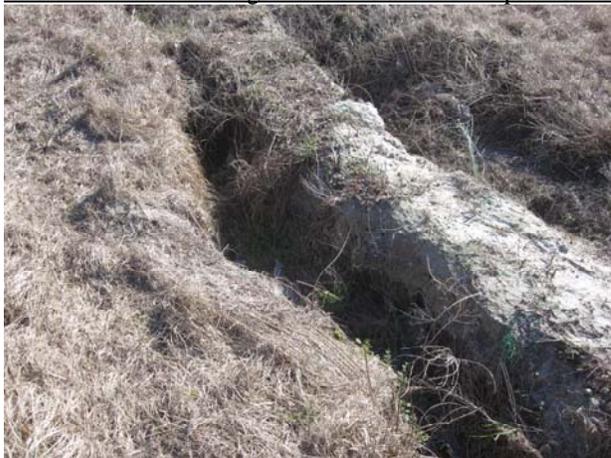
- 22) Eroded areas were observed along the surface water diversion berms on the western sideslope in the closed Phase I.
*Please fill and grade these areas to promote positive drainage of surface waters. All repaired areas should be seeded and mulched to establish a groundcover suitable to prevent erosion of your landfill cap system.

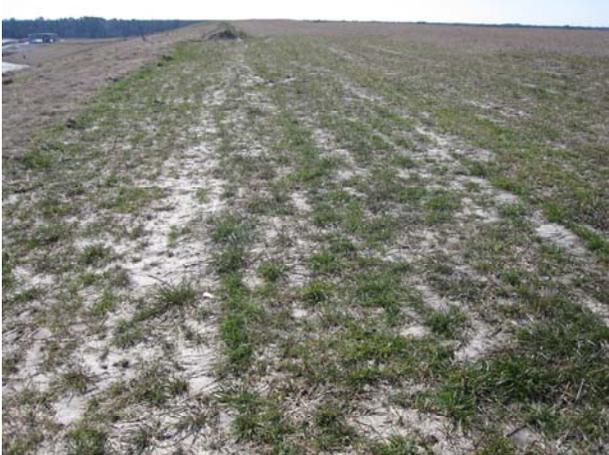
- 23) The area of standing water was noted on the top lift of Phase I in the previous Facility Compliance Inspection Report has

been filled and graded to promote positive drainage of all surface waters from the landfill. The repaired area has been seeded and mulched to establish a cover crop suitable to prevent erosion of the landfill cap system.
