FACILITY COMPLIANCE INSPECTION REPORT
Division of Waste Management
Solid Waste Section

Date of Site Inspection: 23 April 2013

Dare County C&D Landfill
 1603 Cub Road
 Manns Harbor, NC 27953

2803-20130423INSP

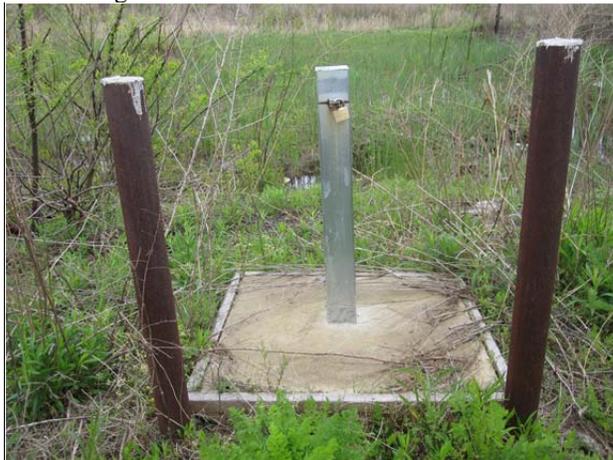
- 24) Several of the older wells adjacent to Cell #1 were noted as needing repair or replacement of the well casing due to damage and/or corrosion in the previous Facility Compliance Inspection Report have had temporary repairs in order to secure the wells. *As per our conversation, in order to provide for secure access, these well casings should be permanently repaired or replaced.

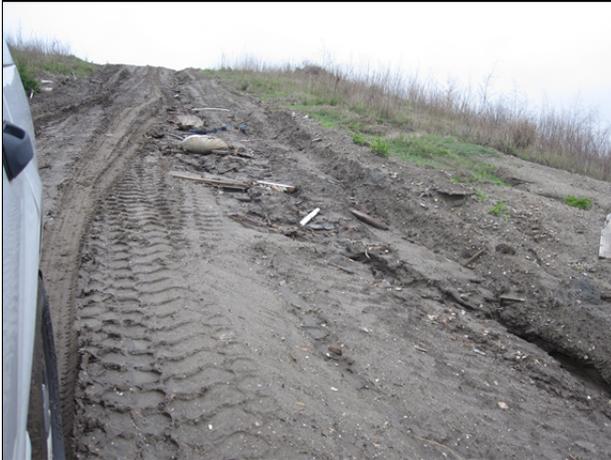
- 27) Erosion was observed on the access road to the top of Cell #3 on the western end of the cell. *Please fill and grade this area to prevent further erosion of your landfill cap system. All repaired areas should be graded at a slope not greater than 3:1 and seeded and mulched to establish a groundcover suitable to prevent erosion of your landfill cap system.

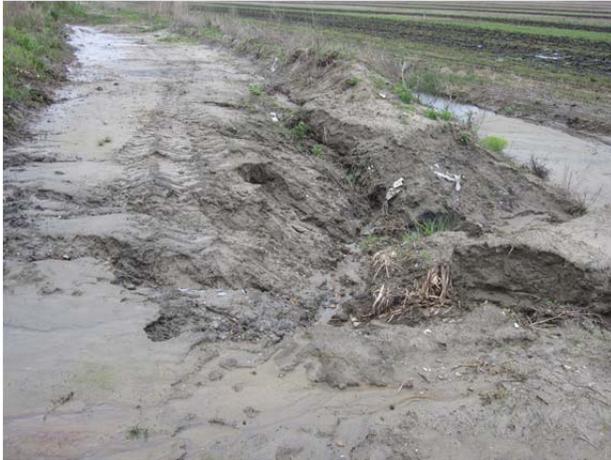
28) An area of ponding water was observed on the Cell #3 perimeter access road at the toe of the southern sideslope approximately 200 yards from the western end of the cell. Some erosion of the access road was also observed in this area. *Please fill and grade this area to promote the positive flow of surface waters away from the toe of the landfill.
