FACILITY COMPLIANCE AUDIT REPORT

Division of Waste Management Solid Waste Section

Date of Audit: December 22, 2010**Date of Last Audit:** May 31, 2007**FACILITY NAME AND ADDRESS:**

Weldon Transfer Facility
 2211 Highway 301 North
 Weldon, NC 27839

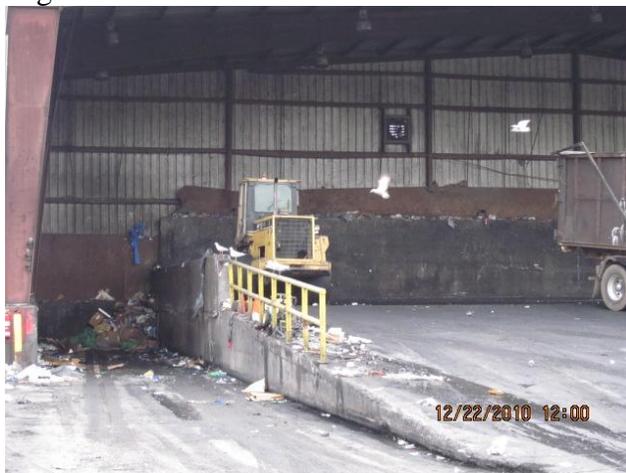
6. The inside of the WTS building including the walls, cross beams, tops of push walls, tipping floor, and areas where the trailers park to be loaded were all extremely dirty. The tops of the push walls, the tipping floor and the area where the trailers park to be loaded must be cleaned daily. The walls and the horizontal beams of the facility must be cleaned on a frequent basis as needed. At the minimum, a quarterly cleaning of the walls and cross beams is recommended. Address in writing, how the worn floor will be maintained in a clean and sanitary condition. Send this to Mary Whaley, P.O. Box 59, Oxford, NC 27565 by January 21, 2011. As was discussed during the audit, **corrective actions need to be taken immediately to insure thorough cleaning of the facility.**

Waste buildup in trailer loading area and tipping floor.

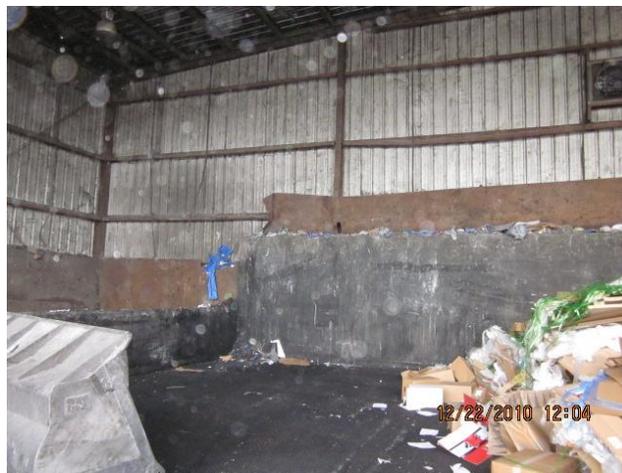
Waste build up on push wall and dirt buildup on walls.

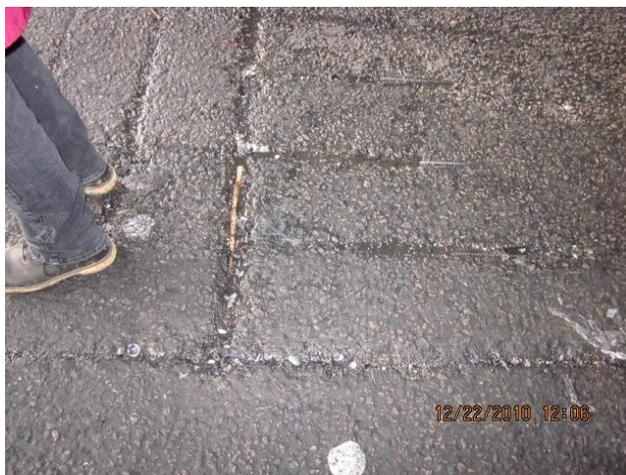
10. The tipping floor needs repair. There is worn concrete with exposed rebar and areas with cracks and crevices.
11. The 'as-built' drawings of the facility should be reviewed so that all employees know how the leachate collection systems work and in order to keep the leachate collection sites clean and in a good working condition. According to the June 2005 Operations Plan submitted with your 2005 Permit Renewal, Section 3.1 *"...The tipping floor and the transfer pit are cleaned at the end of each operating day. The tipping floor area drains to an 18 inch sump pit in an area near the center of the building. The transfer trailer loading areas include 2-foot by 2-foot sump drains in the center of the loading bays. The leachate from the MSW loading areas drains by gravity to two (2) oil/water/grit separators, into a sanitary sewer pump station that is located near the scales, and is then pumped to the Town of Weldon wastewater treatment facility."* All leachate collection areas must be kept clean and in free flowing condition.

Worn tipping floor with exposed rebar.

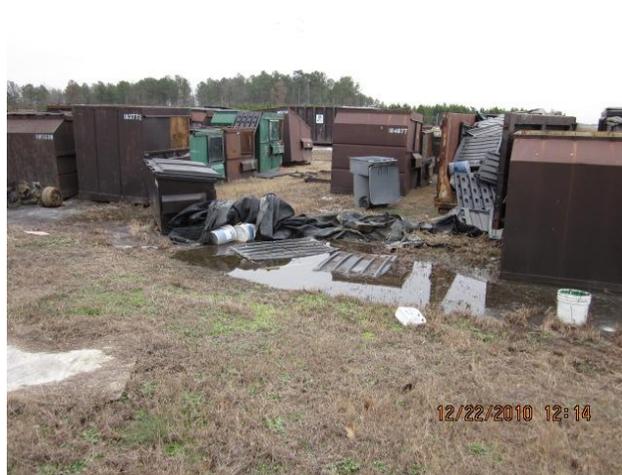
15. The area where the cardboard is being put into the compactor should be kept clean, as well as under the compactor to prevent vermin harborage.
16. There is ponding water in many places throughout the site. There was windblown trash in some of the areas of ponding water. All areas of ponding water should be repaired/ re-graded to prevent mosquito breeding and potential leachate problems.

Waste and ponding water behind the building.

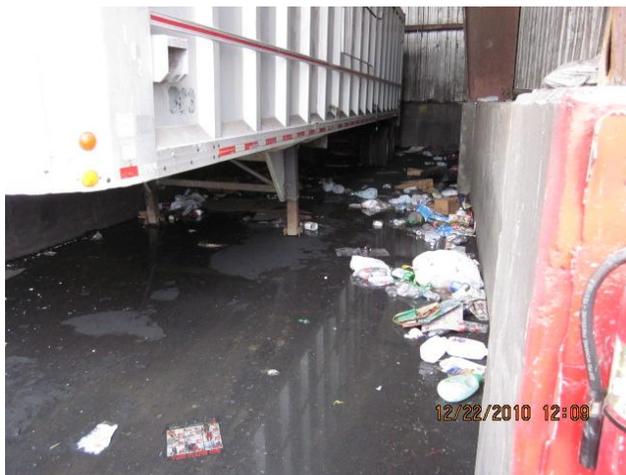
18. The area around the diesel tank on the trailer where leaking has occurred must be cleaned up and the tank repaired.
19. The co-mingled recyclables in the trailer, in the facility, are removed every three weeks. The area around the trailer is extremely dirty with recyclables on the ground. **This area needs to be cleaned daily.** If there are any recyclables in the trailer, the trailer must be covered at the end of each day. There was ponding water in this area. Repairs must be made to prevent the ponding of water.

Recyclables, water and other waste in trailer loading bay for recyclables.

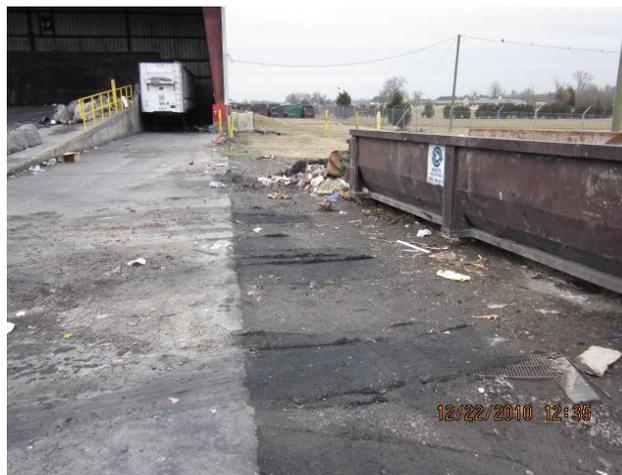
Waste around dumpster used by individual homeowners.

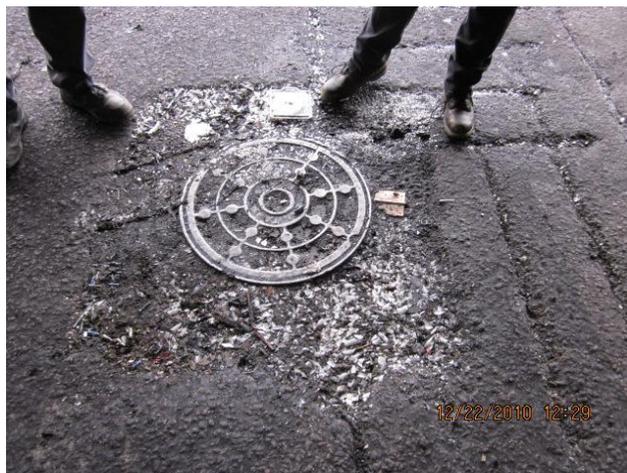
Sump pump and leachate collection in center of tipping floor?

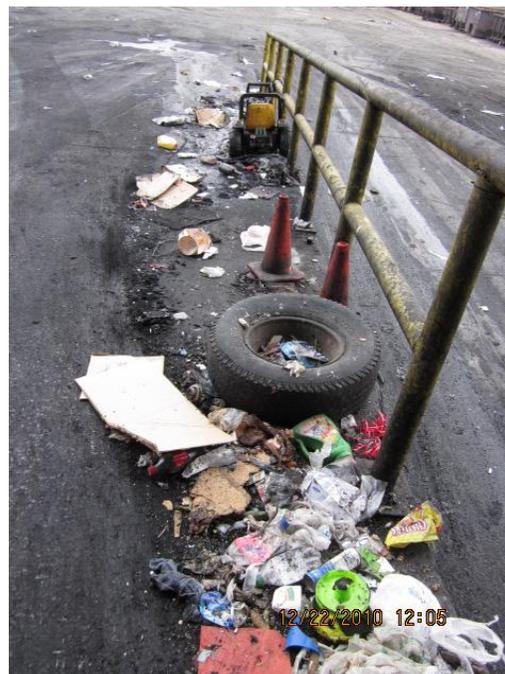
Buildup of waste near the trailer loading area.
