**FACILITY COMPLIANCE AUDIT REPORT**  
**Division of Waste Management**  
**Solid Waste Section**

**Date of Audit:** April 29, 2011**Date of Last Audit:** March 3, 2009**FACILITY NAME AND ADDRESS:**

Hertford County Closed MSW Landfill  
 227 Mount Moriah Road  
 Winton, NC 27986

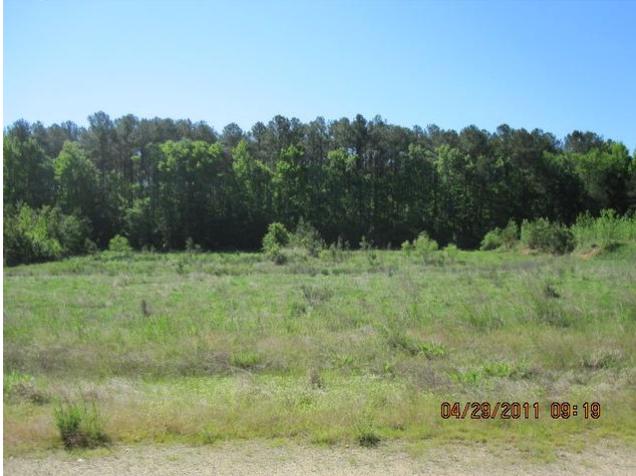
5. There was some woody plant growth on the landfill on both sides of the access road. These bushes and trees need to be removed.
  6. There was some slight erosion close to the access road which should have groundcover established to prevent this from occurring.

Trees and brushy growth that need to be cut.

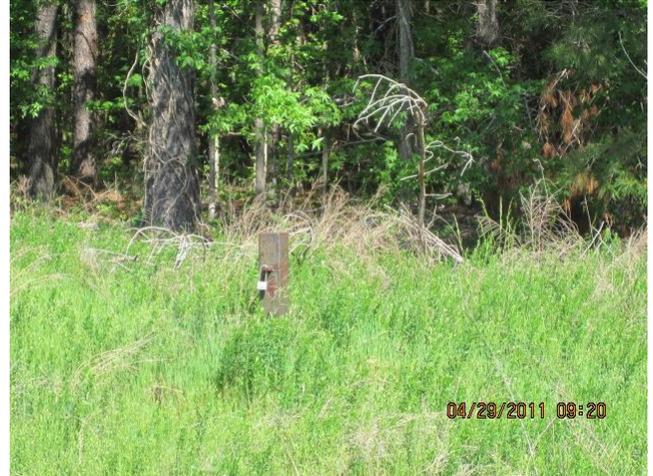
7. The Monitoring wells appeared to be locked and tags were in place.
  8. The groundwater and methane monitoring wells need to be clearly labeled at the wells, according to the site plan. Mr. Nichols assured us that this will be completed in the near future. After the inspection, Mr. Nichols called Whaley and asked if the labeling of the groundwater wells could be done in June when the semiannual samples are being collected, Whaley agreed.

Locked groundwater monitoring well

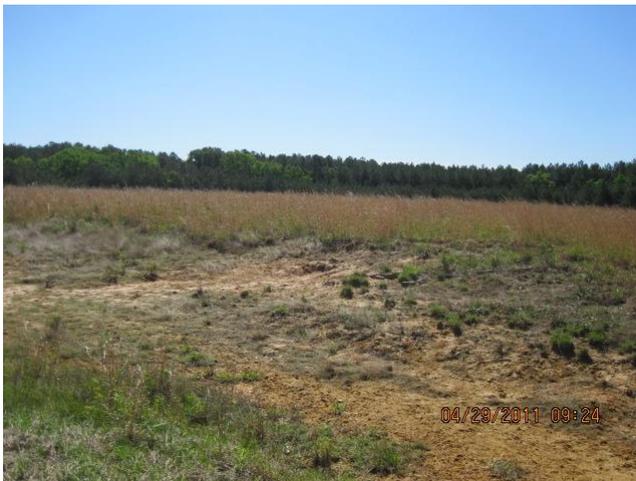
Some slight erosion along the access road

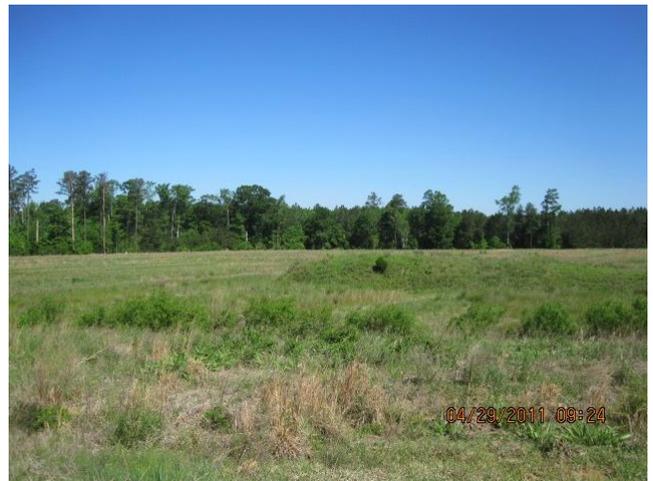
- of 1993, except for the disposal of the demolition debris of a hospital in 1995. There is a mound evident where the hospital was deposited.
2. The 'edge of waste' markers are clearly visible.

Northern side with brushy growth and mound where demolished hospital is located

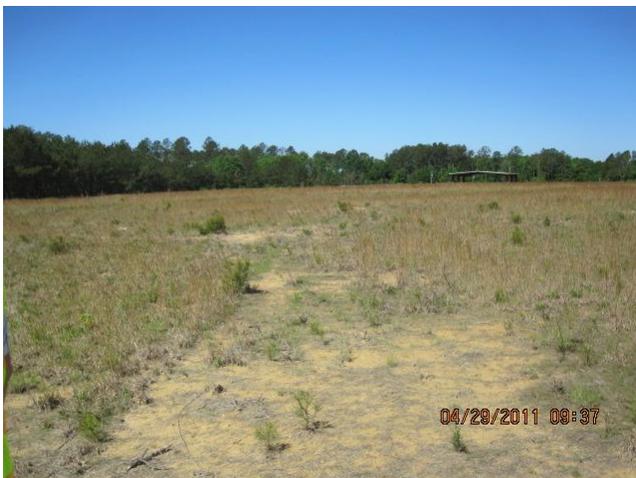
10. There were several bare areas on the LF to the south side of the road. These areas need to have ground cover established on them.
  11. There was no evidence of leachate observed.

Some of the bare areas needing ground cover
