**FACILITY COMPLIANCE INSPECTION REPORT**  
**Division of Waste Management**  
**Solid Waste Section**

**Date of Site Inspection:** 19 November 2012    **Date of Last Inspection:** 19 August 2011

Coastal Dragline Services LCID Landfill  
 175 Brown Farm Road  
 Vanceboro, NC 28586

N0668-20121119INSP

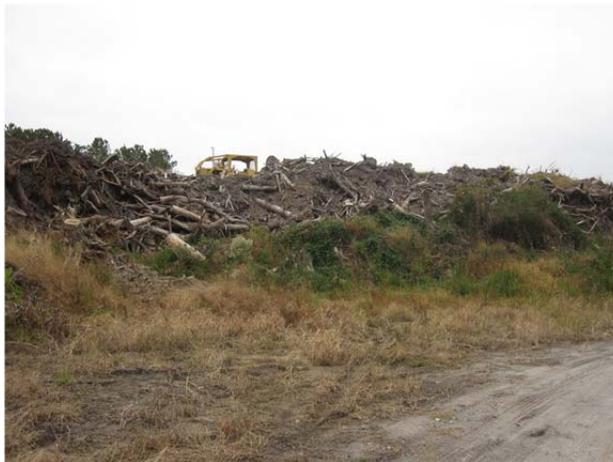
- 11) Several areas on the outside slopes of the landfill were noted as lacking adequate cover. \*Within thirty days of receipt of this Facility Compliance Inspection Report, please compact and cover these areas. All repaired areas should be compacted and graded at a slope of not greater than 3:1. All repaired and graded areas should then be seeded and mulched to establish a groundcover suitable to prevent erosion of the landfill cap.

Sideslope needing additional cover and compaction

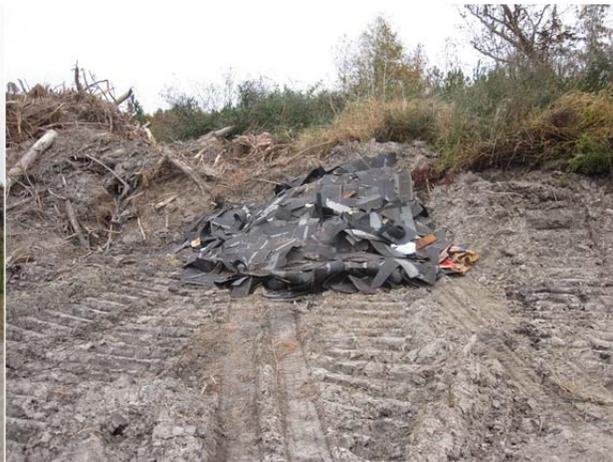
- 9) The waste type was reviewed. Overall, the waste being disposed is LCID waste only. However, one small load of scrap asphalt roofing shingles has been dumped adjacent to the access ramp on the top lift of the landfill. \*Please remove these materials and transport them to a Facility permitted to receive such wastes. The closest permitted Facility is the Coastal Environmental Partnership MSW Landfill, permit #25-09 off of Old Highway 70 in Tuscarora, Craven County, NC.

Unpermitted material needing removal and proper disposal
