FACILITY COMPLIANCE INSPECTION REPORT
Division of Waste Management
Solid Waste Section

Date of Site Inspection: 19 June 2013 **Date of Last Site Inspection:** 10 January 2013

Smith Pit II LCID Landfill
Herring-Smith Road
Newport, NC 28570

N0707-20130619INSP

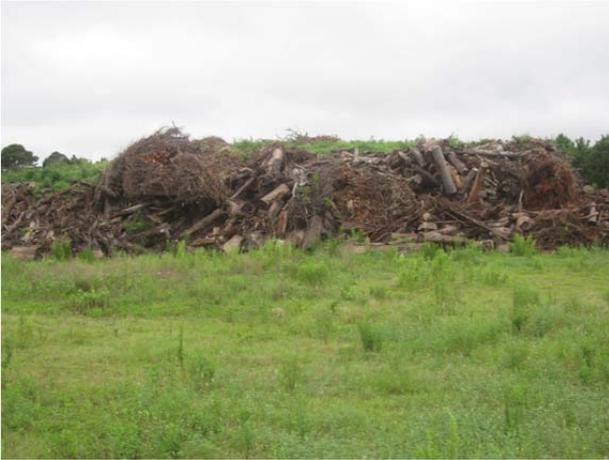
- 12) Overall, the landfill side slopes have been covered adequately and graded to promote positive drainage of surface waters; however, waste from the active working face has been disposed over the eastern side slope which needs to be covered and graded. *The landfill needs to be maintained in a series of vertical lifts. Please compact, cover, and grade the east side slope at a slope not greater than 3:1. This area should then be seeded and mulched to establish a groundcover suitable to prevent erosion of the landfill cap.

- 13) The landfill working face was less than one acre and is being maintained in a manageable size; however, waste from the working face has been pushed over the eastern side slope of the landfill. *Please ensure that the active working face is covered monthly or when it approaches one acre in size, whichever occurs first and that all newly disposed waste is maintained at the working face on the topmost lift.
