FACILITY COMPLIANCE INSPECTION REPORT
Division of Waste Management
Solid Waste Section

Date of Site Inspection: 9/26/2013

Yancey-Mitchell Transfer Station
 555 Landfill Road (SR-1440)
 Burnsville, NC 28714

Comprehensive Inspection

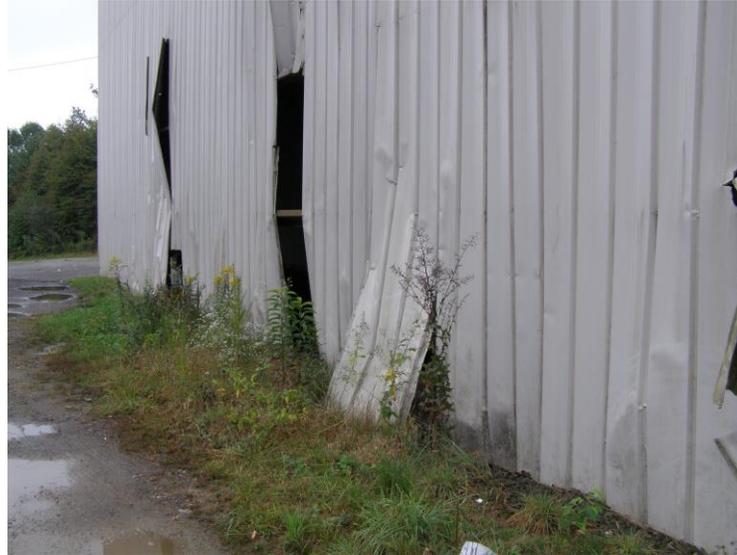
10. The interior walls surrounding the tipping floor had been recently washed. The interior walls of the transfer loading bay need to be washed.
11. There was some litter or windblown trash observed in the areas surrounding the transfer station. Please ensure that this waste is picked up daily as required in the approved operations plan.
12. In the report of the 12/5/2012 inspection the following comment was made: "Repairs are needed to the exterior walls of the transfer building at the loading bay. Large holes are present in the metal siding and the

metal siding is crushed at the entrance to the loading bay.” **The walls have sustained additional damage since the 12/5/2012 inspection. Waste may fall or be blown outside of the loading bay due to the large gaps.**

View of outer wall of transfer loading bay.
 Digital photograph taken by D. Aja on 9/26/2013.
