FACILITY COMPLIANCE INSPECTION REPORT
Division of Waste Management
Solid Waste Section

Date of Site Inspection: 11/13/2013, 12/3/2013

Buncombe County Solid Waste Management Facility
 85 Panther Branch Road
 Alexander, NC 28701

PURPOSE OF SITE VISIT: Comprehensive Inspection

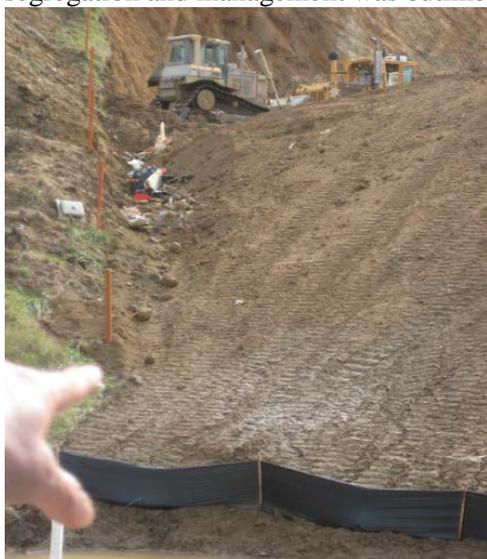
12/3/13

During the SDP-12 sediment basin inspection, below the working face, it was noted that a drainage channel was being maintained along the left side (looking from basin toward working face, see photo below). It was recommended that the facility review the PTO plans for this CDLF Unit to determine if surfacewater flow segregation and management was outlined (fill sequence, berm management, etc.) within the approved Plan.

It was understood that surface water in contact with the visible waste would be viewed as leachate and should be managed as such. The facility will work to exclude all wastes from this drainage channel, to

control surface waters away from the exposed waste area, and to actively manage the CDLF unit with the understanding that this design requires regular inspection and maintenance in order to operate as designed.

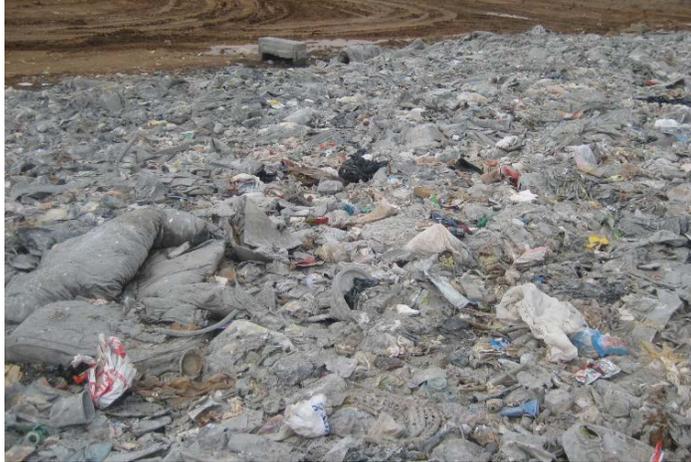
- a. Minimal windblown was noted at the facility.
- b. The approved Posi-shell ACM had been recently applied (see photo below). Alternate Cover Material (ACM) records were reviewed (being managed and maintained by S. Hunter) for 2013 at the office. The area (near edge of active face) discussed during the November 13, 2013 inspection had been recovered and was improved since the last visit. The posi-shell coverage was discussed (with J. Mears) – photo below – and the need for full coverage and/or reapplication of posi-shell was outlined.

Visible color can indicate a lack of full coverage.
