FACILITY COMPLIANCE INSPECTION REPORT
Division of Waste Management
Solid Waste Section

Date of Site Inspection: 10 July 2013

Carteret County Closed MSW Landfill
 Landfill Road
 Newport, NC

1602-20130710INSP

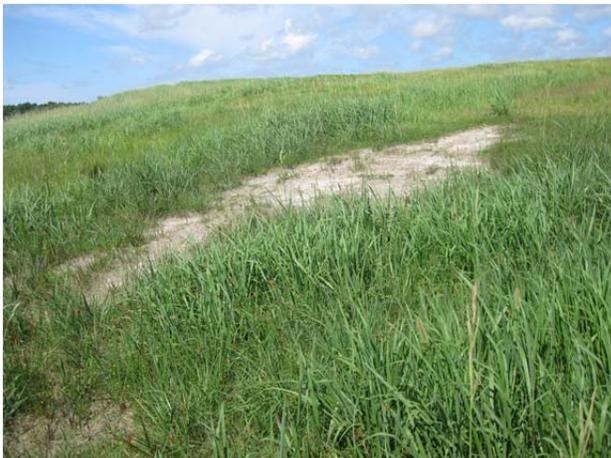
- 10) Overall, the landfill has a well-established and well maintained cover crop of native warm season grasses. However, several small areas of sparse cover crop were noted in various places around the top lift of the landfill. *Please repair these areas by seeding and mulching to establish a cover crop suitable to prevent erosion of your landfill cap system.

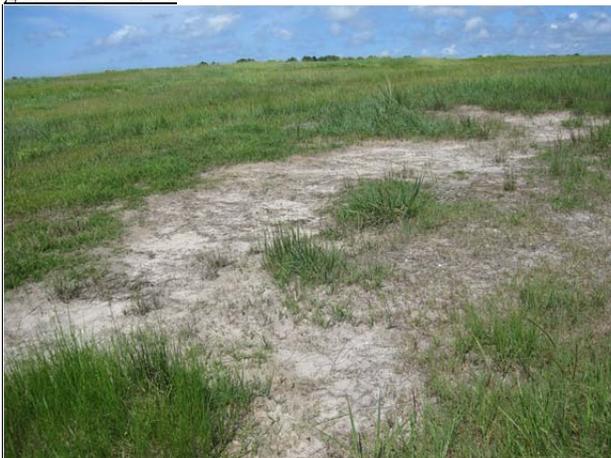
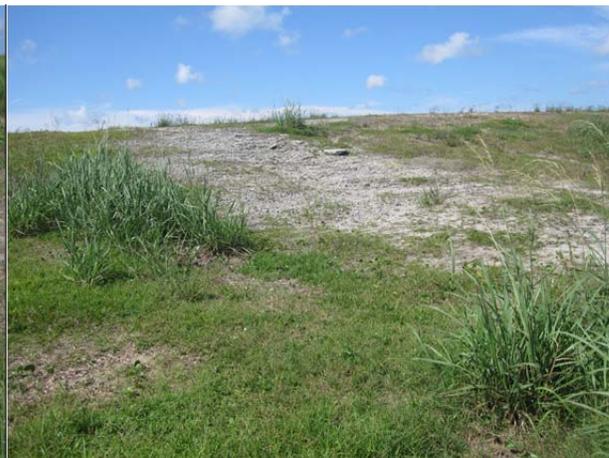
- 11) Soil has been stockpiled adjacent to the landfill access road for use in repair and maintenance of the landfill cap system.
- 12) Small areas of erosion were noted on the southern and western landfill sideslopes approximately halfway up from the toe of the slope. *Please work to repair these eroded areas by grading, seeding, and mulching as necessary to establish a groundcover suitable to prevent erosion of your landfill cap system. All repaired areas should be graded at a slope not greater than 3:1.
