Re: Compliance Inspection Response  
Flue Gas Desulfurization Landfill  
Permit No. 1809-INDUS  
Marshall Steam Station  
Terrell, North Carolina 28682

Attachments: 2014-03 1809-INDUS Leachate System Maintenance Report

*Video Inspection and Cleaning of Sewer and Storm Drain Systems*

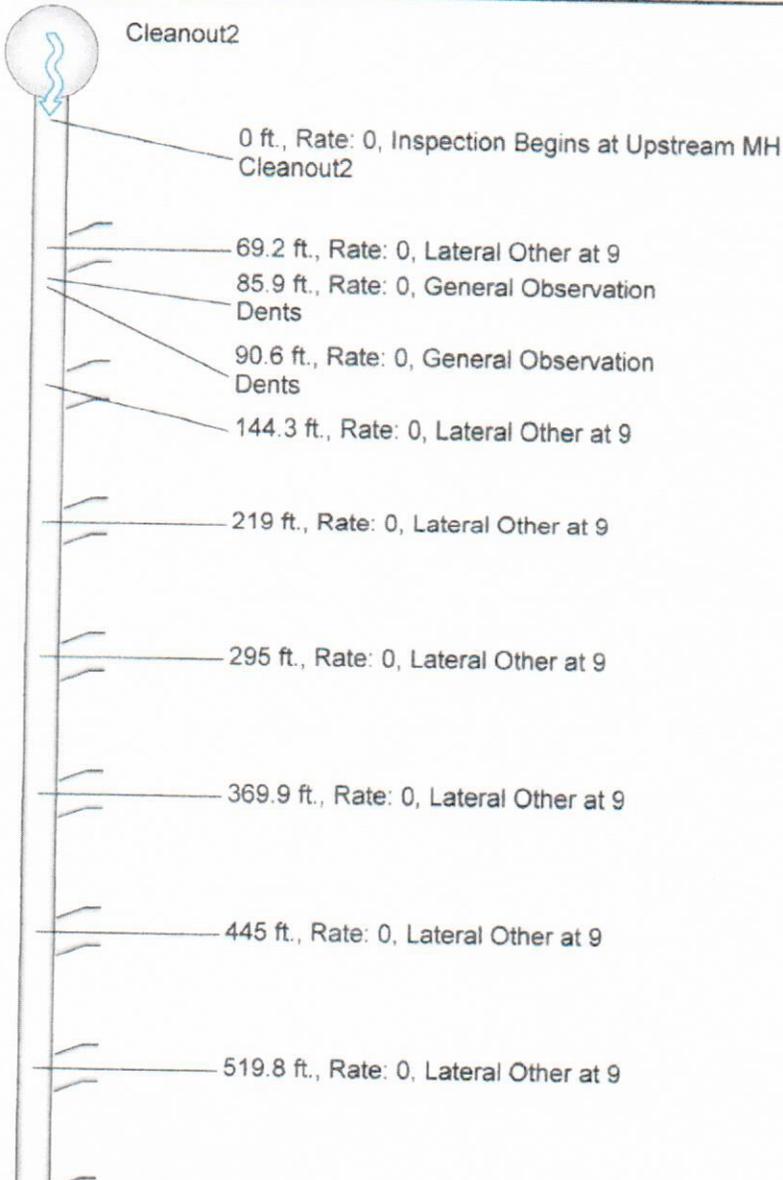
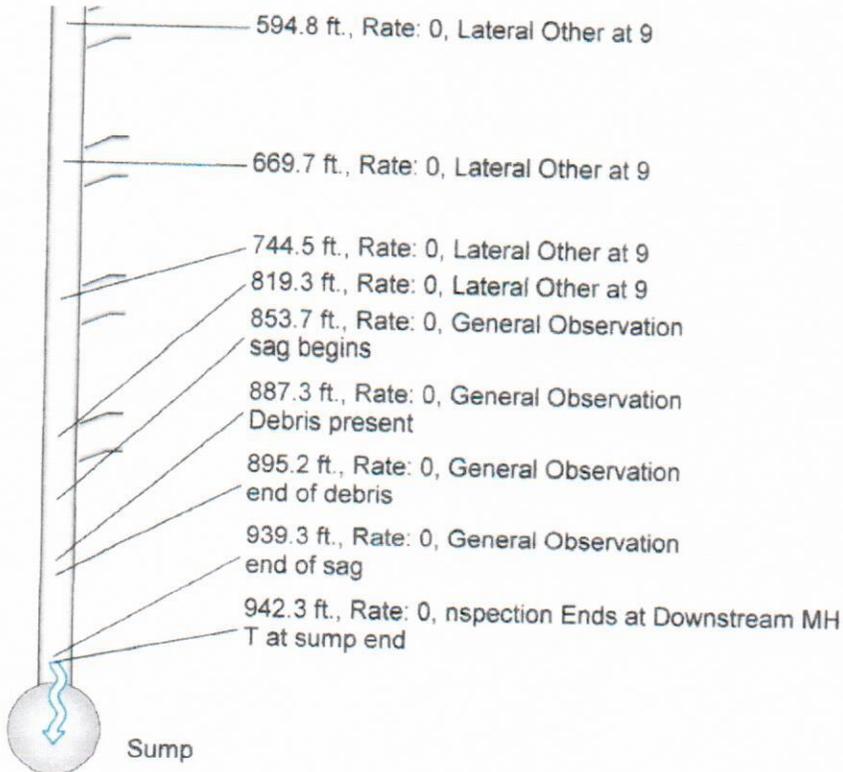
This letter is regarding the FGD Landfill leachate system at the Marshall Steam Station. The system has been cleaned off all debris, except for an 8 foot section of the Cleanout #2 line. At 887', from the access point, to 895' debris is approximately 1" – 2" in depth within a sag in the line that is approximately 85' in length. This was recorded and is documented with the accompanying DVD for the Cleanout #2 line. The Cleanout #1, #2, #3, #4 lines all appear to be functioning properly and were videoed to represent the functioning lines, as well as the sag in Cleanout #2.
