**FACILITY COMPLIANCE INSPECTION REPORT**  
**Division of Waste Management**  
**Solid Waste Section**

**Date of Site Inspection: March 6, 2014**

Currituck County Transfer Station  
 216 Airport Rd.  
 Maple, North Carolina 27956

Comprehensive inspection

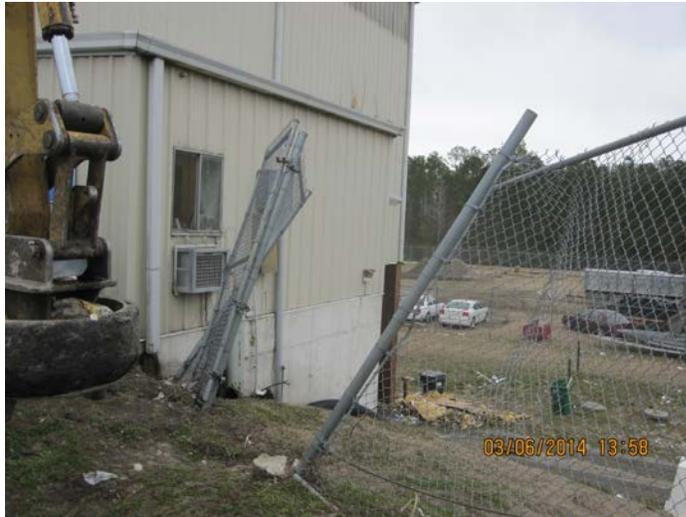
Fencing around the dumping area of the facility needs repair. McQueen indicated that a repair order has been submitted.

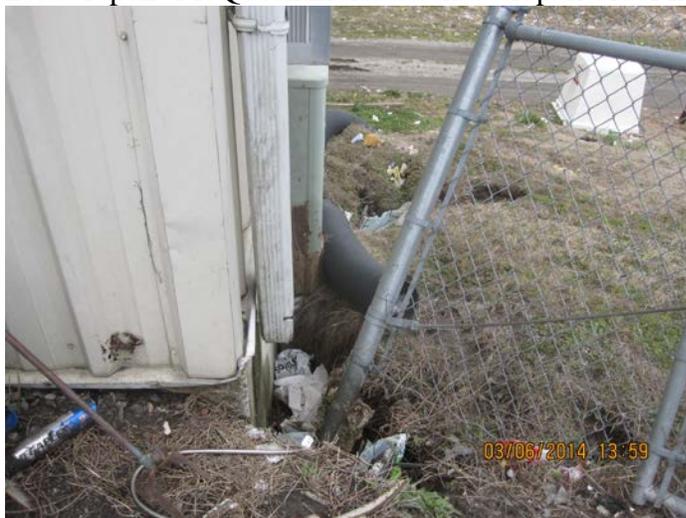
The downspout for the gutter system has become dislodged and is allowing runoff from the roof to wash soil away the anchor from the fencing around the turn area.

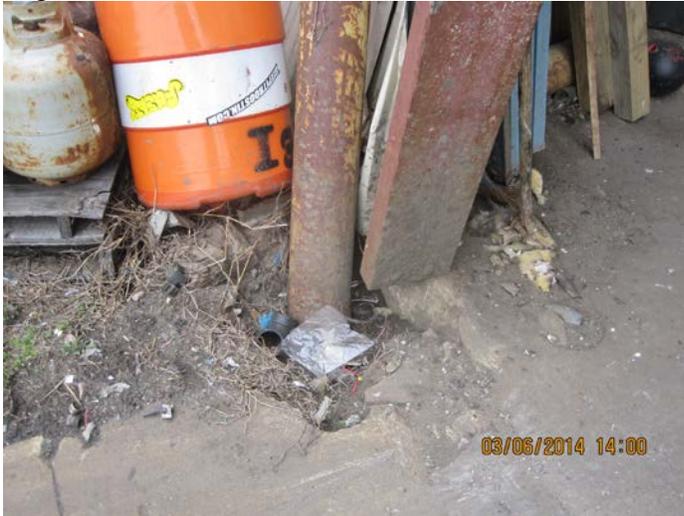
Other repairs needed at the front of the facility

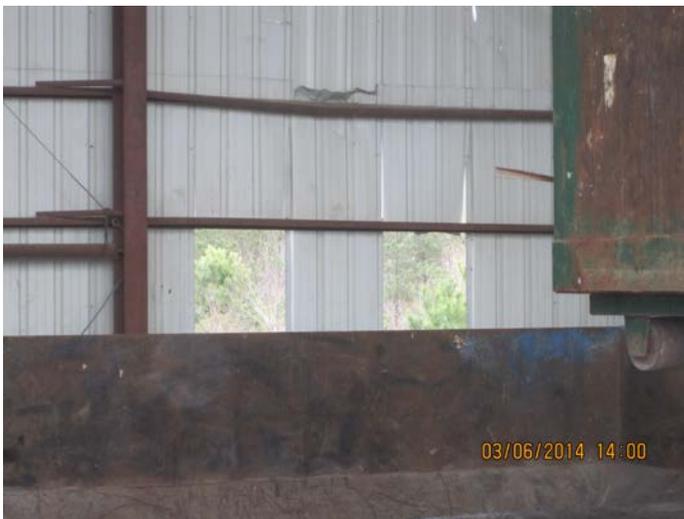
Repairs are needed for the siding on the back wall.

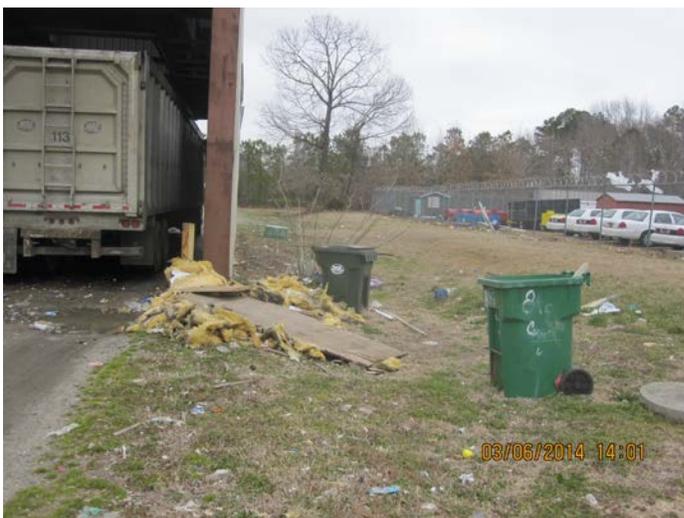
8. Scrap tires are being stored in trailers. Waste Management is handling transportation of the tires.
9. Insulation has been recently removed from the ceiling of the building. The need for this was noted in the previous inspection report.

Much waste material was scattered around the grounds. Insulation removed from the roof had been left piled outside of the building for several days.

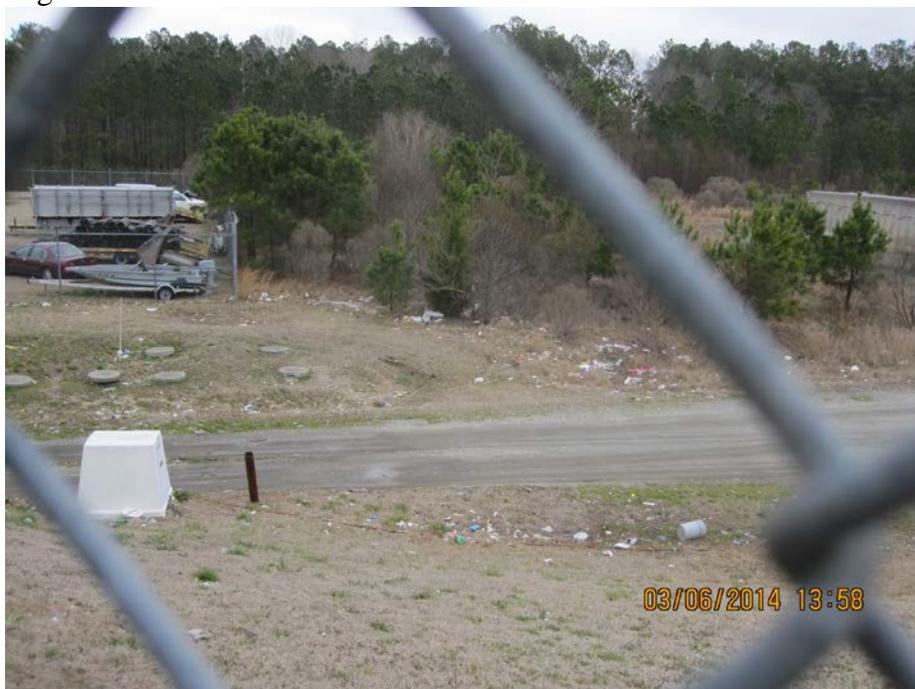
10. **There was much blown waste around the facility grounds. It could not be determined if this was from one day's operation or if the grounds had not been cleaned for several days. Blown litter must be removed daily.**

Much blown waste was observed outside of the building.

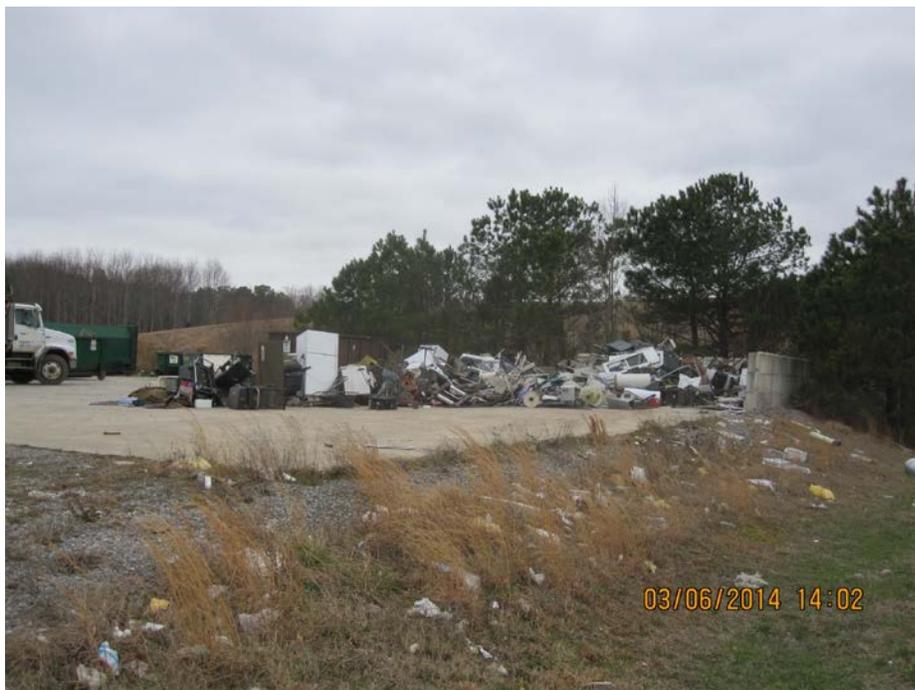
6. White goods need better management. **Freon containing white goods should be stacked neatly and marked for Freon removal.** Freon removal is being handled by Murky Waters Shawboro, NC.

White goods area, also showing blown waste
