**FACILITY COMPLIANCE INSPECTION REPORT**  
**Division of Waste Management**  
**Solid Waste Section**

**Date of Site Inspection:** March 6, 2014

Soundside Recycling & Materials Inc.  
 7565 Caratoke Hwy.  
 Jarvisburg, North Carolina 27947

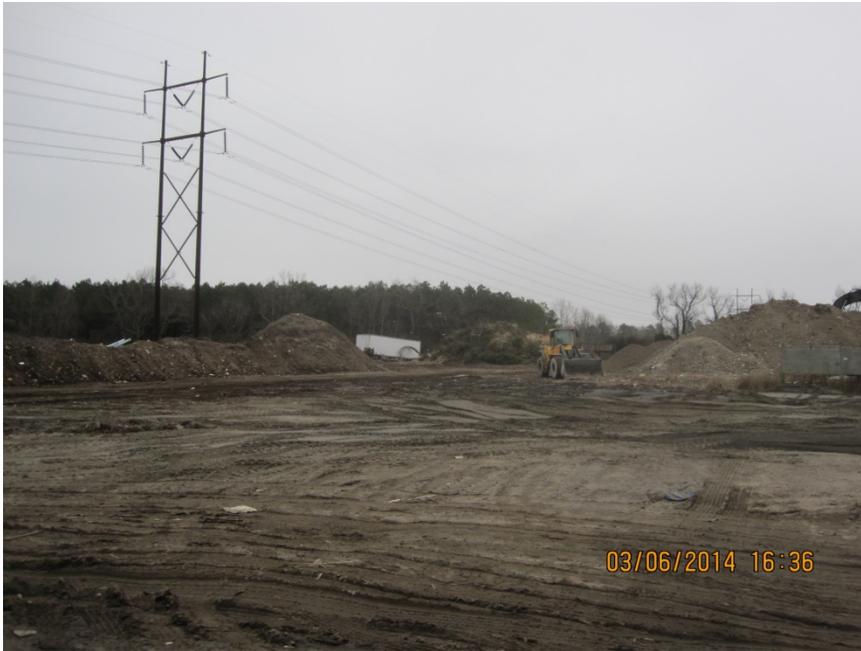
The mulch that had been spread out over the storage area has been removed and stockpiled

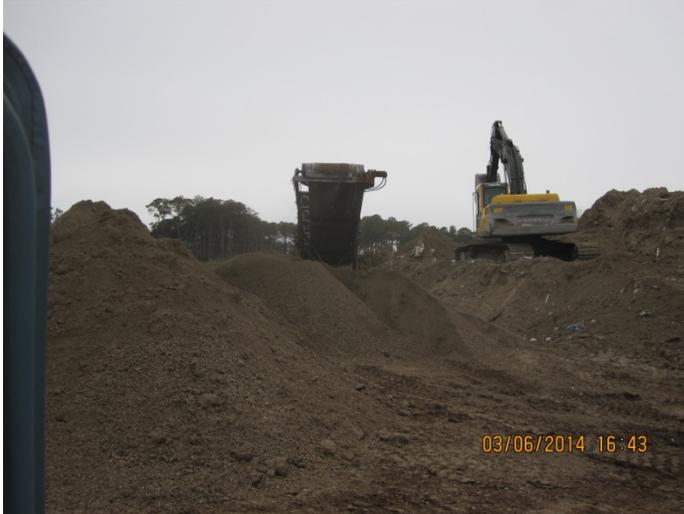
Gypsum is still being stored on the ground but was being screened during the time of this inspection in preparation for being land applied.

**General Facility Operations Condition 9 states in part:** Gypsum materials will be recovered or directly offloaded onto a crushed stone or concrete pad. The material will be allowed to weather and will be ground and screened to remove the paper. Gypsum storage will consist of a pile surrounded on three sides by 2-3 foot berms. A liner system similar to the compost pad design will be deployed under the stone base in this storage area. The pile will remain uncovered as the gypsum processing will be wet. The area under construction for the storage of gypsum should satisfy permit requirements if an engineer's certification is issued.

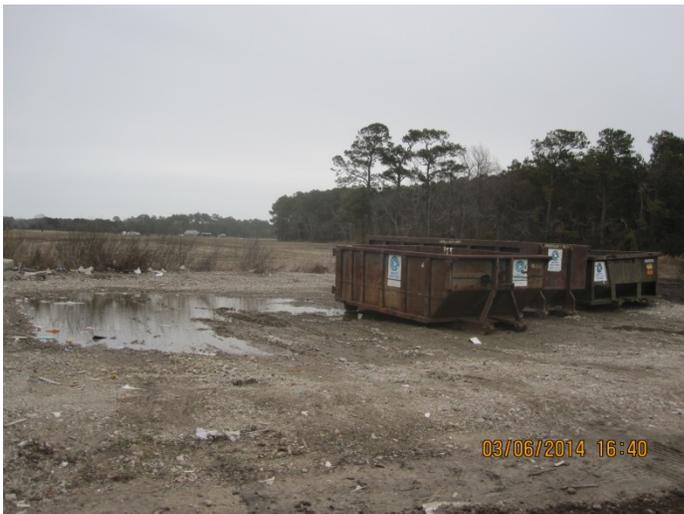
Location of the pad for the storage of incoming gypsum, care must be taken to ensure that the amount of stored gypsum can be contained within the boundaries of the pad. The footprint of gypsum pile currently being stored and processed on site far exceeds the size of this pad

20. **The pad for the storage of incoming gypsum has been constructed. Newbern has indicated that he is waiting for the engineer's certification.**
21. **Mark the permitted area with permanent stakes. Keep all activities not related to the transfer and treatment and processing of waste outside of the permitted boundary.**

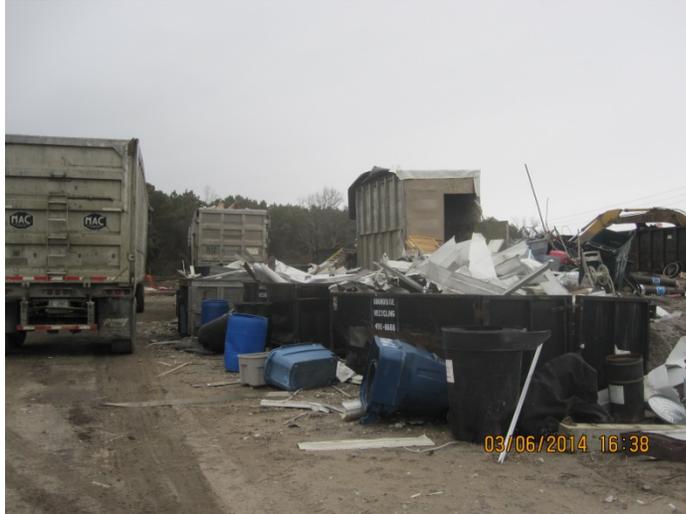
16. Metals for recycling are being stored in two 30 yd containers and three 10 yd containers. Plastics for recycling are being stored in six 10-12 yd containers. Shingles for recycling are being stored in two 30 yd containers. **Some of the containers are constructed of wood and are prone to being damaged and structural failure. Some of the containers were overfilled and could not be covered at the end of the working day as required.**

The containers storing plastics were not covered during the time of the inspection but must be covered at the end of each operating day. **Permit to Operate Condition Number 17 states in part:** Recycled materials and waste tires placed in containers must be removed from the site once the container is full. Some of the containers for the recyclables are constructed of wood and are prone to being damaged. A hole is observed in side of one of containers. The containers are overfilled.

Loose cardboard and plastic (not baled), metal, glass, and shingles must be sorted and stored in containers by the end of each operating day. Containers must be covered at the end of each operating day and during precipitation events.

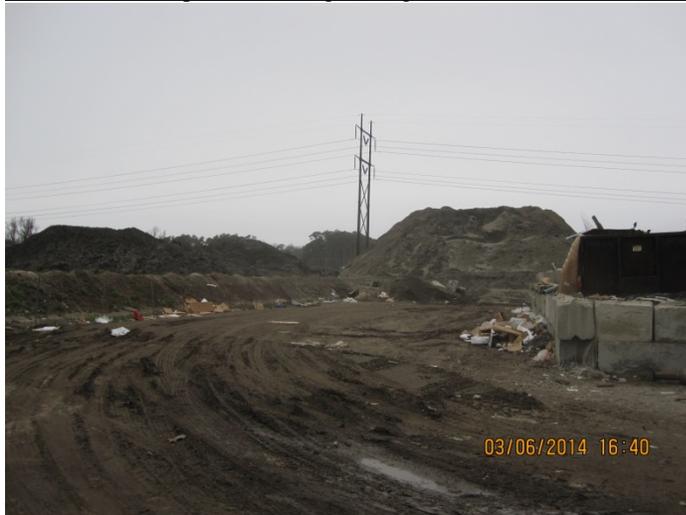
The grounds were generally clean, waste was being contained by the berm and fencing. Conditions were very windy on the date of the inspection.

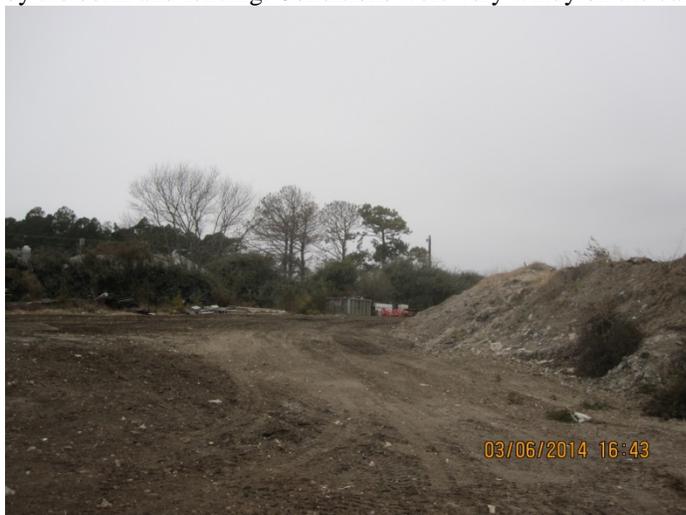
Shingles that were stored on the ground have been removed.
