**FACILITY COMPLIANCE INSPECTION REPORT**  
**Division of Waste Management**  
**Solid Waste Section**

**Date of Site Inspection: September 11, 2013**

Eastern Composting LLC  
 8487 Battleboro-Leggett Rd  
 Battleboro, North Carolina 27809

Partial inspection of Type IV Compost Facility

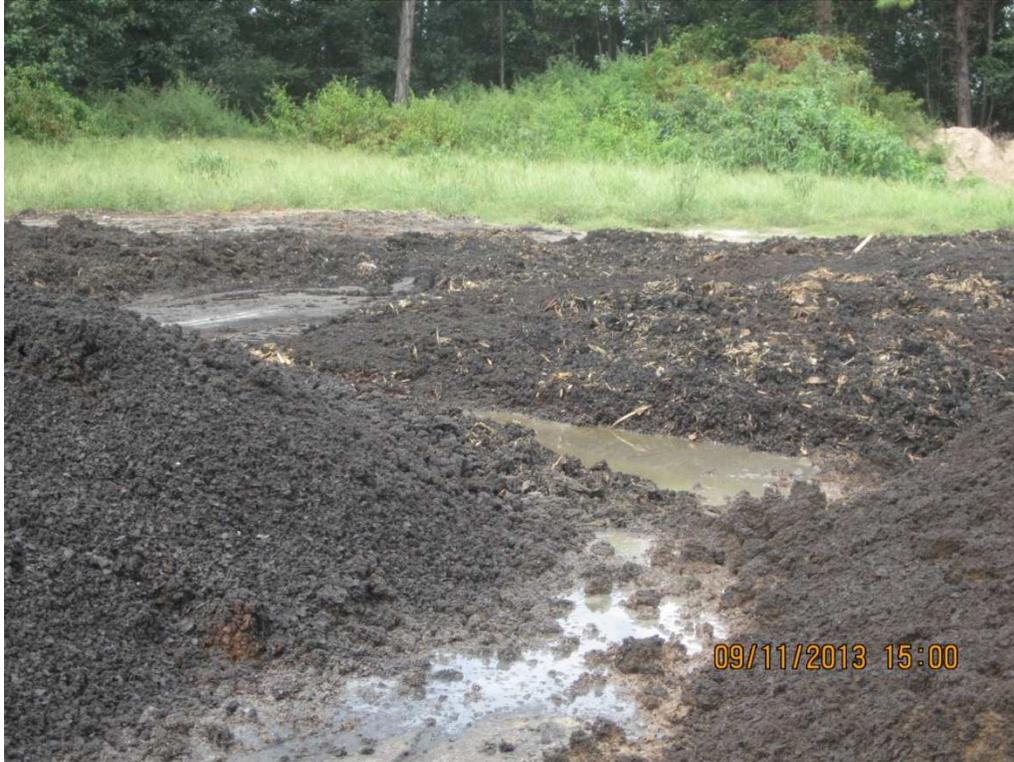
Leachate is being impounded between piles of incoming feedstock. This pile is located near the lower slope of the pad and is exposed to the maximum amount of runoff.

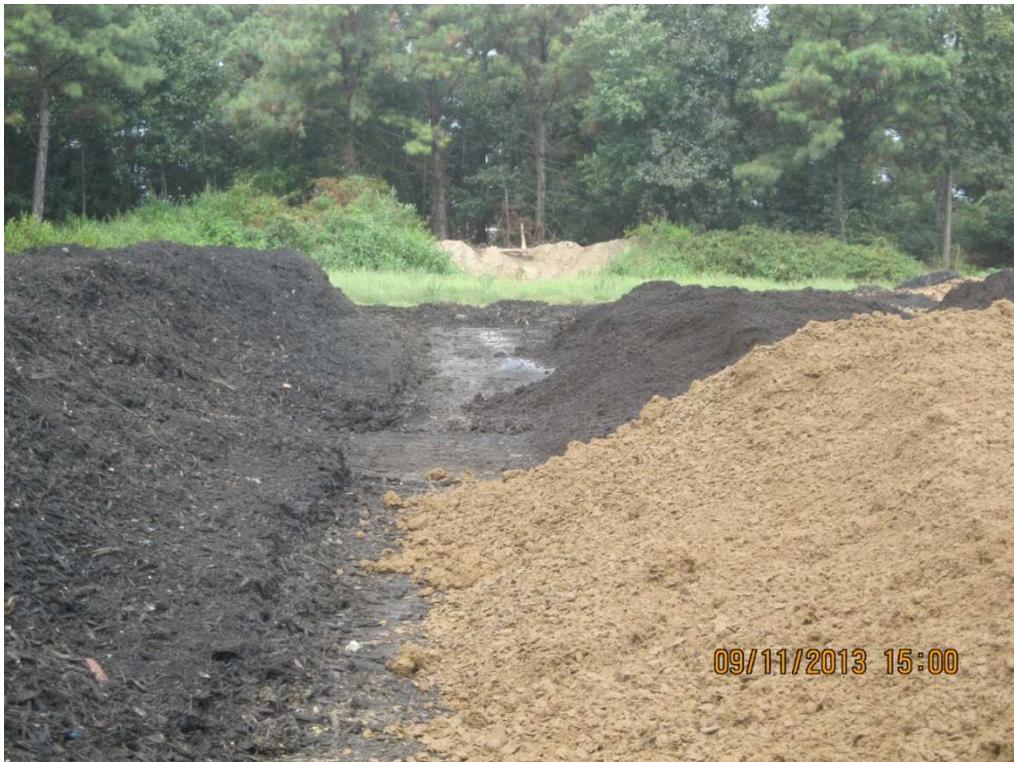
More leachate is being impounded between piles of incoming feedstock. This material is windrowed but is also located at the base of the pad and is exposed to the maximum amount of runoff.

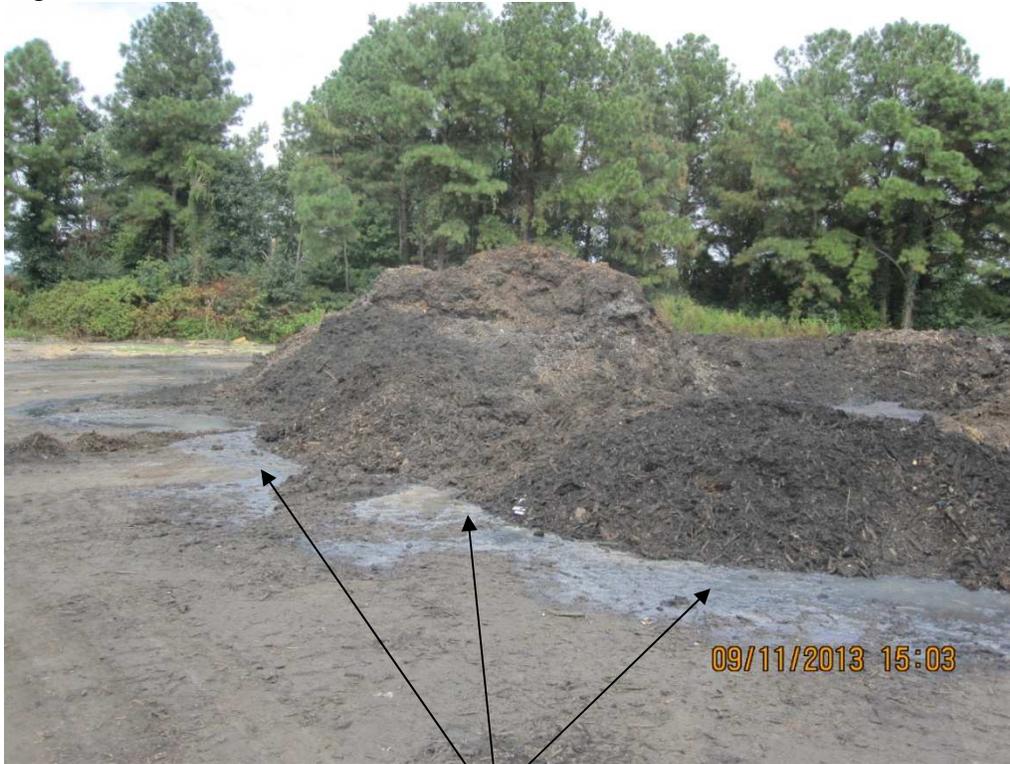
Runoff is being impounded against a pile of incoming feedstock. Windrowing the incoming feedstock upon receipt in the direction of runoff flow and placement upslope of the pad would minimize the amount of runoff flowing past this material and greatly reduce leachate generation.

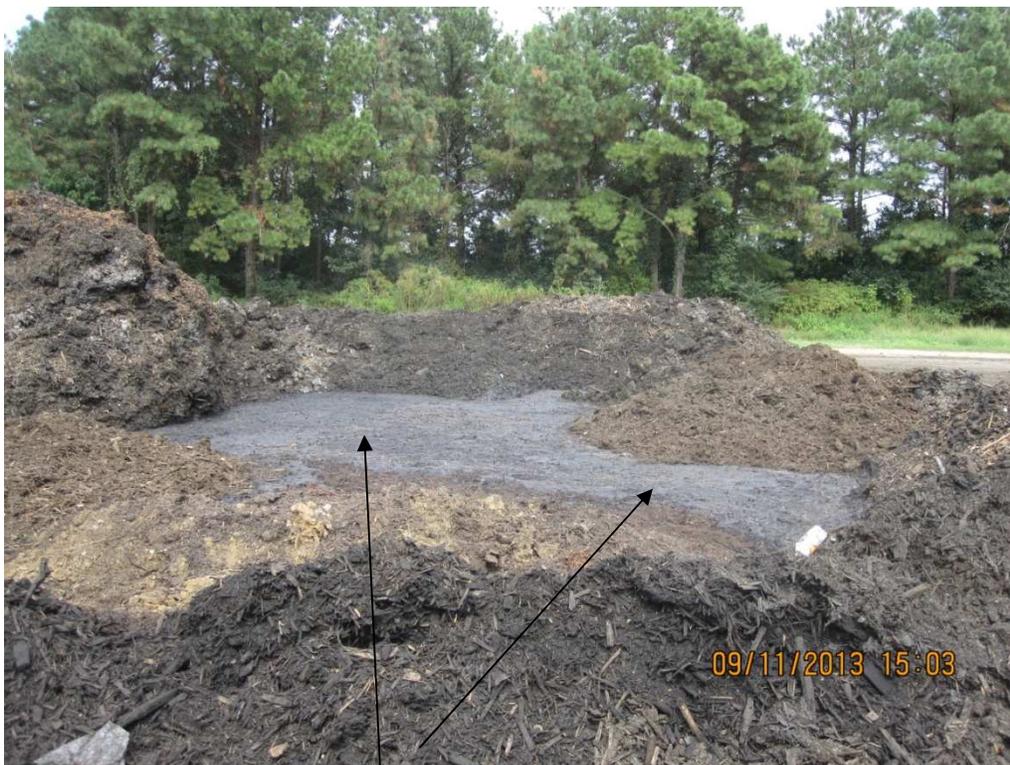
Grease being mixed with other incoming feedstock on the pad. A better method to store and manage incoming grease material needs to be found.

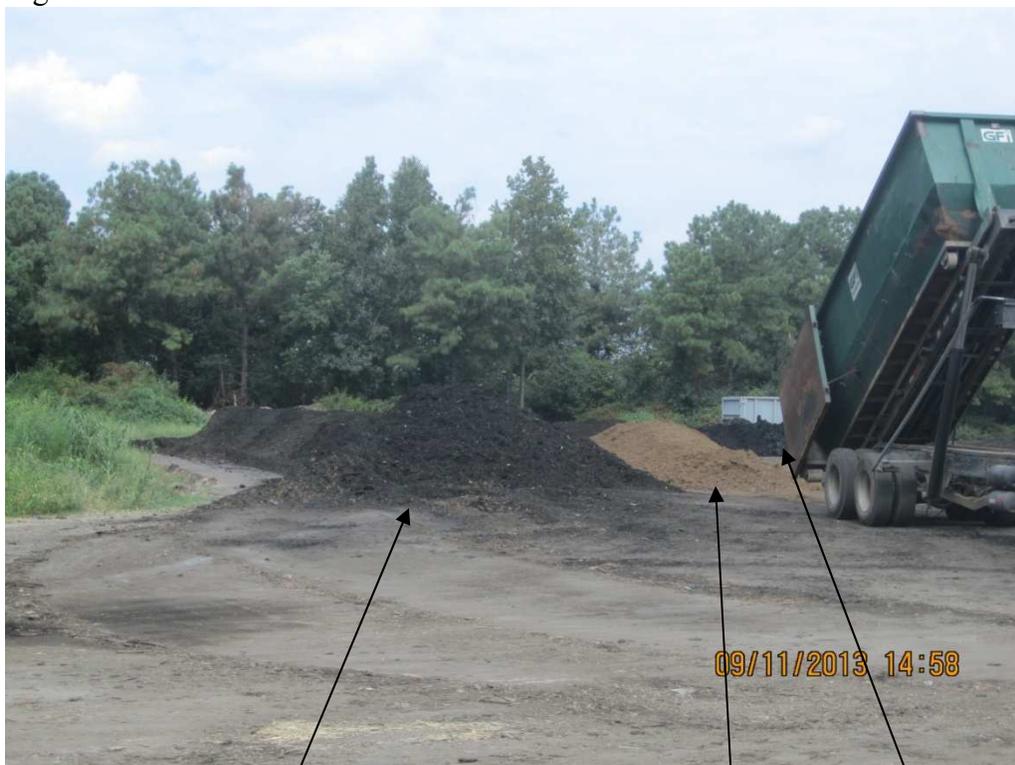
Better placement of incoming feedstock in the foreground. Material has been windrowed and the pile was started up slope. Feedstock in the background is not being managed properly. Placement of the feedstock in a windrow along the direction of the pad slope would diminish contact between the runoff and the material and minimize leachate generation.

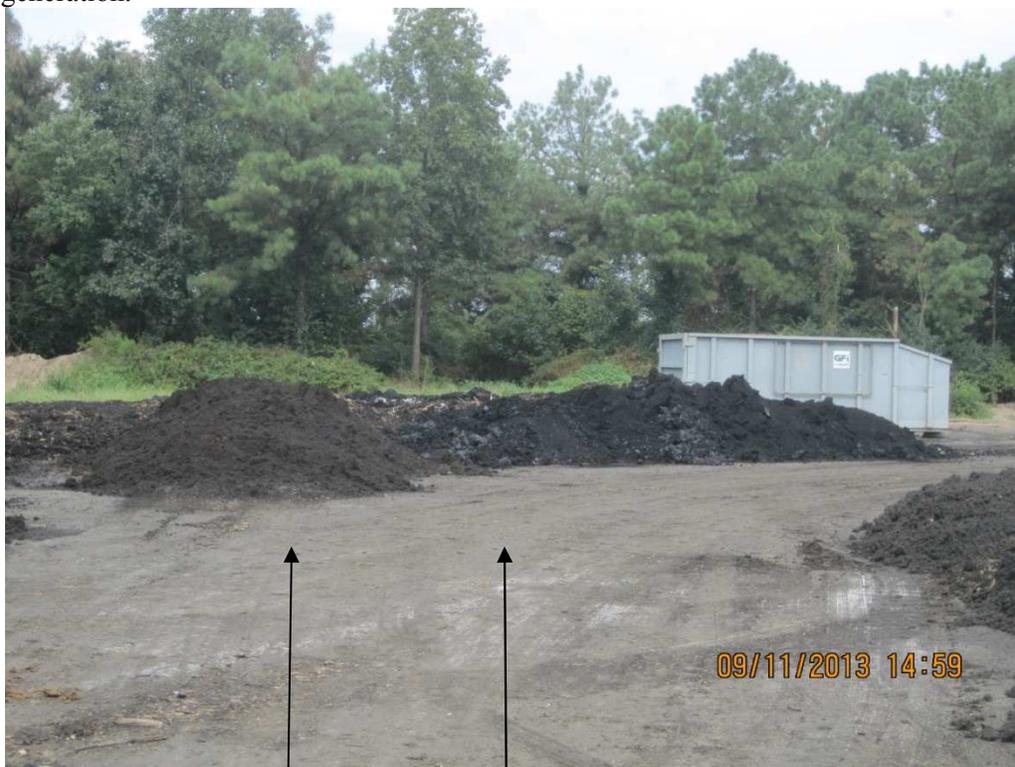
Incoming feedstock improperly placed a right angle to the direction of pad slope that would tend to dam runoff in the event of rain. Direction of slope. Placement of this material in a windrow along the direction pad slope would diminish contact between the runoff and feedstock and minimize leachate generation.

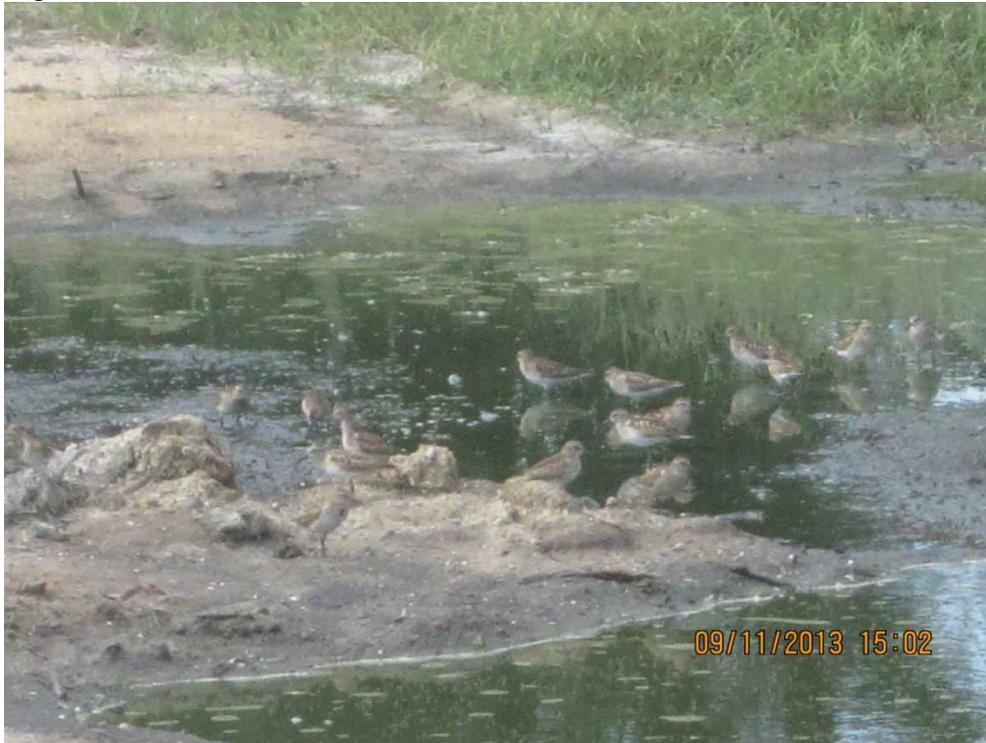
Runoff ponded at the base of the pad.
