FACILITY COMPLIANCE INSPECTION REPORT
Division of Waste Management
Solid Waste Section

Date of Site Inspection: 05/14/14

Duke Energy, Allen Steam Station – Retired Ash Basin (RAB)
 253 Plant Allen Road
 Belmont, NC 28012

Comprehensive Compliance Inspection

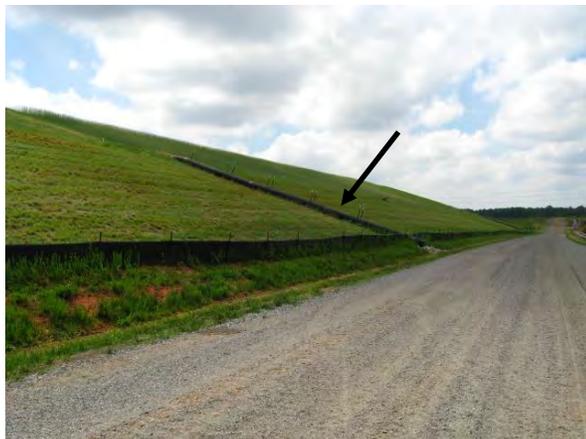
11. There are three 'chimney drains' in Cell 2 of Phase 1 that collect and direct storm water that contacts the coal ash to the leachate collection system. (Photo #1)
12. Both the edge of waste and the edge of liner are identified with white PVC markers.
13. The side slopes of the landfill had well sloped and have an established vegetative cover. (Photos 1 &2).

1. Looking (S) down the perimeter road, at the eastern slopes the landfill. (Note the "down slope" drain pipe in the center of the photo.)

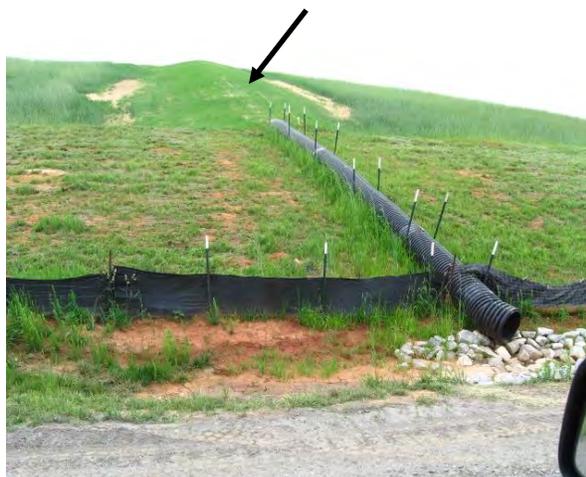
2. Down slope drain located eastern side of the landfill, near the SW corner. (Note the upper portions of the drain are now covered with soil for increased stabilization.)

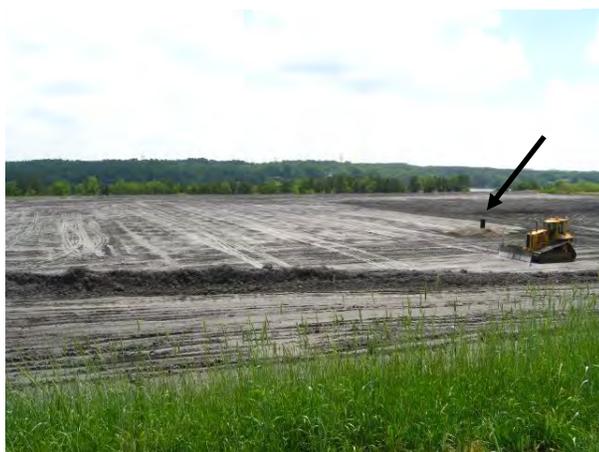
3. Looking (N) at Cell 2, in Phase 1. (Note one of the three "chimney drain" the right center of the photo.)

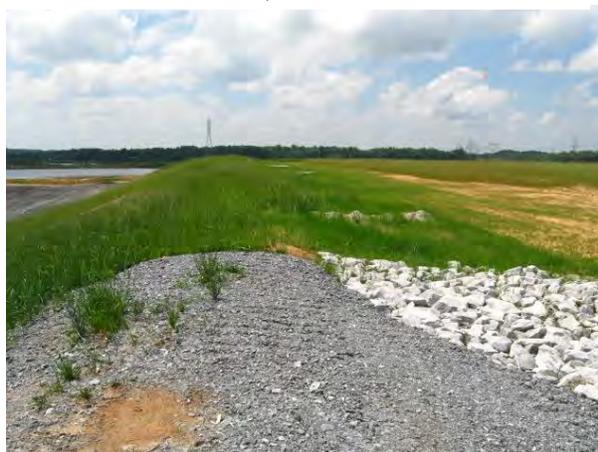
4. Looking (N) across the top of Phase 1, Cell 2.

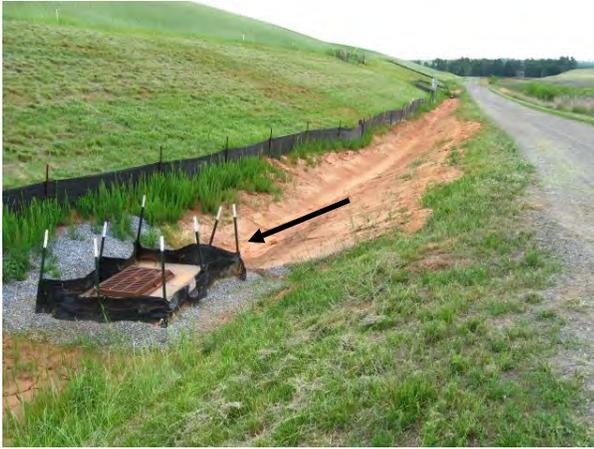
14. The perimeter stormwater ditches are free of excessive sediments and well maintained. (Photo #5)
15. The sediment basin on the south side of the landfill is well maintained and appears to be relatively free of sediments. (Photo #6)
16. The access roads are well maintained. (Photo #1)
17. Dust is very well controlled.
18. Daily management and operations of the landfill is carried out by CHARA, Inc.

5. Looking (E) down the perimeter ditch on the (S) side of the landfill. (Note the drop inlet in the ditch, on the left.)

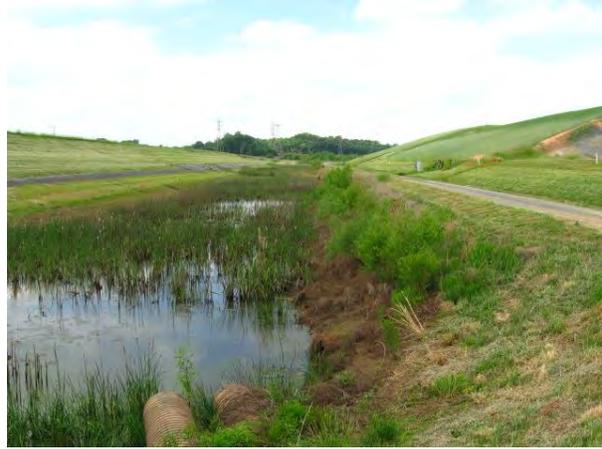
6. Looking (W) down the sediment basin located to the (S) of the landfill. (Landfill is in right.)
