FACILITY COMPLIANCE INSPECTION REPORT
Division of Waste Management
Solid Waste Section

FACILITY NAME AND ADDRESS:
 Duke Energy, Allen Steam Station – Retired Ash Basin (RAB)
 253 Plant Allen Road
 Belmont, NC 28012

PURPOSE OF SITE VISIT:
 Partial Compliance Inspections in response to two separate reported “off-liner” release of waste on 12/27/13 and on 1/13/14.

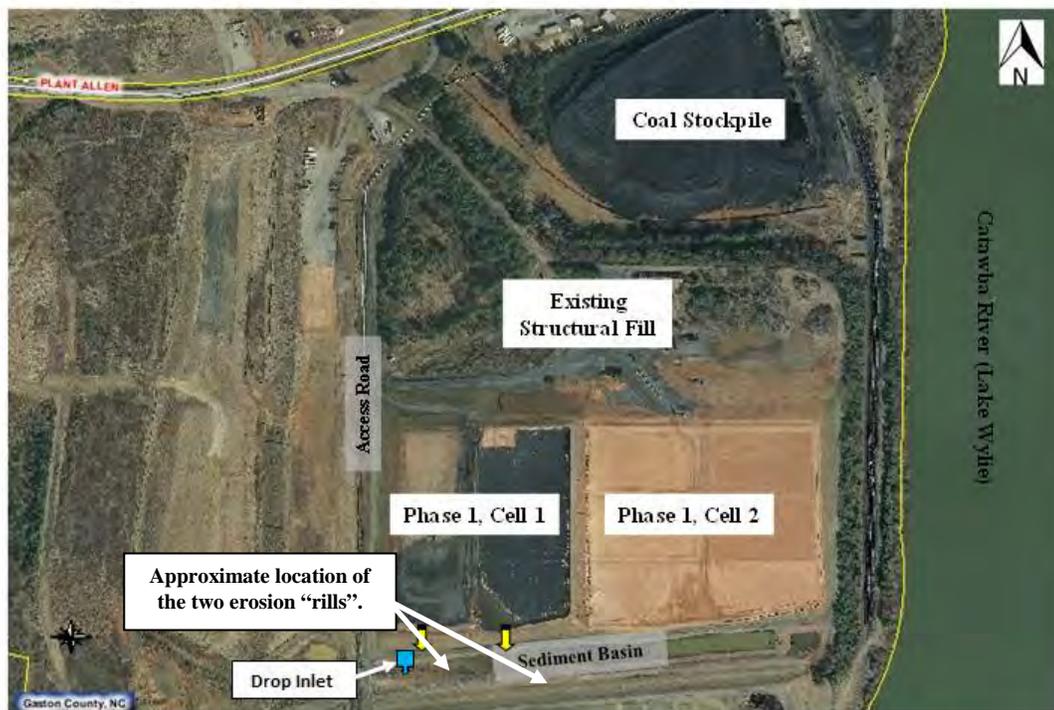
Site Map of the Approximate Location of the “Off-site”
Release of Waste and Silt on 12/27/13

- a) The release was discovered at approximately 7:15AM on 12/23/13.
 - b) The release occurred on the southern slope of Cell 1 of Phase 1.
 - c) Heavy rainfall (approximately 3-inches in the 16-hours leading up to the discovery of the release) caused two “significant erosion rills” from the cap of Cell 1 of Phase 1 to the southern perimeter stormwater perimeter ditch.

7. The current active area of the landfill is Cell 2, of Phase 1. (Figure 1)
8. The retired ash basin (RAB) landfill has been constructed on top of a former structural fill landfill.

9. There are three ‘chimney drains’ in Cell 2 of Phase 1 that collect and direct storm water that contacts the coal ash to the leachate collection system. (Figure 1 and Photo #1)

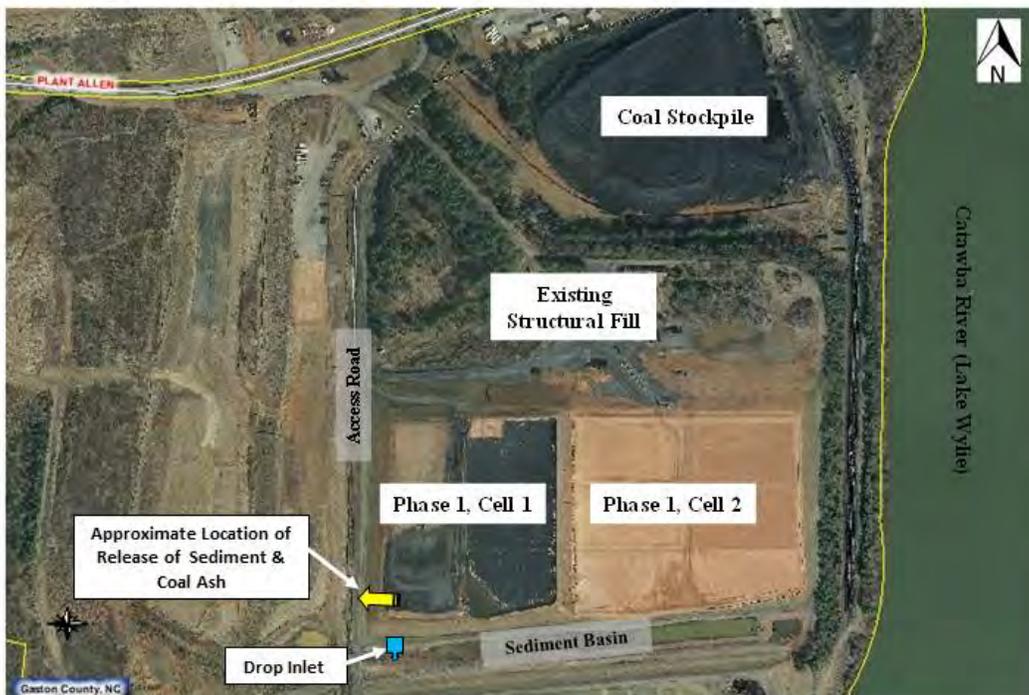
Site Map of the Approximate Location of the “Off-site”
Release of Waste and Silt on 1/12/14

- g) The release occurred when the inlet to the “down slope drain” in the SW corner of the top of the landfill became blocked during a heavy rain event (approximately 2.5-inches) on Saturday (1/11/14) and Sunday 1/12/14. This caused stormwater run-off on the cap of Cell 1 of Phase 1, to spill over the top of the containment berm and flow down the western slope, off the liner, and to the perimeter stormwater ditch. It did not appear that any sediment or waste moved beyond the perimeter stormwater ditch in the immediate vicinity of the outfall of the “down slope drain”. (Photos 1,2,3,4, & 6)

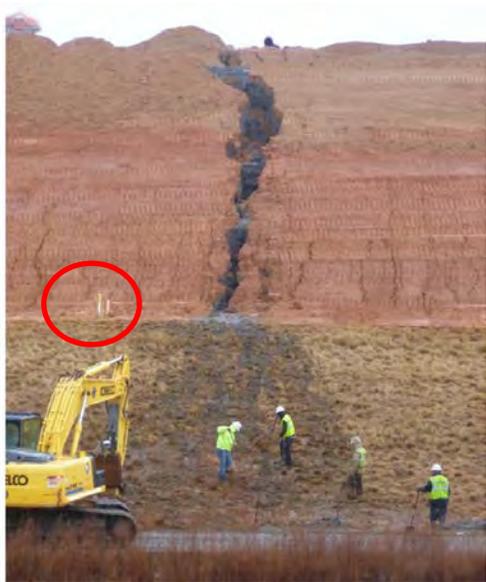
1. Western “rill” in the (S) slopes of the landfill under repair. (Photo taken by Duke Energy 12/23/13) Note edge-of-waste maker.

- d) Crews immediately began repairing the two rills
 - e) Crews also recovered the coal ash and soil that had been released beyond the edge of the landfill liner. This material was returned to the landfill.

- f) Two additional “down drains” will be installed on the southern slope of Cell 1 of Phase 1 to control surface water runoff.

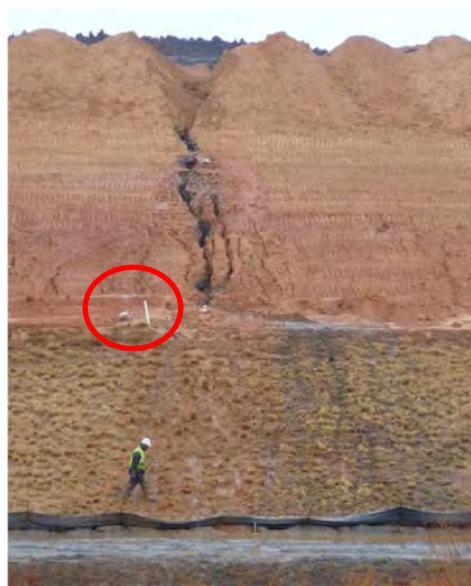
2. Eastern “rill” in the (S) slopes of the landfill. (Photo taken by Duke Energy 12/23/13) Note edge-of-waste marker.

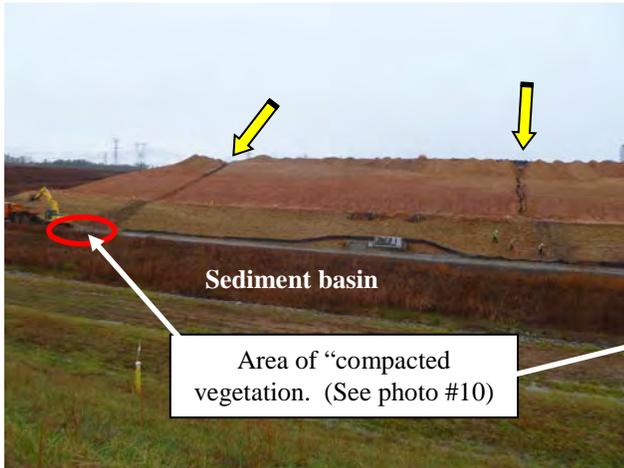
3. Looking (N) across the sediment basin at the two "rills" on the (S) slope of the landfill. (Photo taken by Duke Energy 12/23/13)

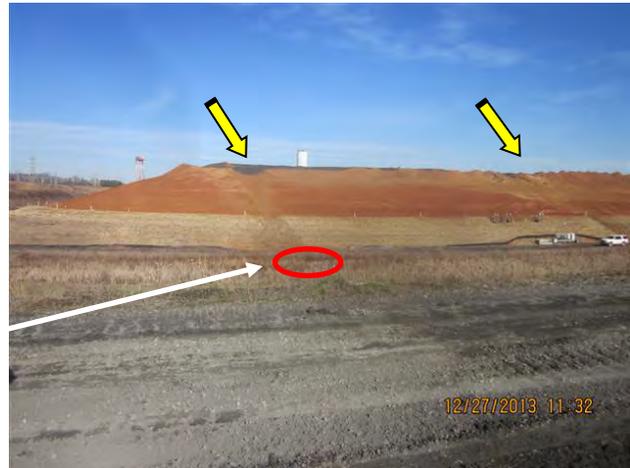
4. Looking (N) at the (S) slopes of the landfill at the two repaired "rills" caused by stormwater runoff from the cap of Phase 1. Photo taken by B.Wagner 12/27/13.

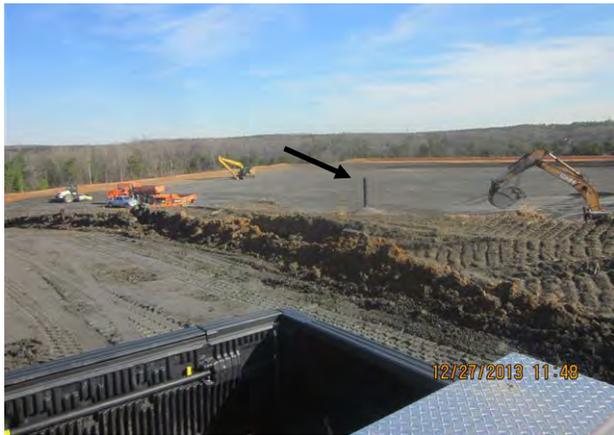
5. Looking (NNE) at Cell 2, in Phase 1. (Note the "chimney drain".) Photo taken by B.Wagner 12/27/13.

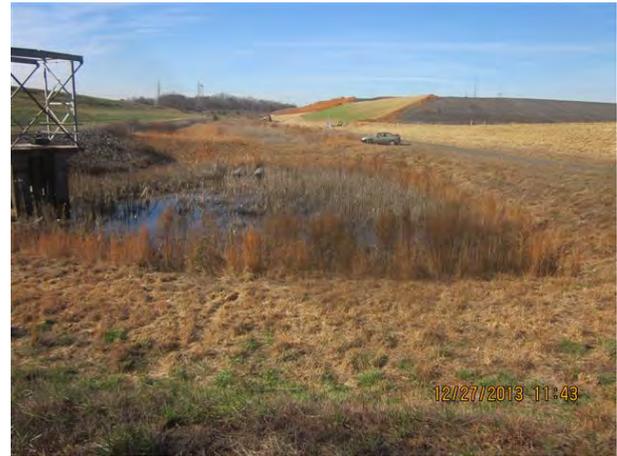
6. Looking (W) down the sediment basin located to the (S) of the landfill. (Landfill is in the upper right background.) Photo taken by B.Wagner 12/27/13.

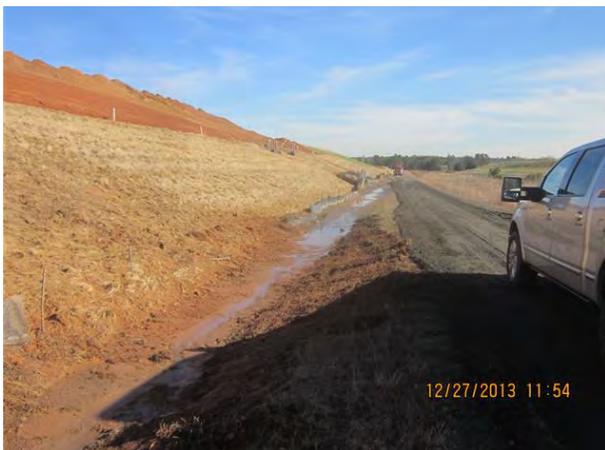
7. Looking (E) down the perimeter road on the (S) side of the landfill., Cell 2, Section A, at the cap on Phase 1, Cell 1, Section B. Photo taken by B.Wagner 12/27/13.

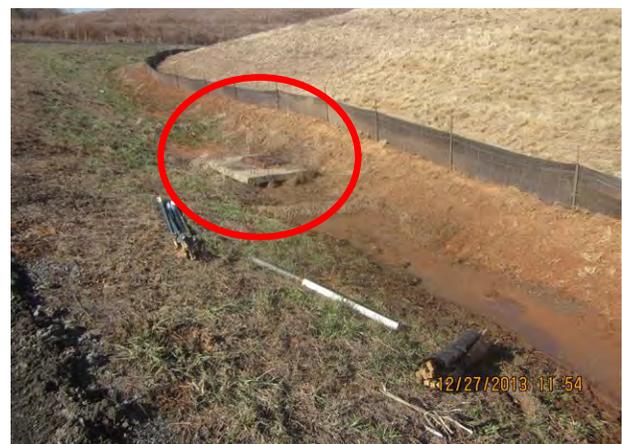
8. "Drop inlet" at the (W) end of the perimeter ditch on the (S) side of the landfill. Photo taken by B.Wagner 12/27/13.

12. There is a “drop inlet” at the western end of the perimeter stormwater ditch that channels the contents of the stormwater ditch to the sediment basin on the south side of the landfill. (Figure 1 & Photo #8)
13. There was no visual evidence that any ash or soil associated with this episode reached the sediment basin.
14. Other than the two “erosion rills” on the southern slope, the landfill does not exhibit any excessive on-site erosion.
15. The side slopes of the landfill had well sloped.

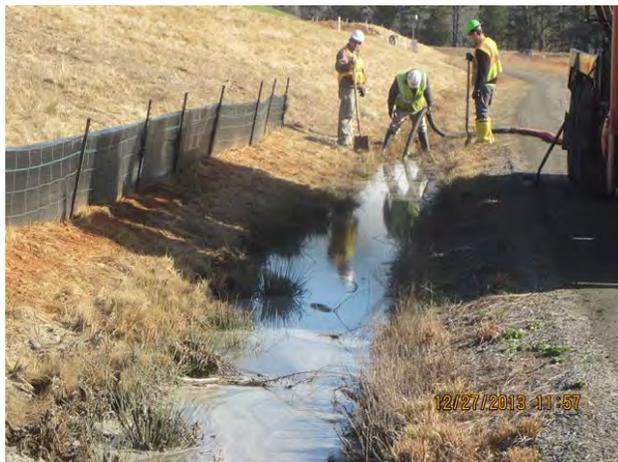
9. Crew vacuuming stormwater from the perimeter ditch on the (S) side of the landfill. Photo taken by B.Wagner 12/27/13.

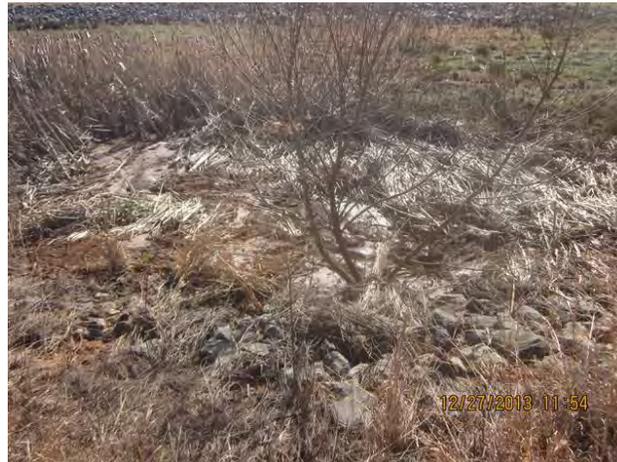
10. Both the edge of waste and the edge of liner are identified with white PVC markers.
11. While it appeared that leachate from the two “rills” was mostly held within the limits of the perimeter stormwater ditch, there was matted vegetation in the sediment basin that suggested that leachate and / or stormwater had spilled from the perimeter ditch, over the perimeter access road and into the sediment basin. (Photo #10)

10. Vegetation in the sediment basin compacted by runoff from the outfall of the western rill. Photo taken by B.Wagner 12/27/13.

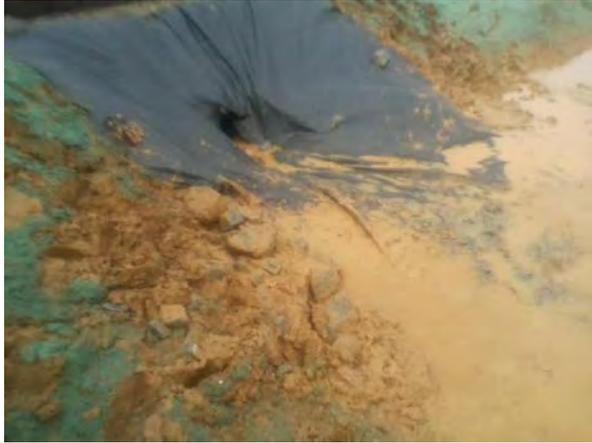
11. Inlet to the “down slope drain” in the SW corner of landfill after initial repairs. (Photo taken by Duke Energy on 1/12/14)

- h) Crews recovered the coal ash and soil that had been released beyond the edge of the landfill liner. This material was returned to the landfill.
 - i) The inlet to the “down slope drain” was repaired. (Photo #1)

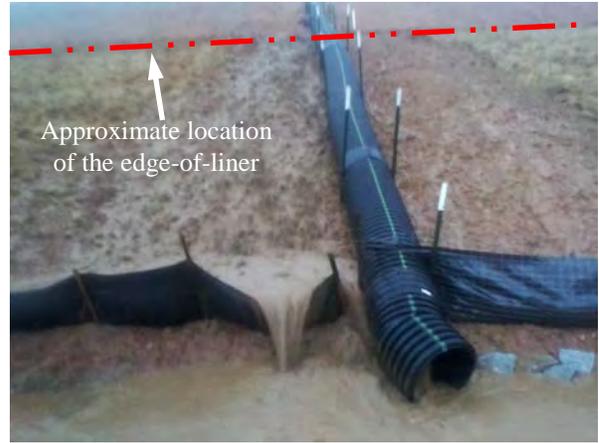
12. Out fall of the “down slope drain” in the SW corner of landfill. Note the surface water runoff spilling over the silt fence into the perimeter stormwater ditch. (Photo taken by Duke Energy on 1/12/14)

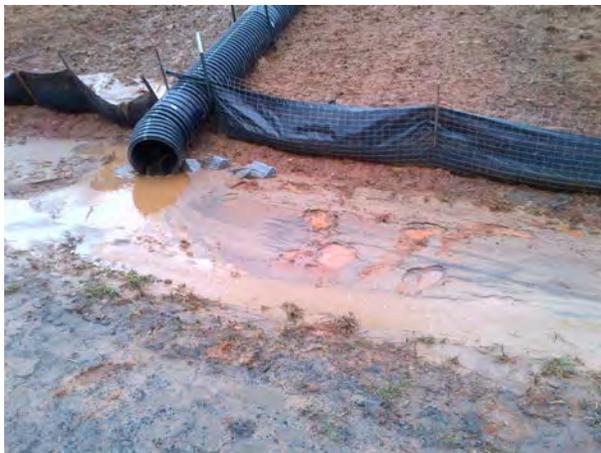
13. Perimeter stormwater ditch partially filled with sediment & possibly waste, at the outfall of the “down slope drain” in the SW corner of landfill. (Photo taken by Duke Energy on 1/12/14)

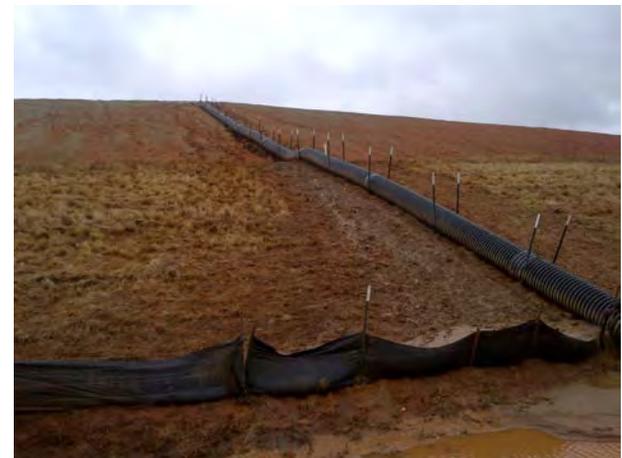
14. “Down slope drain” in the SW corner of landfill and the silt fence after the rain event and before being repaired. (Photo taken by Duke Energy on 1/12/14)

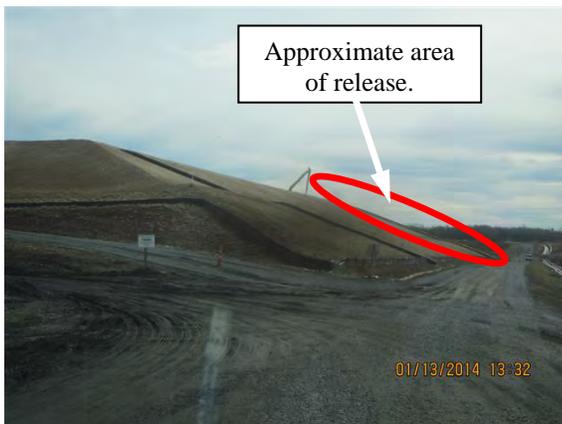
15. Looking (S) the NW corner of Phase 1, Cell 1, of the RAB landfill. (Photo taken by B.Wagner on 1/13/14)

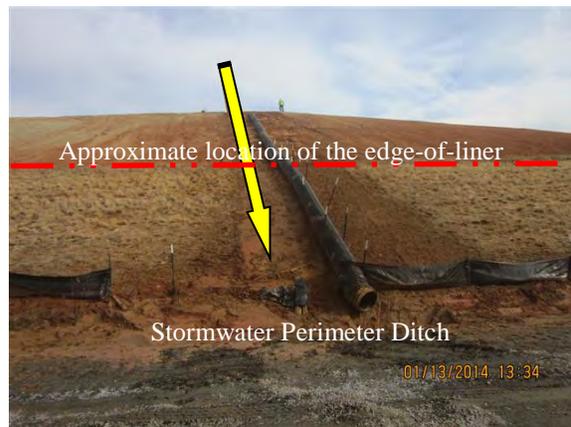
16. Looking (E), from the perimeter road, at the repaired & cleaned up path of the release of sediment & coal ash. (Photo taken by B.Wagner on 1/13/14)

- 17. On the early afternoon of Monday 1/13/14 *Chara* (Duke Energy’s construction subcontractor) finishing up repairs to the slope, the down slope drain and to the perimeter stormwater ditch of the landfill. (Photos 16 - 19)
- 18. There was no evidence that any waste had migrated beyond the stormwater perimeter ditch in the immediate area of the outfall from the down slope drain in the SW corner of the landfill. (Photos 17 -20)
- 19. None of the other three down slope drains were adversely impacted.
- 20. Since October 2012 this is the fourth incidence of the release of waste off of the liner due to heavy rains.

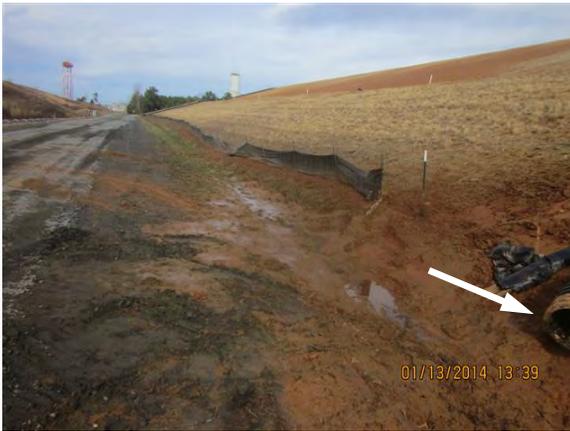
17. Looking (N) down the perimeter ditch on the (W) side of the landfill. Outfall of the down slope drain is on the lower right. (Photo taken by B.Wagner on 1/13/14)

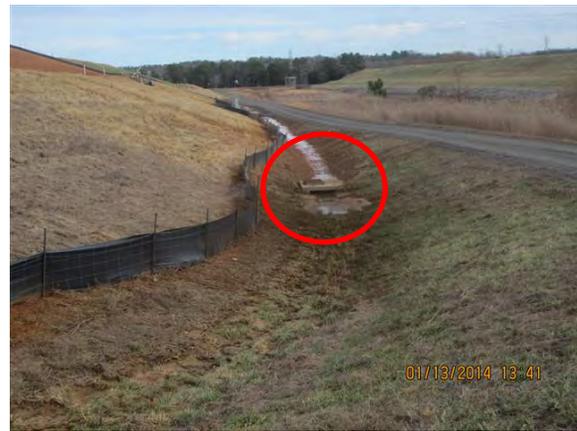
18. Looking (E) down the perimeter ditch on the (S) side of the landfill. Note the “drop inlet” in the center of the photo. (Photo taken by B.Wagner on 1/13/14)

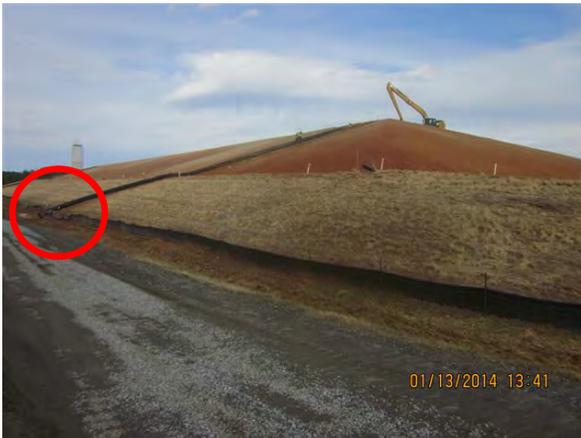
19. Looking (NE), from the perimeter road, at the SE corner of the landfill. Outfall of the down slope drain is on the center right. (Photo taken by B.Wagner on 1/13/14)

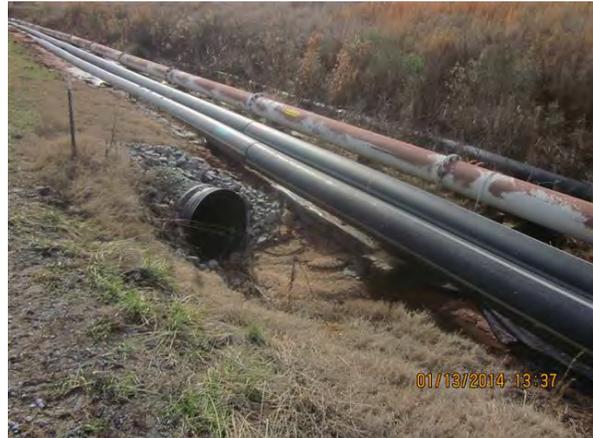
20. Stormwater ditch on the (W) side of the perimeter road, directly across from the point where the outfall from the down slope drain in the SW corner of the landfill discharged. (Photo taken by B.Wagner on 1/13/14)
