# SITE VISIT REPORT

**Project:** Dunn Erwin Landfill CAP Projects

| <b>Job No.:</b> 3002B | <b>Date:</b> August 20, 2013 |

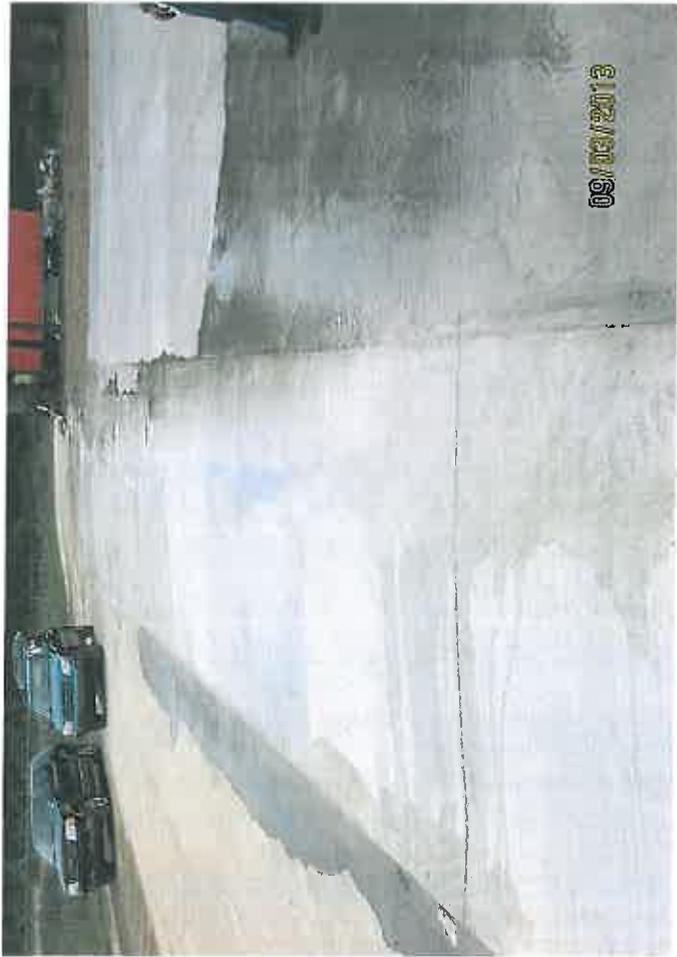
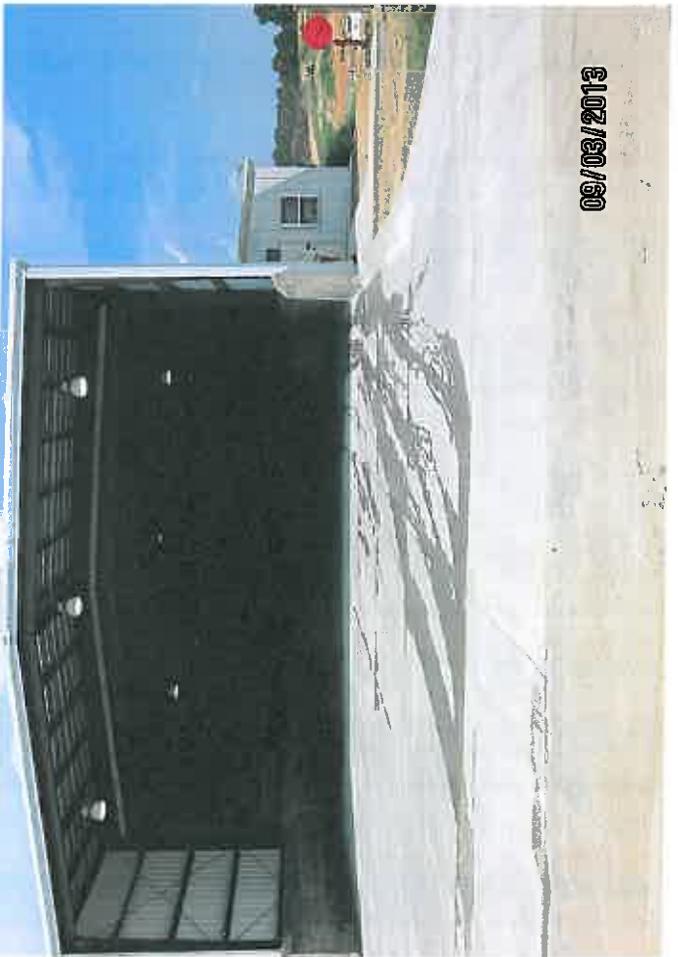
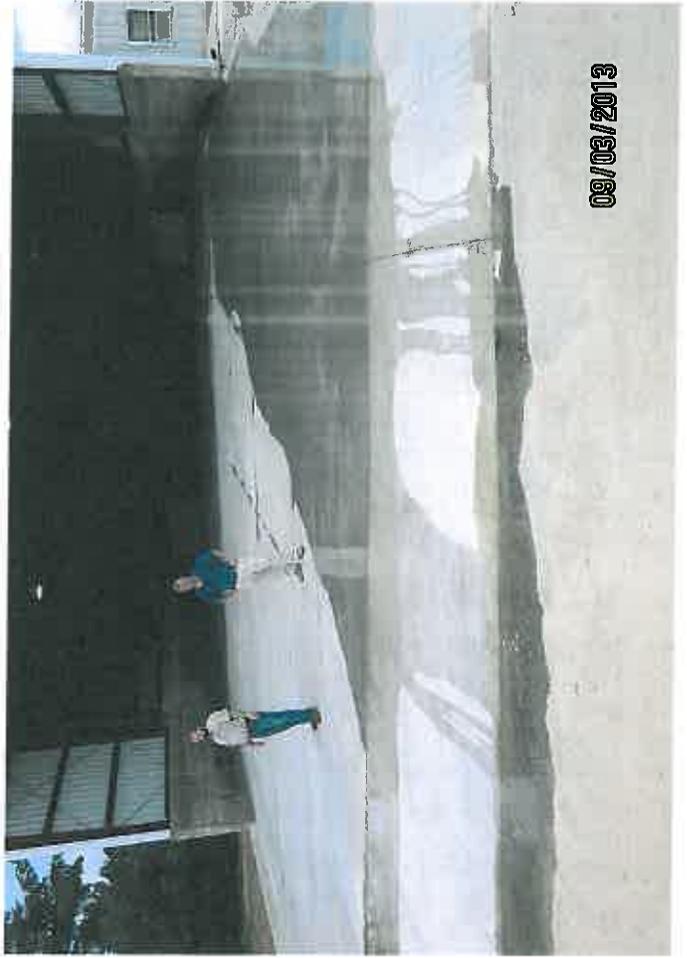
Arrived on-site in afternoon to check on progress at the site. WECC continued with general site cleanup and seedind and mulching. Met with Tyrus Clayton and Scott Eldridge and discussed flow pattern at Transfer Station. Water from the yard hydrant was sprayed onto the tipping floor and water was observed exiting the tipping floor onto the approach apron SE corner. It was discussed that two of the saw cut squares would need to be removed and replaced to remedy the situation. It was also noted that water overtopped the berm on the apron in a few spots.

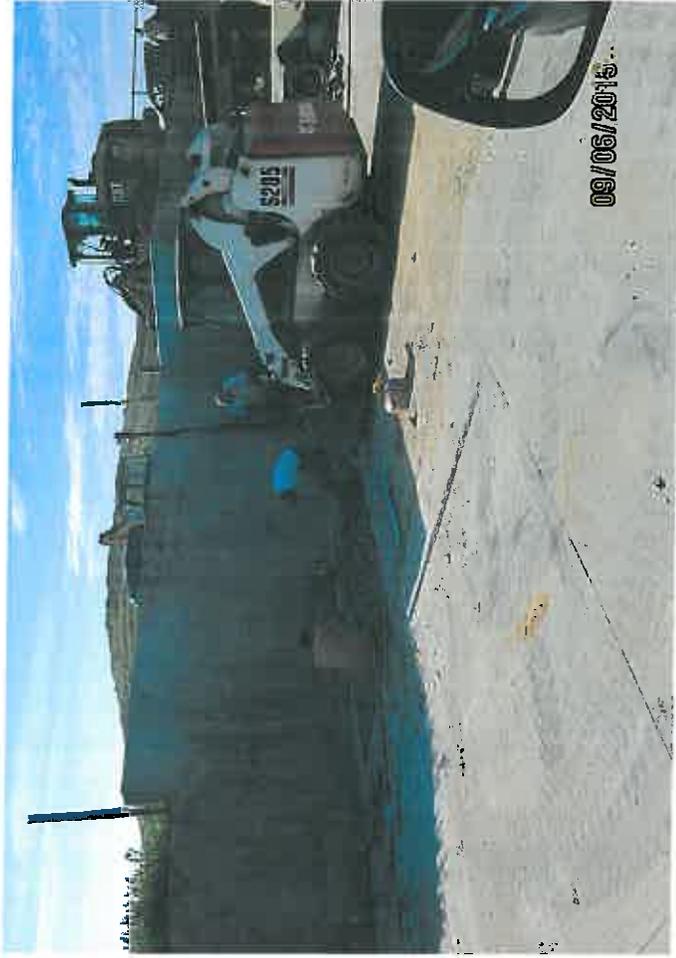
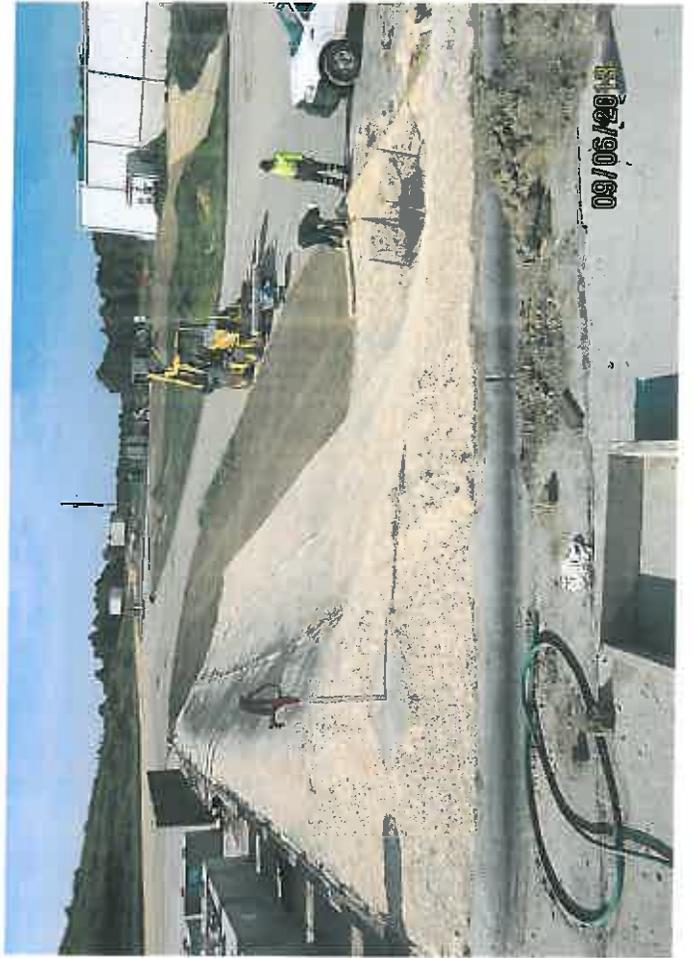
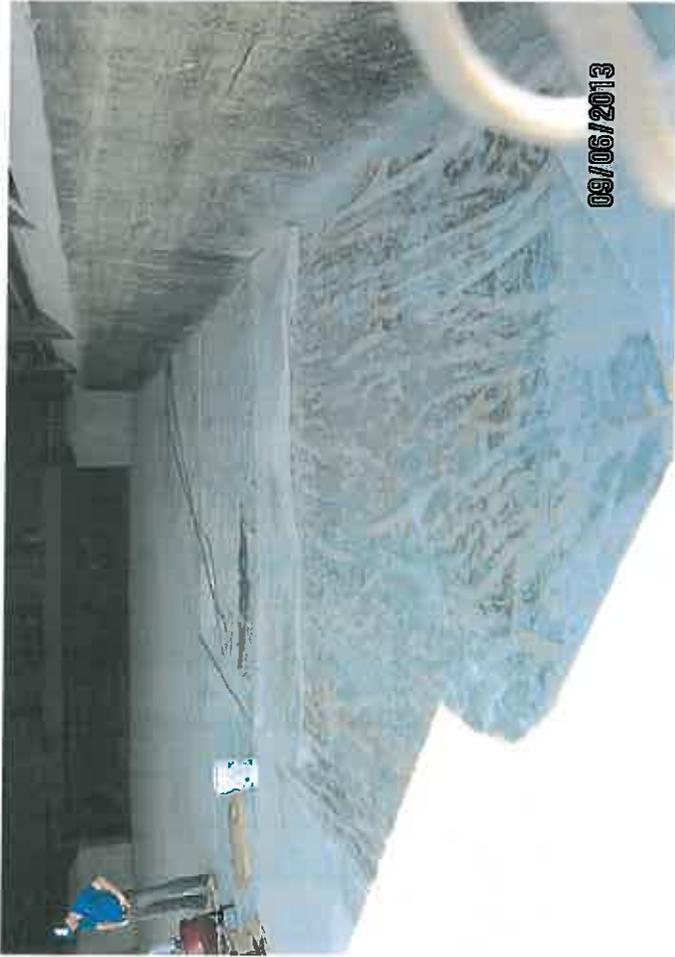
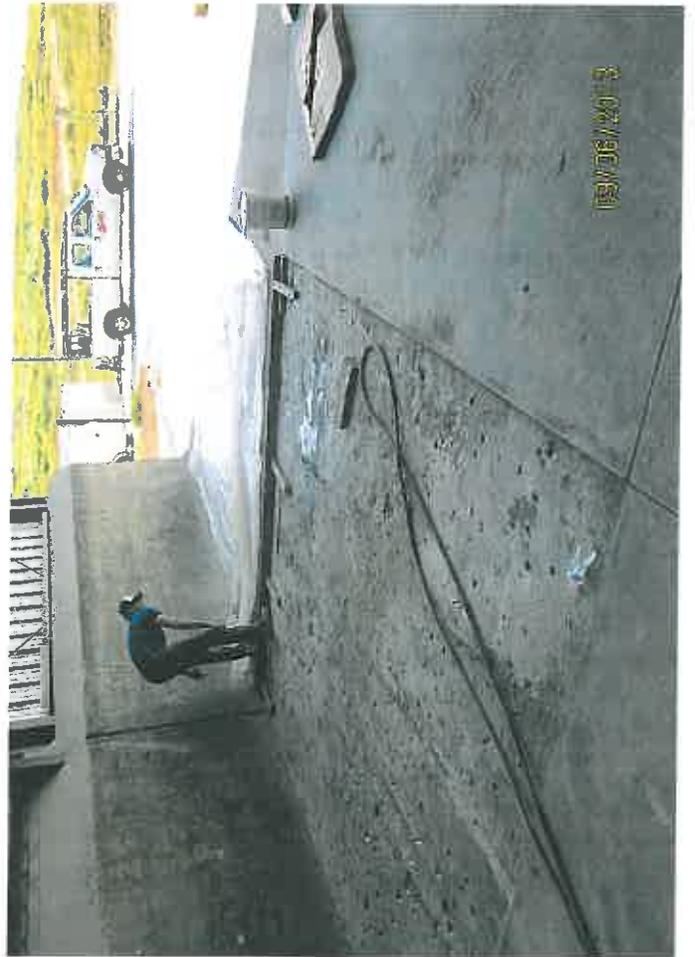
Arrived on-site in afternoon to check on progress at the site. WECC continued with general site cleanup and punchlist items. C&C onsite removing & replacing two squares of concrete/Eucotop at SE corner of Transfer Station and also removing concrete at trench drain. WECC also seeding and mulching.

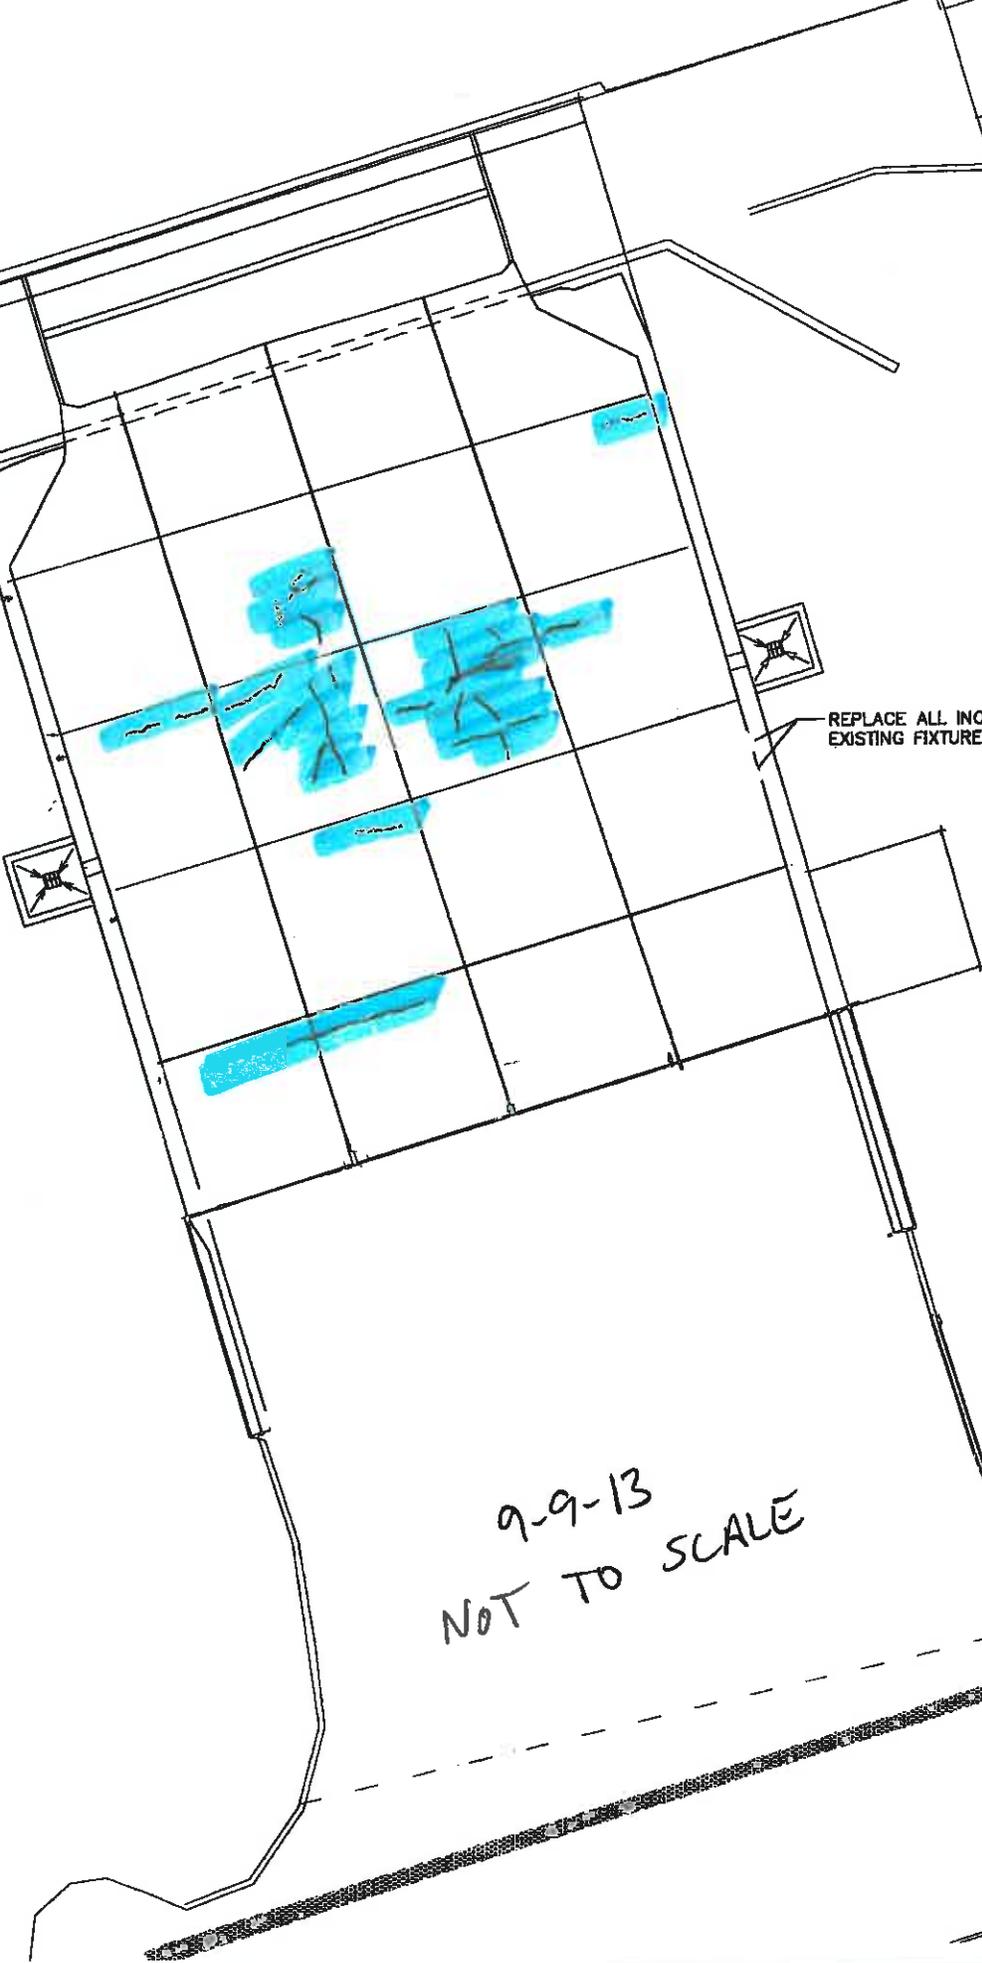
9-9-13  
NOT TO SCALE

I took pictures of the cracks in the Eucotop and sketched their locations for email to Euclid rep.

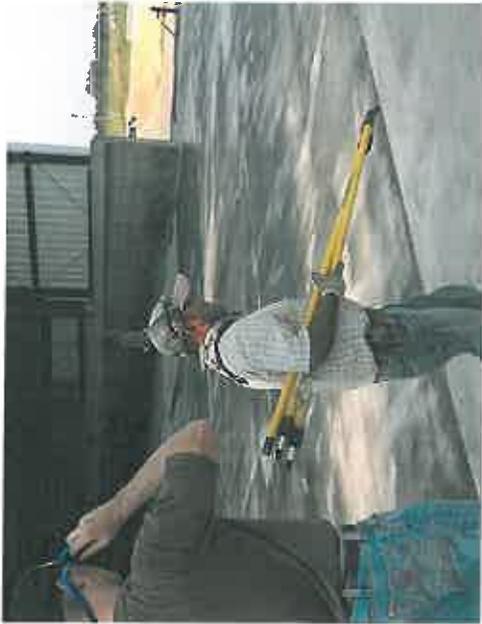
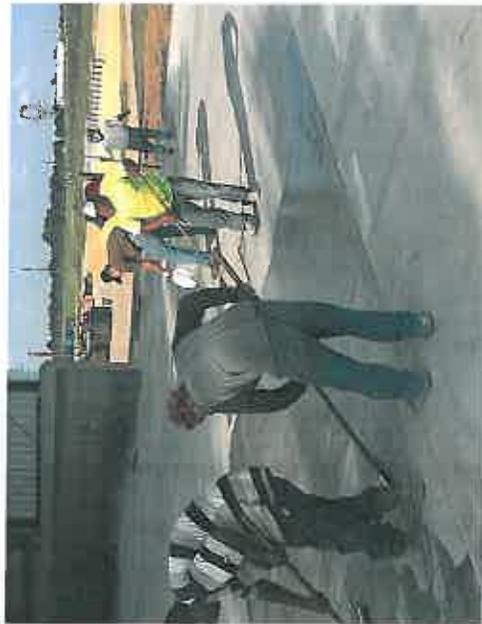
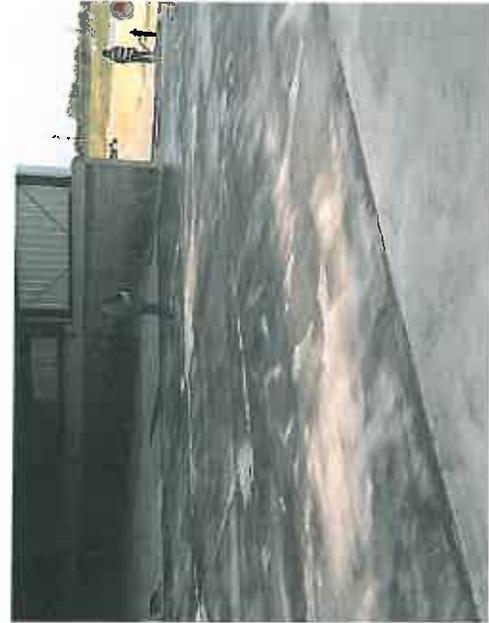
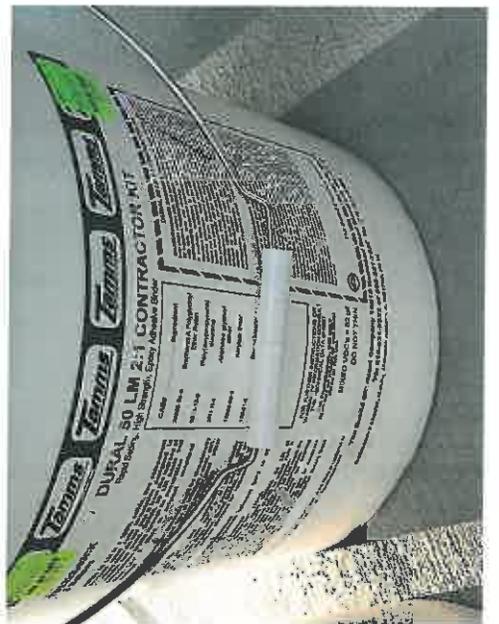
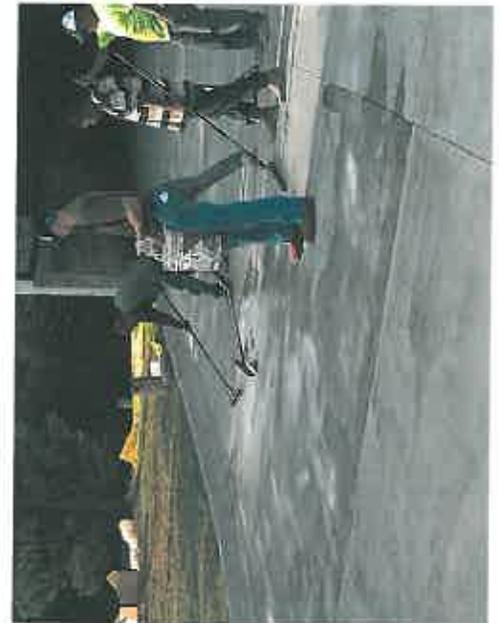
I returned in the late afternoon and witnessed the installation of the Dural 50 sealer. ECS rep, Mr. Randy Smith and Ralph Barile were onsite as well. As the material was being applied (squeegeed) I began to notice that there would not be enough material to do all of the apron. I asked Ralph about it and he stated that they had not planned on covering the upper section (last row of sawcut squares leading into transfer station) as he said it did not contain cracks. I began looking at the squares and they did indeed have several hairline cracks visible. Having not enough material, the subcontractor was only able to fill the cracks as I pointed out and did not provide full coverage of all the squares or outer curbing.

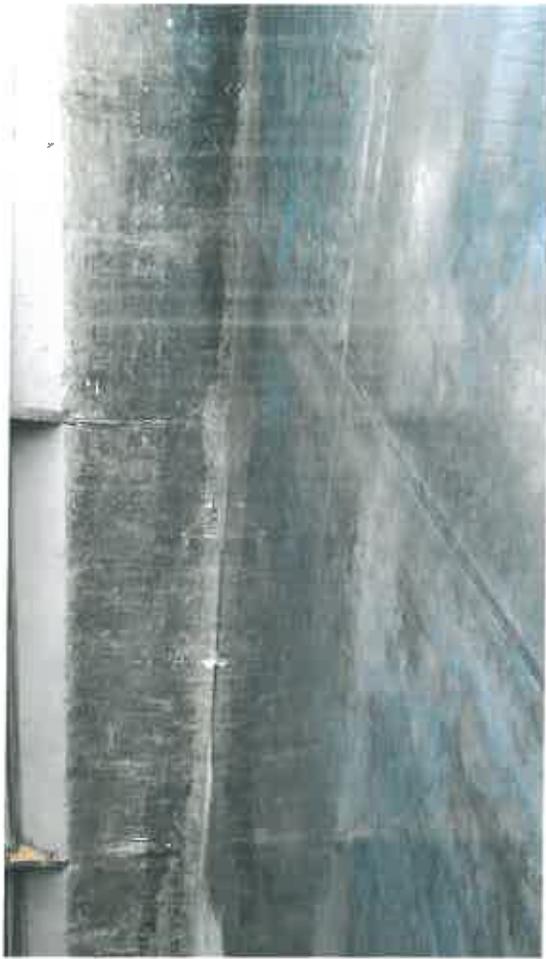
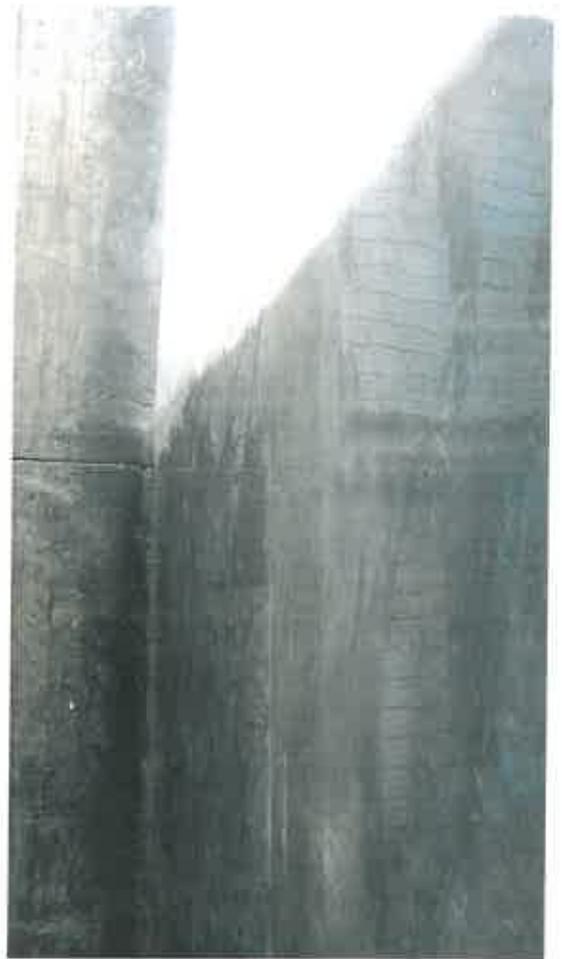
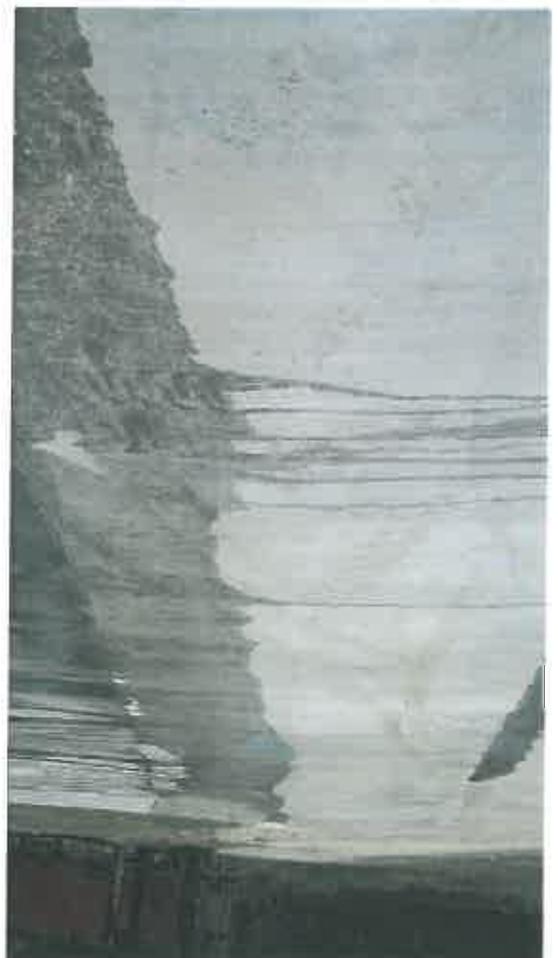
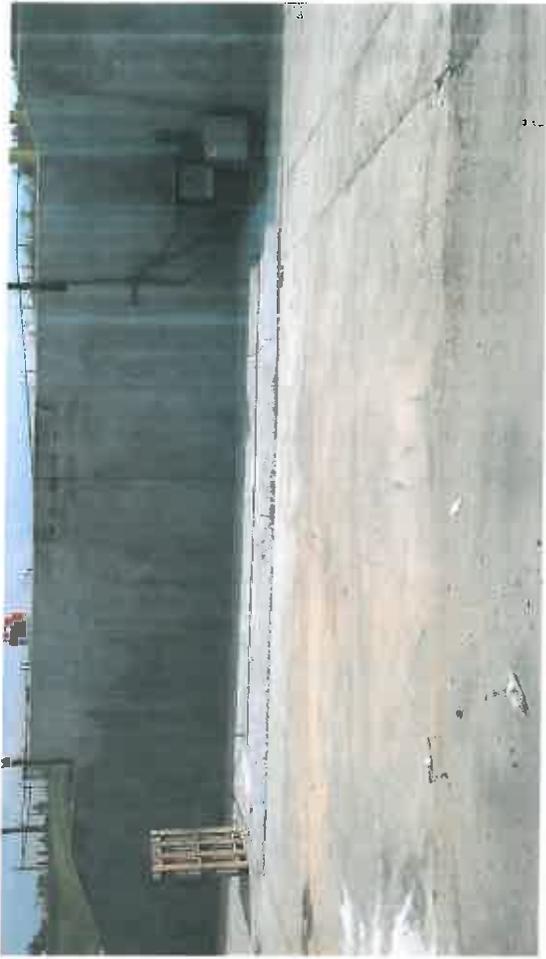
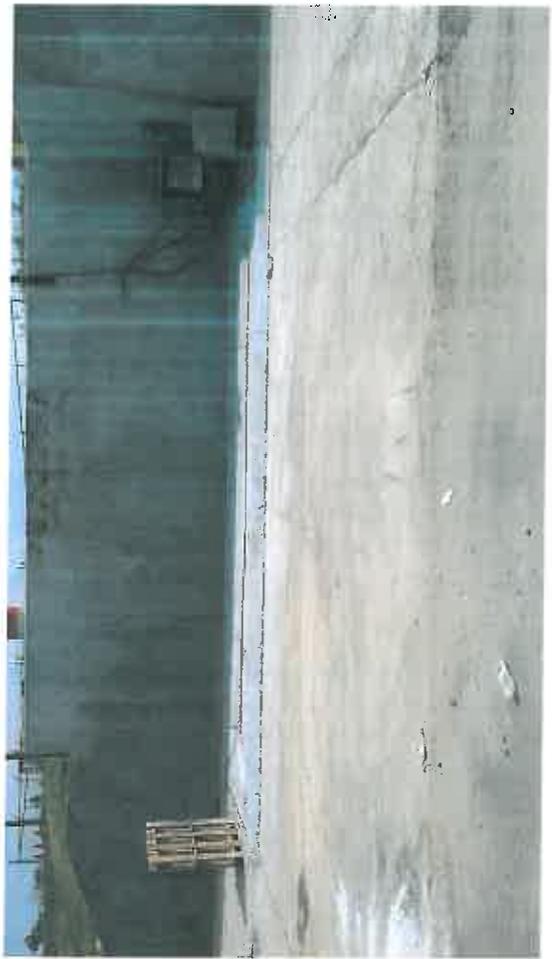
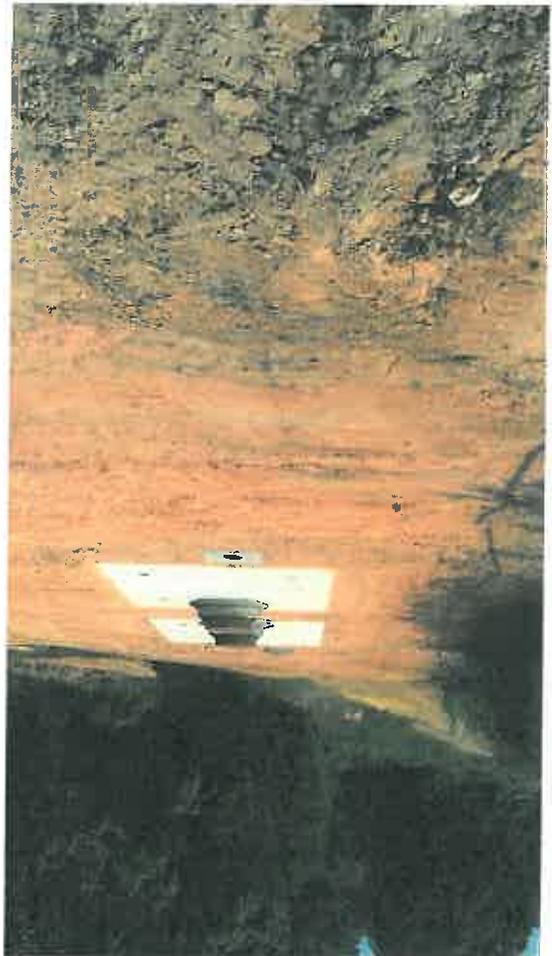
Arrived onsite at approx 9:00 am. Dave Popa was already present and inspecting the cracks in the Eucotop. Ralph Barille and Scott Eldridge arrived shortly thereafter. Mr. Popa indicated the saw cut joints were necessary and would not impact the performance of the EucoTop. We discussed the cracks that have appeared in the floor. Mr. Popa observed that all the cracks were centrally located with the exception of one linear crack that mirrored a saw cut joint. Mr. Popa stated he did not know why the cracks only appeared in the location. We observed a oily residue along each crack. Mr. Popa could not identify the substance. We discussed the need to seal the entire EucoTop with Dural 50 LM or another type of sealant. Mr. Popa indicated he saw no need to coat the entire EucoTop floor. Mr. Popa also indicated in order to be sure of the cause of the cracking, cores would have to be taken and tested and may take up to 6 weeks to get results. Mr. Popa stated he would email out a letter based on his findings and opinions tomorrow.

After Mr. Popa's departure, we observed and discussed the Dural 50 LM application that was completed earlier. Several cracks have not received sealant along the curbing and in the section underneath the building. The overall appearance of the sealant application appears to be uneven and not uniform. There are gaps in the coverage. Mr. Eldridge asked that we re-visit the need to coat the entire section not completed. I indicated I would revisit this with ECS.

A discussion was held concerning the performance of the diversion berm. The washdown hose was used to observe the performance. During heavy flows the water overtops the berm in two locations. In addition, water is passing through the saw cut joints. The bottom of the berm appears to have a high spot immediately downstream of the second overflow location. Mr. Barille discussed a possible means to raise the berm with a keyed in EucoTop application. It was determined to seal the saw cuts and re-evaluate.

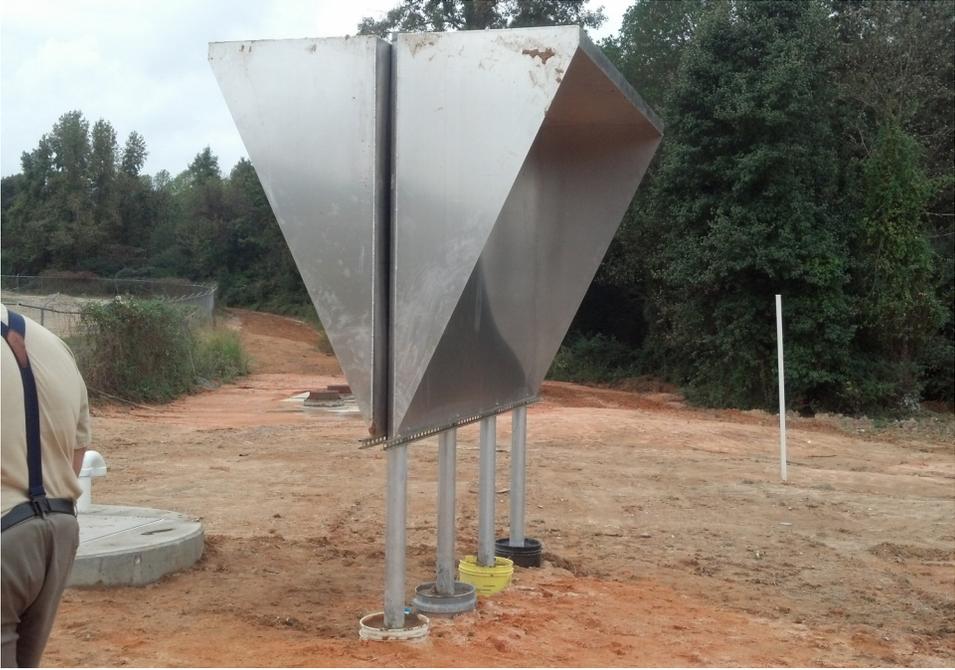
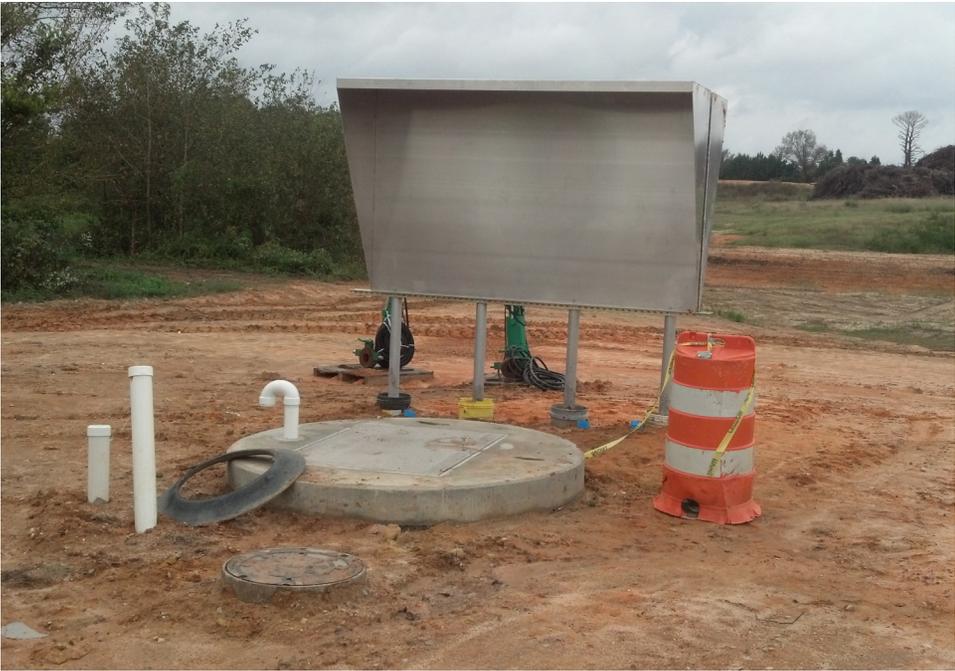
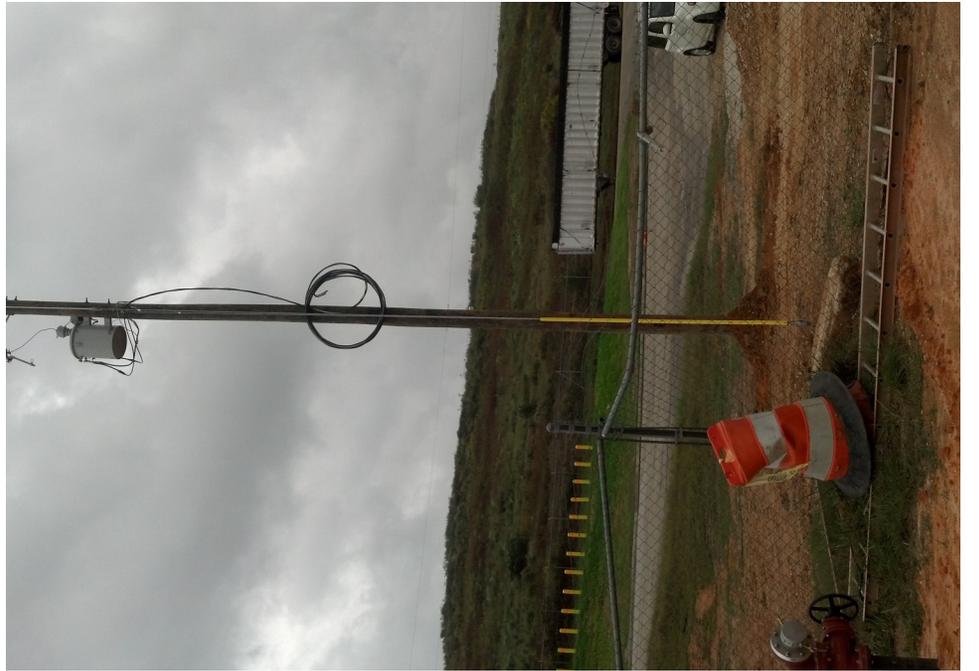
We inspected the wetwell. No coating has been installed to date. There was evidence of some infiltration (stains) along the lower joint. However, there is only 6-inches of water present in the bottom of the wet well. No pumping has occurred since the wet well was set. Joe confirmed the joints had been wrapped with the mastic type tape during install.
