July 8, 2014

**RE: French Drain Removal Update - Response to Comments
C&D Landfill (Permit No. 43-03)
Harnett County Anderson Creek Landfill Facility
Spring Lake, North Carolina**

**ANDERSON CREEK C&D LANDFILL
 FRENCH DRAIN REMOVAL DETAIL**

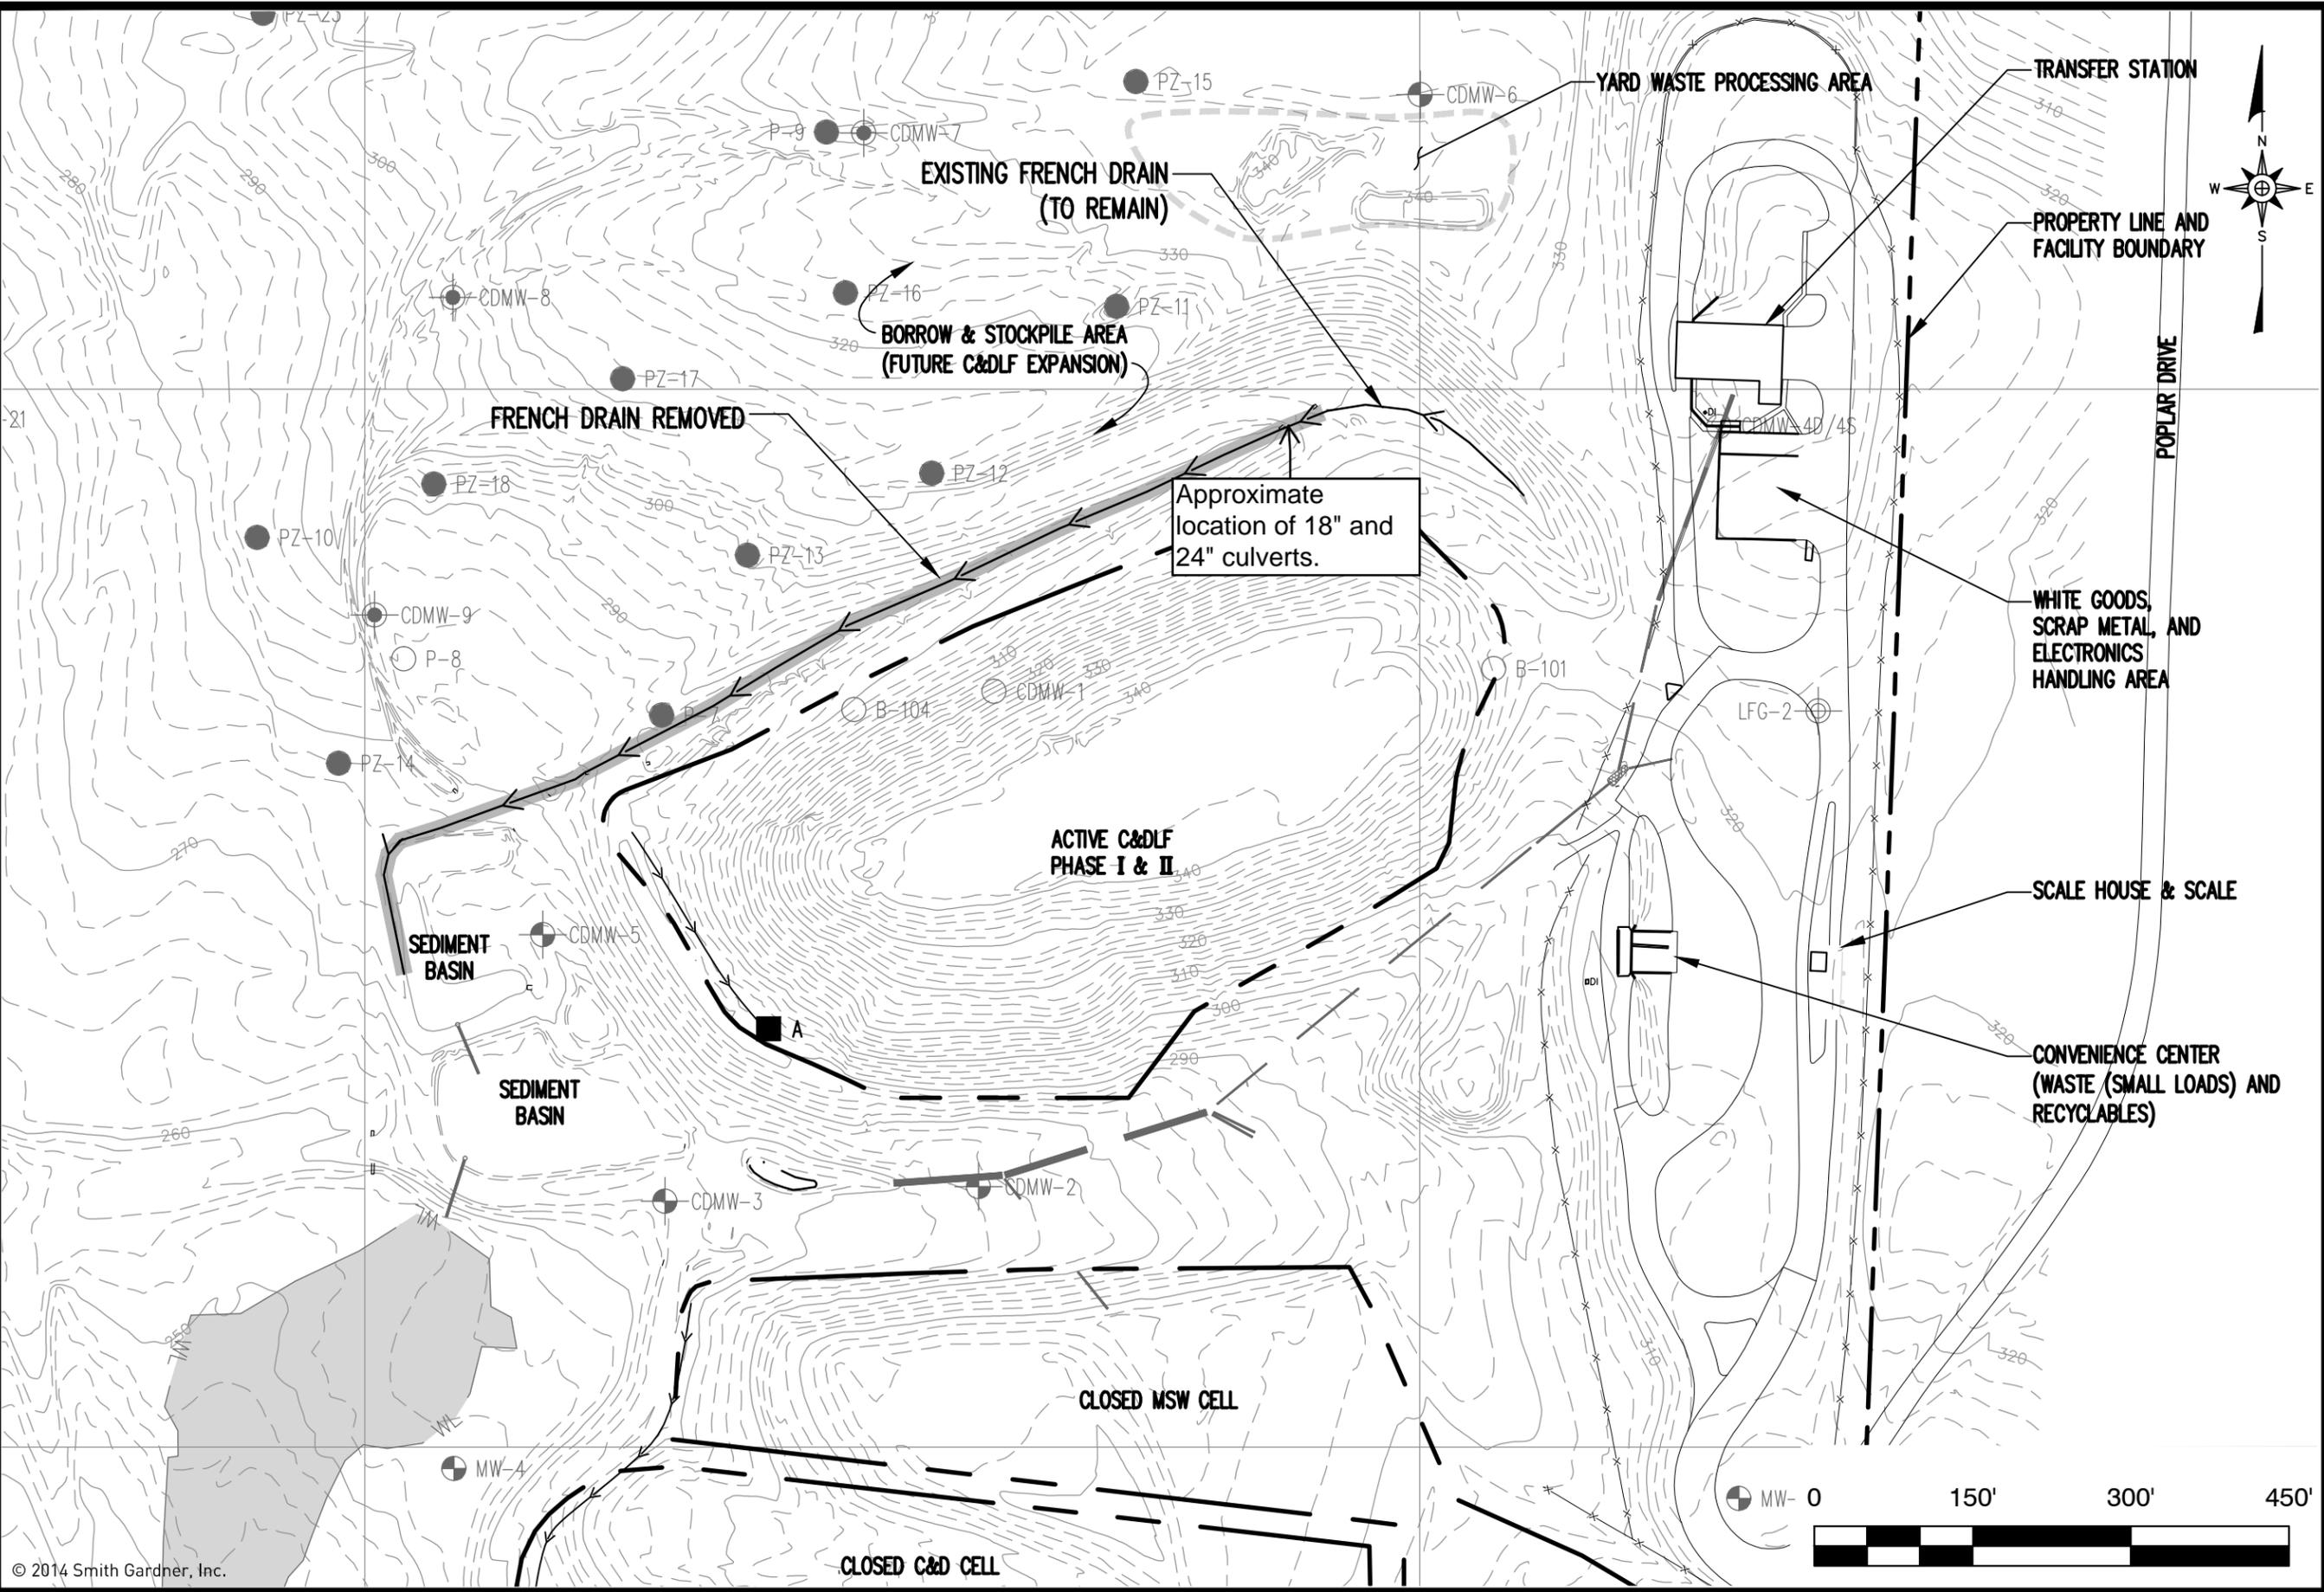
FIGURE NO. 1
 SCALE: AS SHOWN
 APPROVED: J.A.S.
 DRAWN: K.C.B.

Response #1: The french drain consisted of a 6-inch diameter pipe and a 4-inch diameter pipe. These pipes were perforated corrugated polyethylene (CPE-Type P). At the location of the old road at the east end of the active C&D landfill, there were two culverts –18-inch and 24-inch diameter, respectively (shown on **Figure 1**). The french drain pipes and two other previously unknown french drains, were found within the culvert piping. All the piping at this location was excavated and the two additional french drains were found to extend only a short distance and stop. These pipes were found to be dry and were removed with the main french drain piping in this area.

Approximately 50 feet of the french drain piping, at the end near the sedimentation basin was surrounded by gravel. The remainder of the french drain system was installed in native soils. Both pipes were covered with geotextile material (“sock”). As stated in our original letter, the original site berm of clayey material was located adjacent to the piping in the area where removal stopped. At this location, the piping was approximately 24 feet below current grade. Near the sedimentation basin, the french drain piping was approximately 5 feet below grade.
