FACILITY COMPLIANCE INSPECTION REPORT
Division of Waste Management
Solid Waste Section

Date of Site Inspection: 1/10/12, 4/8/13, 5/29/13, 1/6/14

Haywood County Francis Farm Landfill
Francis Farm Road
Waynesville, NC

Comprehensive Site Inspection

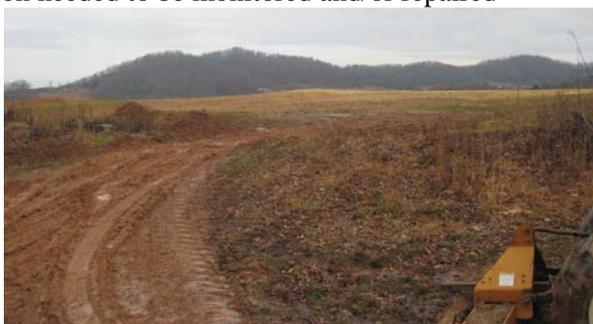
1/10/12

On site to review the progress of the gas extraction system installation (LFGTE). The cap exhibited some areas where vegetation needed to be monitored and/or repaired

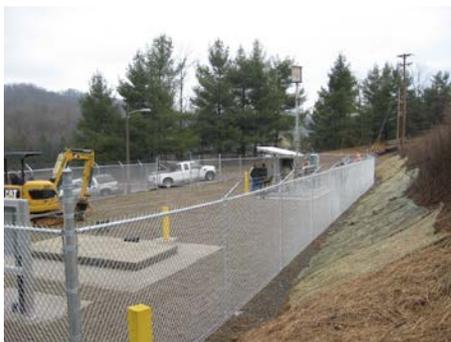
1/10/12

The LFG extraction system/flare was installed but not completed or operational at the time of the inspection.

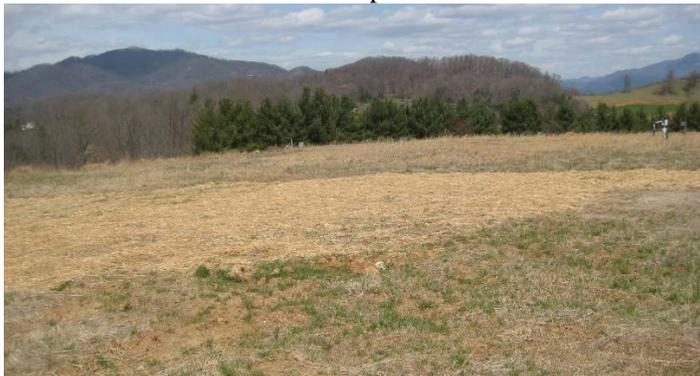
4/8/13

3. Work had been conducted to repair erosion on the landfill cap since the last inspection

Some work remained to be done at the upper access location onto the landfill cap (rutting) and the facility intended to conduct repair work to surface water diversion berms/drainage locations on the west side of the landfill cap.

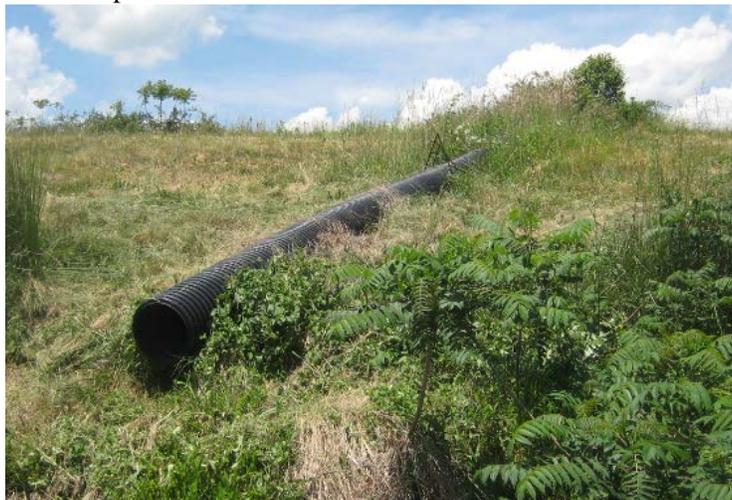
5/29/13

In general, the facility was well maintained and appeared compliant with Solid Waste Section Rules. The area noted in item #3 above had been resolved and repaired at the time of the inspection along with the surface water diversion piping (see below). Please continue to keep woody vegetation from being established on the cap/side slopes of the waste disposal area.
