**FACILITY COMPLIANCE INSPECTION REPORT**  
**Division of Waste Management**  
**Solid Waste Section**

Evergreen Packaging Industrial Landfill  
 State Road 1550  
 Canton, NC 28716

Active under permit #4406-INDUS-1984  
 Closed phases: Landfill No.6 Areas A, B, C, F, G & H  
 Active Phase: Landfill No. 6 Area D-South  
 Permit to Construct issued for: Landfill No. 6, Area D-South

Comprehensive Inspection

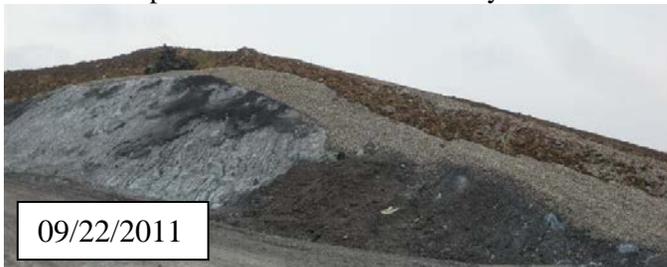
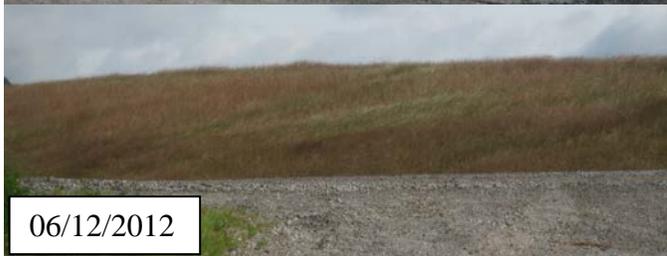
1. On site to conduct comprehensive inspection of facility. Document review was conducted at the office prior to the site inspection. All records were available for review and appeared compliant with Permit and Operation Plan requirements.
2. Area 6A West closure activities were complete and Cell 6D-South was actively accepting waste. Area 6A-West had established vegetation at the time of the inspection. Several small areas of erosion were noted on the north slope of 6A West and the facility had been conducting recent repair and re-seeding of these regions.

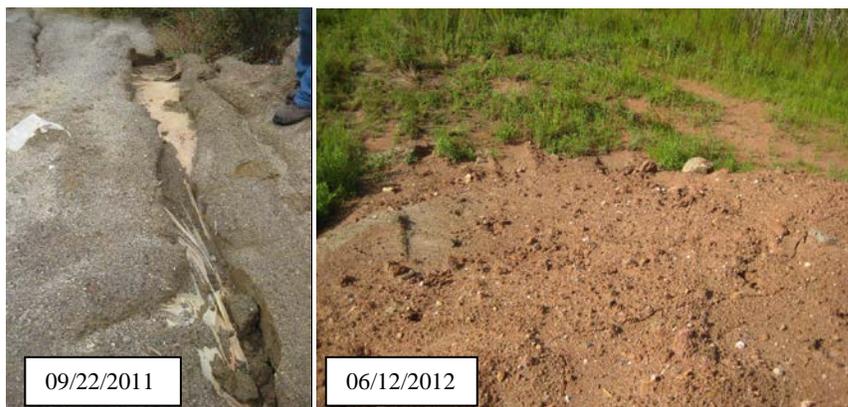
4. The asbestos disposal area is located between Areas F and H. The approved Operations Plan (DocID 11173, dated May 2010) states that “before the end of the day, at least 18 inches of soil will be placed over the plastic covered asbestos waste.” During the September 22, 2011 site inspection, plastic sheeting used to contain the asbestos was visible due to erosion rills in the soil cover. It appeared as though the original 18-inches of soil had been placed at the time of disposal, but excessive erosion had not been prevented. The facility (J. Giaque) notified the section in the November 2011 time frame that this area had been repaired.

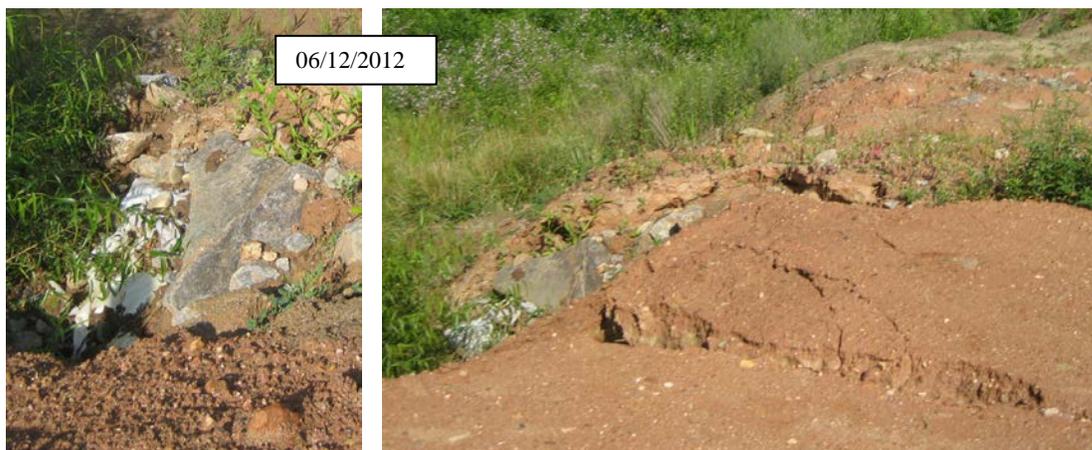
During the June 12, 2012 inspection the asbestos disposal site was observed. The previously noted area of erosion had been repaired. However, a new region of erosion was observed and the plastic sheeting covering the asbestos wastes was visible.

In order to remain compliant with the 15A NCAC 13B .505 (4)(b) requirement, repair the erosion noted during the inspection and insure that this region of the landfill receives adequate monitoring and maintenance.

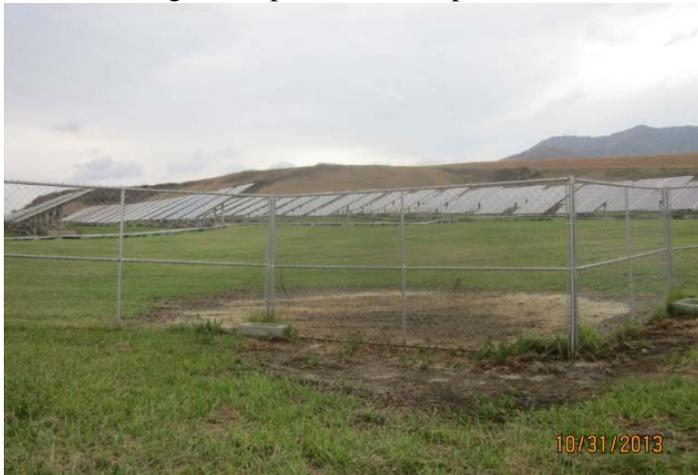
6. Settlement issues were discussed. C-Lower, B-Upper, and some areas of B-Lower (solar panel field) require work to improve shedding of surface waters/avoid impounding water on the closed cell cap. It was stated that it is the responsibility of FLS Energy to maintain the cap on this portion of the landfill and that Mr. Giaque will communicate with FLS regarding the results of this inspection report. In particular, there was a lack of established vegetation/potential for impoundment of water along the fence line.

The C-Lower and B-Upper areas have upcoming planned maintenance to address settlement with soils generated from the construction of the new cell (part of the upcoming PTC).
