FACILITY COMPLIANCE INSPECTION REPORT
Division of Waste Management
Solid Waste Section

Date of Site Inspection: April 16, 2014 **Date of Last Inspection:** October 16, 2013

FACILITY NAME AND ADDRESS:
 Waste Industries Black Creek Road Transfer Facility
 3031 Black Creek Road
 Wilson, NC 27893

PURPOSE OF SITE VISIT:
 Comprehensive Inspection

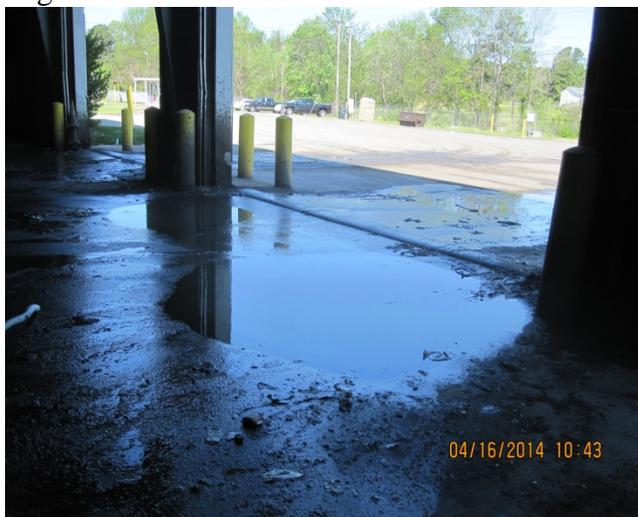
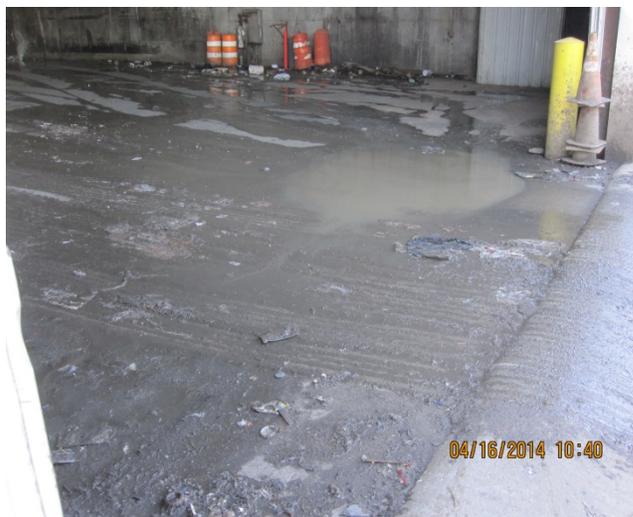
12. There was a fair amount of blown litter observed during the inspection. Fencing seems to be keeping it mostly contained in the operational area.
13. A new tipping floor was installed in 2013 and reconfigured to better direct leachate into the floor drain. A new floor drain was also installed. Previous inspections have revealed the drain on the west side of the building prone to clogged allowing water to collect. The operator indicated that the drain pipes installed may be too small. The floor drains need to be maintained in a free flowing condition.

The floor drains were filled during the time of the inspection. This condition has been noted in a previous inspection. The operator indicated that when the floors were replaced last year, the drainage pipe installed was too small.

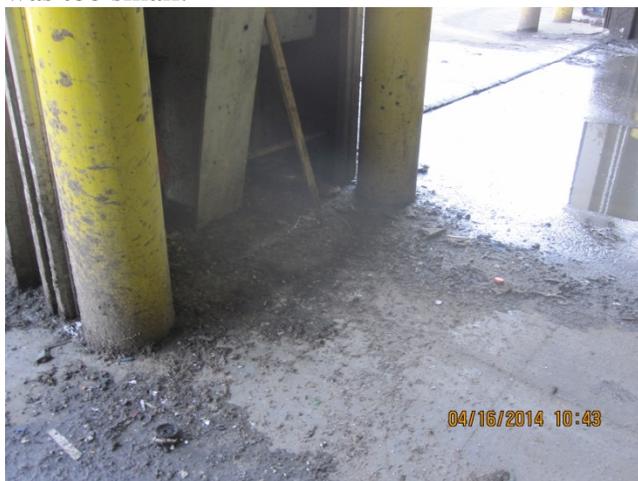
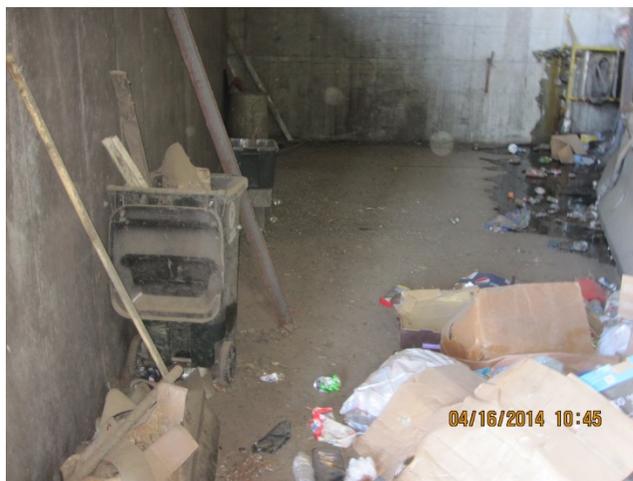
14. The Operations Plan specifies that the floor be cleaned daily. The amount of trash in hard to reach areas appears to be more than one days accumulation.

The facility needs to be cleaned.

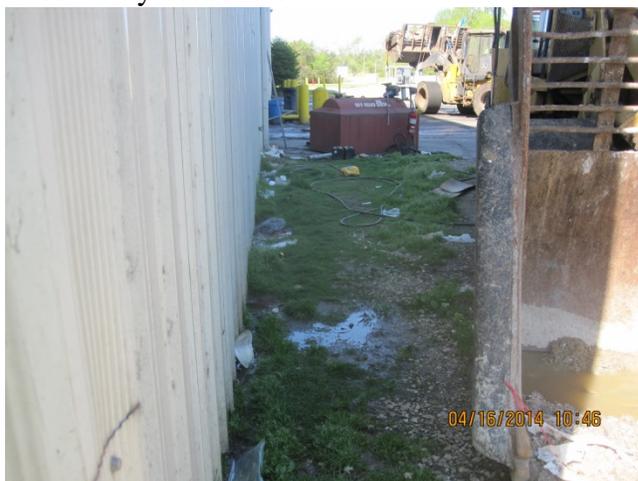
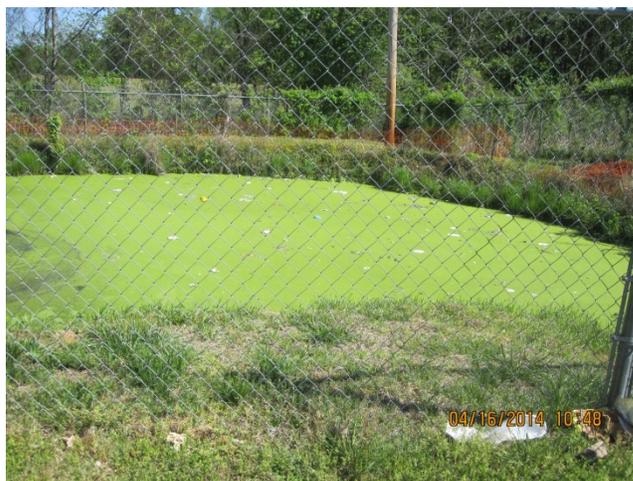
There is a fair amount of blown litter on site. The conditions were very windy. Above, litter in the sedimentation basin. It cannot be determined if this litter is from one day only, but all blown litter must be cleaned at the end of the operating day.

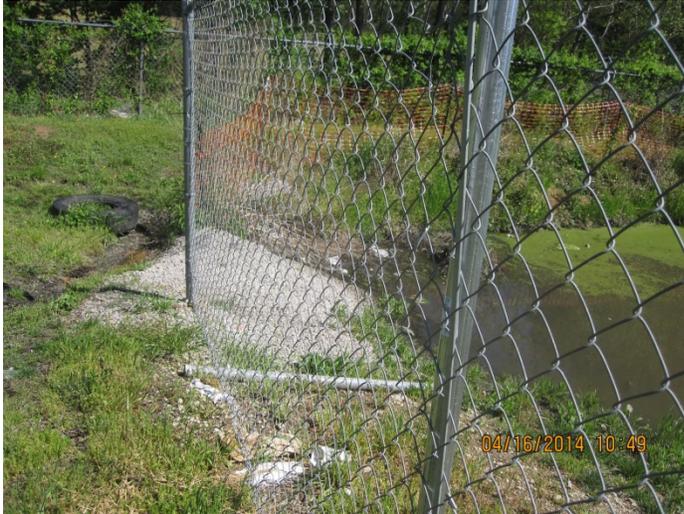
The rock dam filtering runoff entering the sedimentation basin needs repairing. The center of the dam has washed.

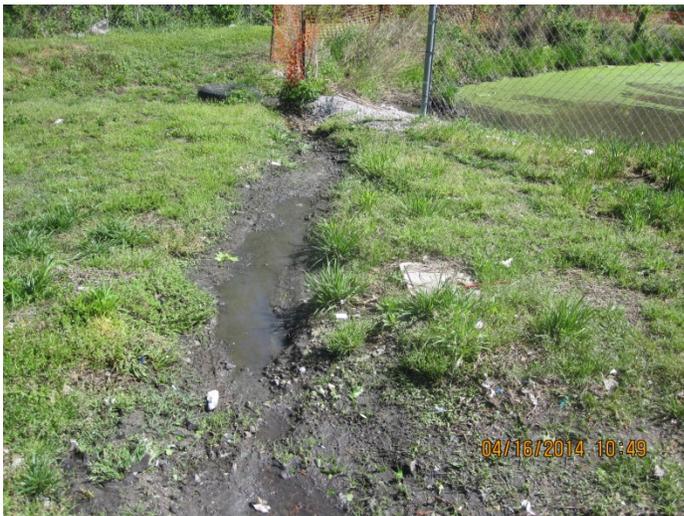
The trench draining the turn platform needs to be stabilized with gravel to lessen erosion and aid in keeping trash from entering the basin.

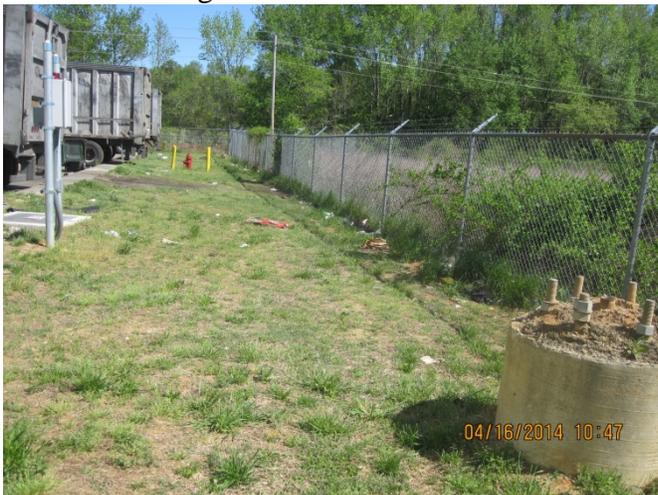
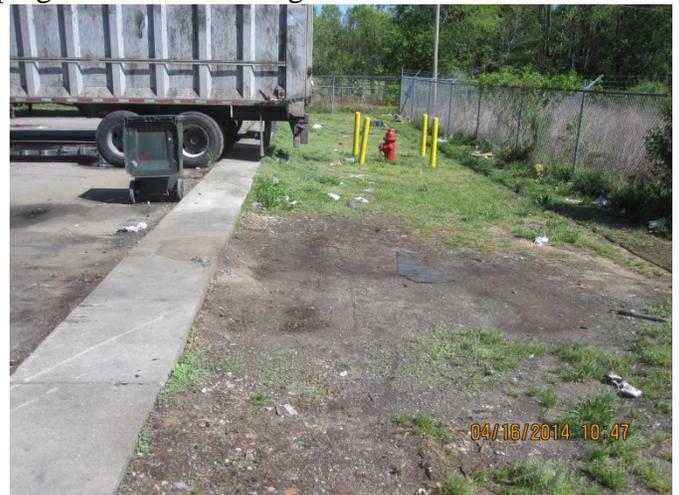
The trucks did not appear to be leaking, dead vegetation behind the center parking area indicated leakage may have occurred in the past. All possible efforts should be made to prevent the trailers from leaking. If leakage is observed containers must be placed behind the trailers to prevent the leachate off the ground.
