**FACILITY COMPLIANCE INSPECTION REPORT**  
**Division of Waste Management**  
**Solid Waste Section**

**Date of Site Inspection:** 12 August 2013      **Date of Last Inspection:** 16 January 2013

Miller Farm LCID Landfill  
 Miller Farm Road  
 Morehead City, NC 28557

N0190-20130812INSP

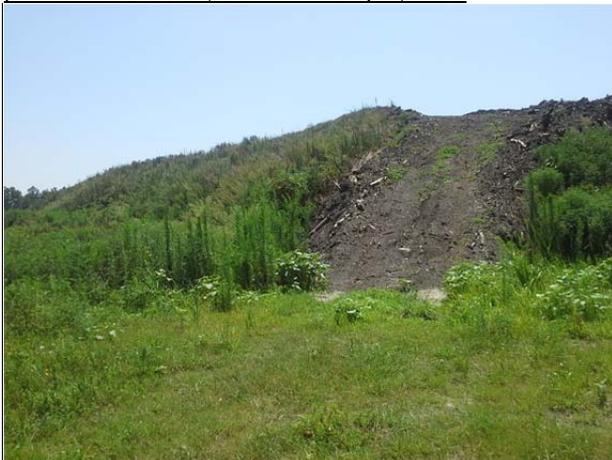
- 13) No new disposal activity was noted as having occurred since the last Facility Compliance Site Inspection.
- 14) The operator has been working to repair the areas of differential settlement that were noted in the previous Facility Compliance Inspection Report. The sinkholes observed on the sideslope on western end of the landfill have been filled and graded. This repaired area has been seeded, however, no germination of the seed was observed during this Facility Compliance Inspection. \*Please continue grading, seeding, and mulching these areas to establish a cover crop suitable to prevent erosion of your landfill cap system.

- 15) \*Please continue to fill, compact, and cover all areas of differential settlement to provide for positive drainage of surface waters away from the landfill. All sideslopes and repaired areas should be graded at a slope not greater than 3:1 and seeded and mulched to establish a groundcover suitable to prevent erosion.

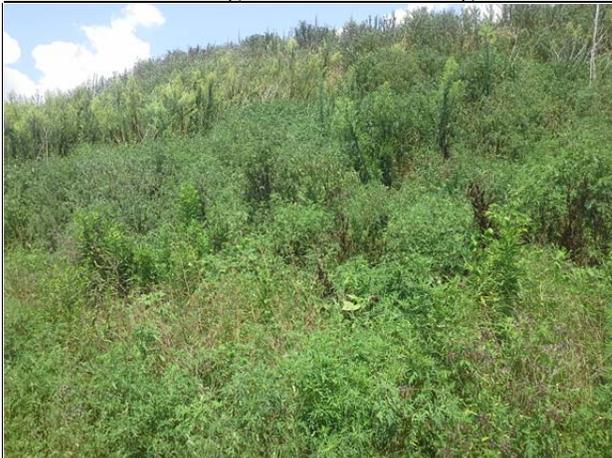
- 16) Overall, this Facility has a well-established cover crop of native warm season grasses and plants. However, several areas of the landfill cap were observed as having sparse cover and/or bare soil that is insufficient to prevent the erosion of your landfill cap system. \*Please continue grading, seeding, and mulching these areas to establish a cover crop suitable to prevent erosion of your landfill cap system.

- 17) \*The Facility sideslopes need to be mowed to prevent the growth of brush and woody vegetation which can shade out and otherwise inhibit the growth of the desired grass cover crop.

- 18) \*Corrective actions are required as a result of this Facility Compliance Inspection.
