FACILITY COMPLIANCE INSPECTION REPORT
Division of Waste Management
Solid Waste Section

Date of Site Inspection: October 17, 2011 **Date of Last Inspection:** December 2, 2008

Murray LCID Landfill
 5352 Friendship Rock Creek Road
 Snow Camp, NC 27349

Comprehensive Audit (to ensure that the notified land clearing and inert debris (LCID) landfill is in compliance with 15A North Carolina Administrative Code (NCAC) 13B .0563, .0564, and .0566)

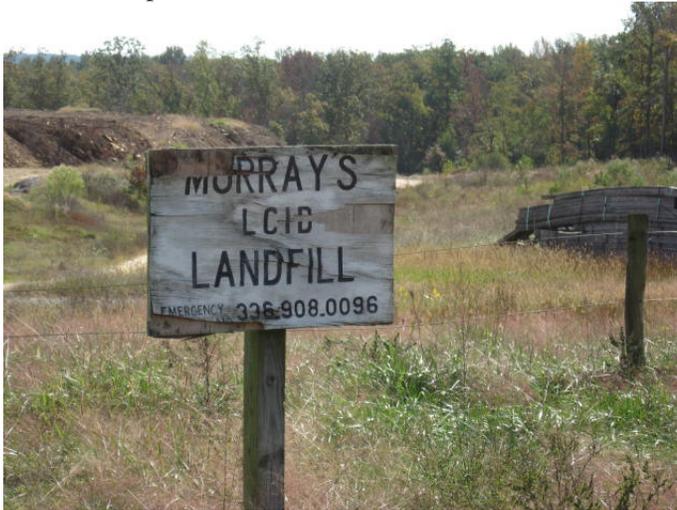
Facility sign with contact information
in need of repair

12. The facility has proper signage. Although, the lettering on the sign should be repainted.
13. A copy of the rules pertaining to notified LCID landfills is included with this audit report.

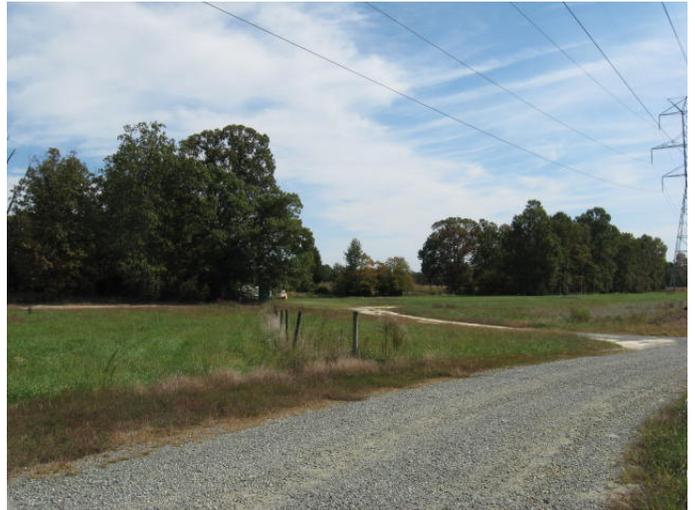
Entrance to LCID landfill, steel cable not secured

10. Access roads are of all-weather construction.
11. The facility is secured by a steel cable. Although during the site inspection, the steel cable was not secured and an attendant was not on duty. Ensure that the LCID landfill is adequately secured when an attendant is not on duty.

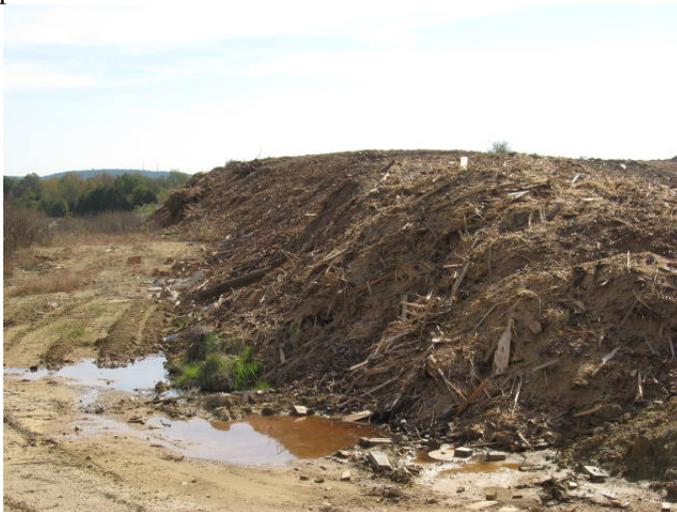
LCID landfill left side slope in need of additional soil
cover, grade toe of side slope such that water does not
pool

6. Ensure that edge of waste markers are installed outlining the required < 2 acre footprint of the LCID landfill.
7. Side slopes should be graded and covered with soil such that a 3:1 slope ratio is obtained or a ratio of which no indication of erosion or runoff is observed. Ensure that water does not pool at the toe of side slopes.

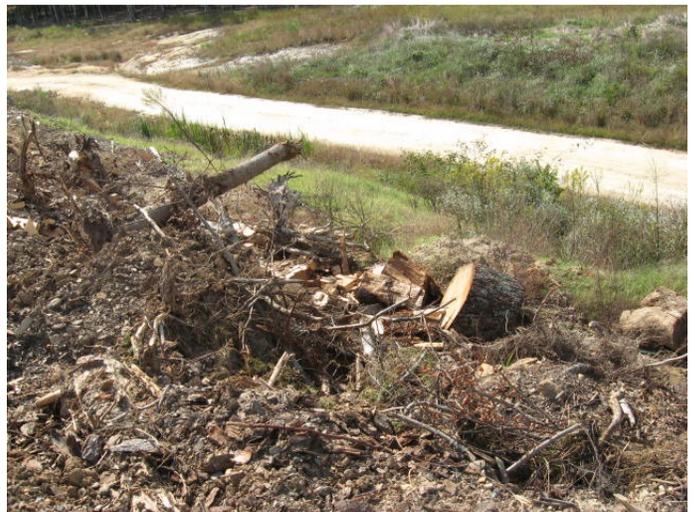
LCID landfill right side slope in need of additional
soil cover

2. The LCID landfill is estimated to be < 1.5 acres.
3. Per 15A NCAC 13B .0566(4), "Adequate soil cover shall be applied monthly, or when the active area reaches one acre in size, whichever occurs first." A large area of the LCID landfill is covered with mulch/bark chip and portions of the side slopes need additional soil cover. Ensure that the landfill, to include side slopes, is adequately covered with soil.

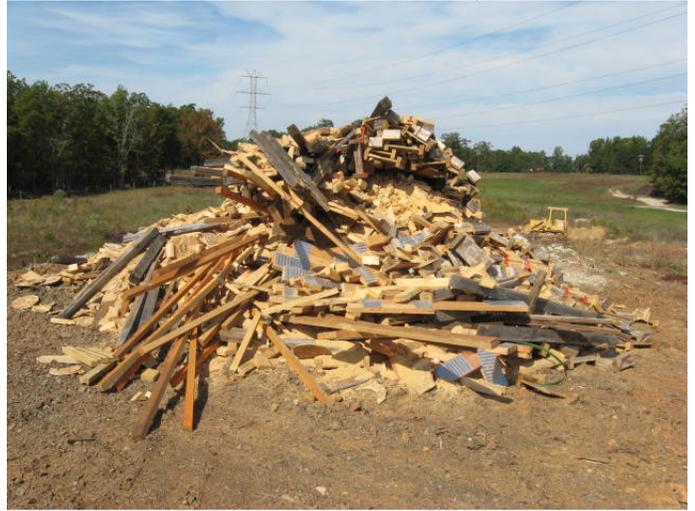
New construction debris, remove steel joist connectors

8. Remove new construction debris containing steel joist connectors.
9. There was no indication of runoff. Areas of rill erosion were observed on the side slopes. Repair accordingly.

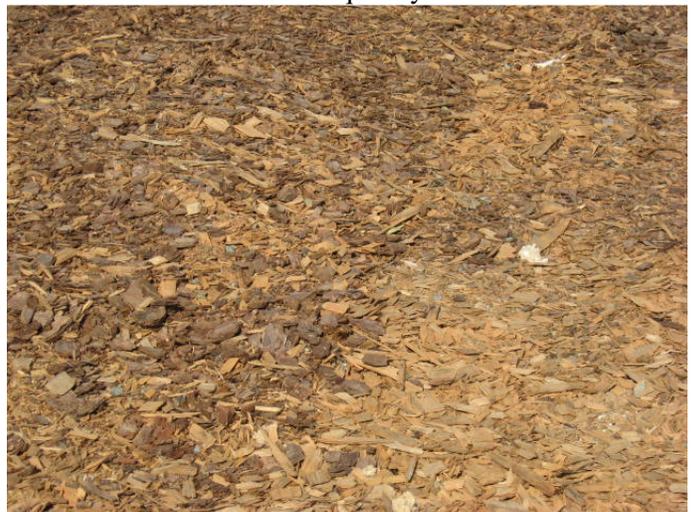
Mulch/bark chip material atop landfill area, ensure LCID landfill is adequately covered with soil
