From: Parris, Bruce
Sent: Monday, July 15, 2013 4:08 PM
To: Ramey, David E
Subject: "Virkler" FW: Phase I Report - AEI
Attachments: Final Phase I ESA Charlotte NC - Project 320548.pdf; Unlisted Virkler Property FOIA 7-12-13.pdf

Attached please find a Phase I report completed July 1 2013 by AEI Consultants. Right before Appendix F is a report done by Steve Hart of Hart Hickman which should be helpful.

12345 Steele Creek Road, Charlotte, North Carolina 28273

Project Number: 320548

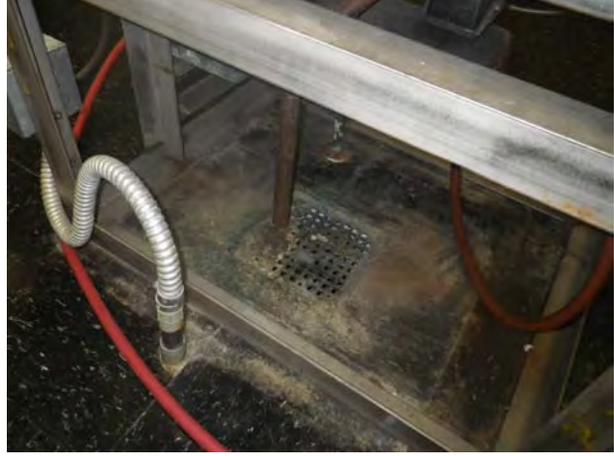
6. Floor drain in laundry

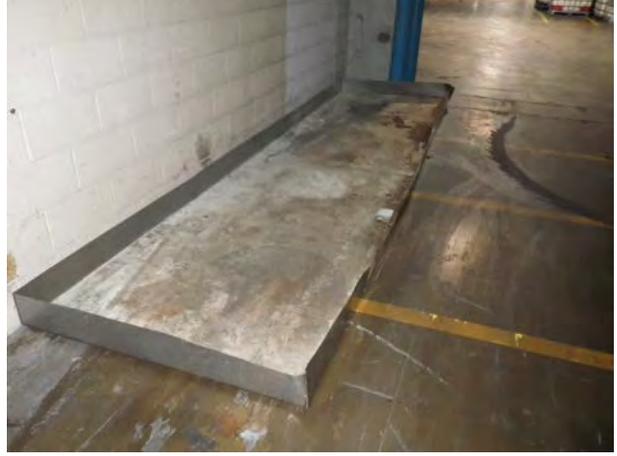
14. Stainless Steel tray where former tenant's solvent distiller was housed (alarm float switch, midway right)

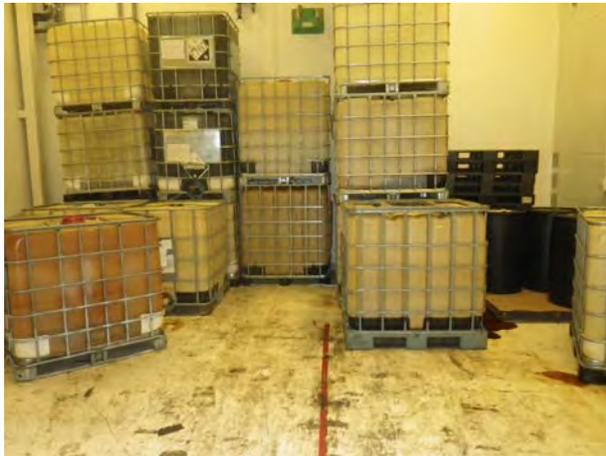
27. Tote and drum storage in warehouse – fluid leak shown right side of view

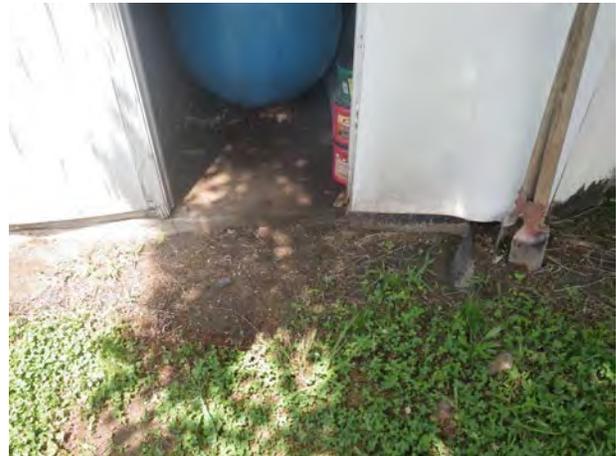
- Surrounding the canopy-covered air compressors in the eastern portion of the subject property and near the doorway to the Mechanic Building air compressor were areas of apparent oily-substance stained soil. The concrete pads housing the air compressors were observed with oily-substance staining and oil dry to contain/absorb oil spills and leaks. The area of affected soil was estimated to be approximately 50 square feet. During prior subsurface investigations, no substantial impacts were detected. Based on these prior investigations, the staining is considered de minimis.

36. Mechanic Building Air Compressor – Stained Soil

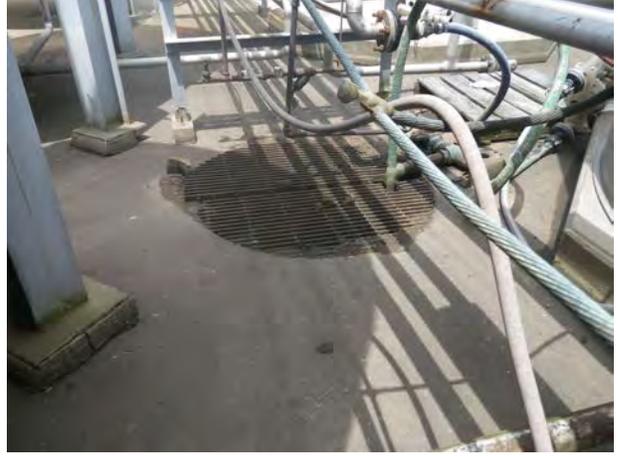
38. Exterior Tank Farm Sump

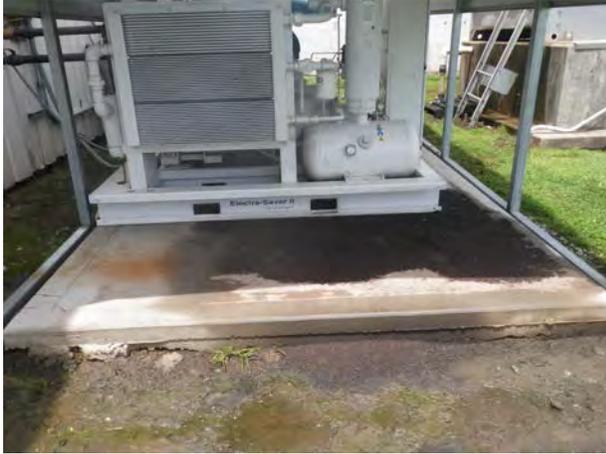
41. East Covered Canopy Air Compressor – soil stain

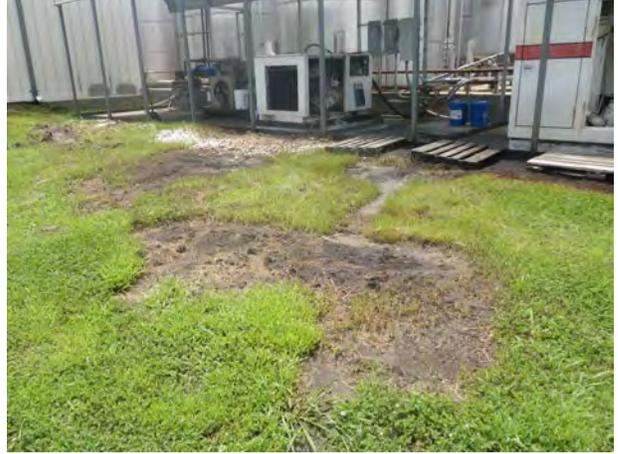
42. Southeast Covered Canopy Air Compressor – soil stain

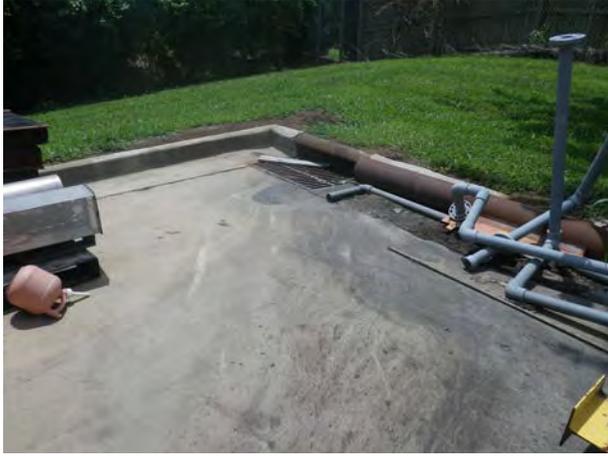
45. Stained pavement near southeast storm drain

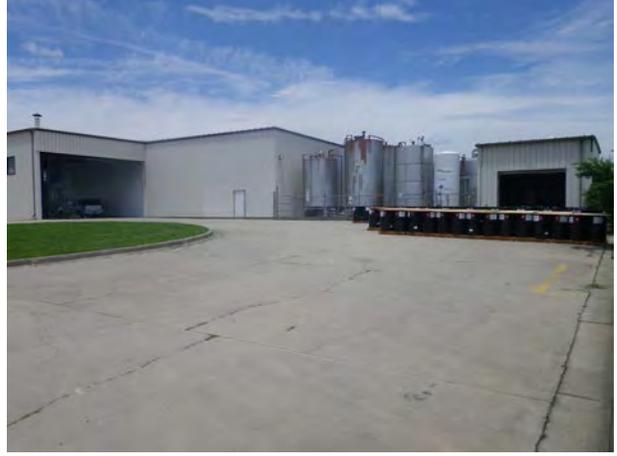
- Two exterior areas were identified where intact drums were staged for pending offsite shipment with no apparent leaks observed. Sixteen drums were staged in on the asphalt at the north loading dock area. Fifty-six drums were staged on the asphalt at the southeastern loading area (near the flammable storage building). In both locations, the staged drums were located upgradient of storm water drainage inlets that discharge to the onsite retention pond and were absent of secondary containment. While no significant environmental concerns were noted for these stored drums, AEI recommends development of and implementation of a site-specific spill containment and countermeasure plan that addresses drum staging for shipment.

46. Southeast Drum Staging
