FACILITY COMPLIANCE INSPECTION REPORT
Division of Waste Management
Solid Waste Section

Lined MSWLF	LCID	YW	Transfer	Compost	SLAS	X	COUNTY: GASTON PERMIT NO.: SLAS-36-04 FILE TYPE: COMPLIANCE
Closed MSWLF	HHW	White goods	Incin	T&P	FIRM		
CDFL	Tire T&P / Collection	Tire Monofill	Industrial Landfill	DEMO	SDTF

Stanley Environmental Solutions, Inc.
 351 Colt Thornburg Rd. (SR-1802)
 Dallas, NC

Comprehensive Audit

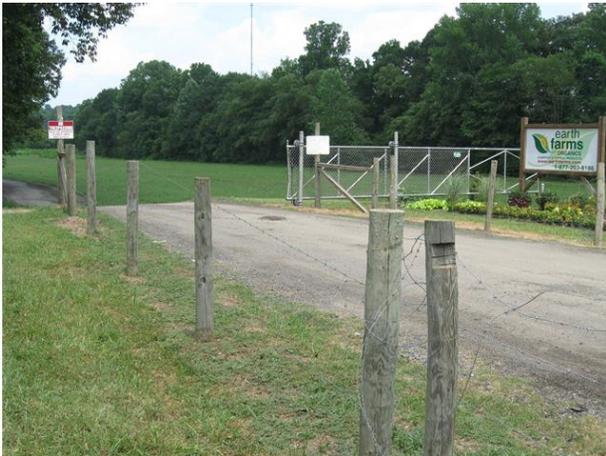
1. Entrance gate to the facility.

5. The access road to the facility was well maintained.
6. Proper signage was displayed at the entrance to the site. Each of the three septage application fields is marked with ID signs. (Photo #2)

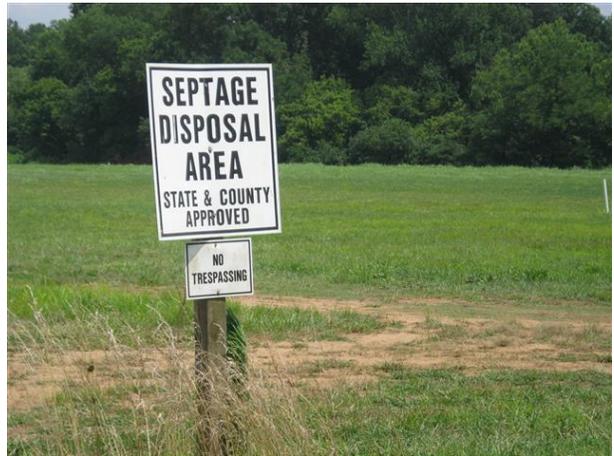
2. Signage at the entrance to the septage land application fields.

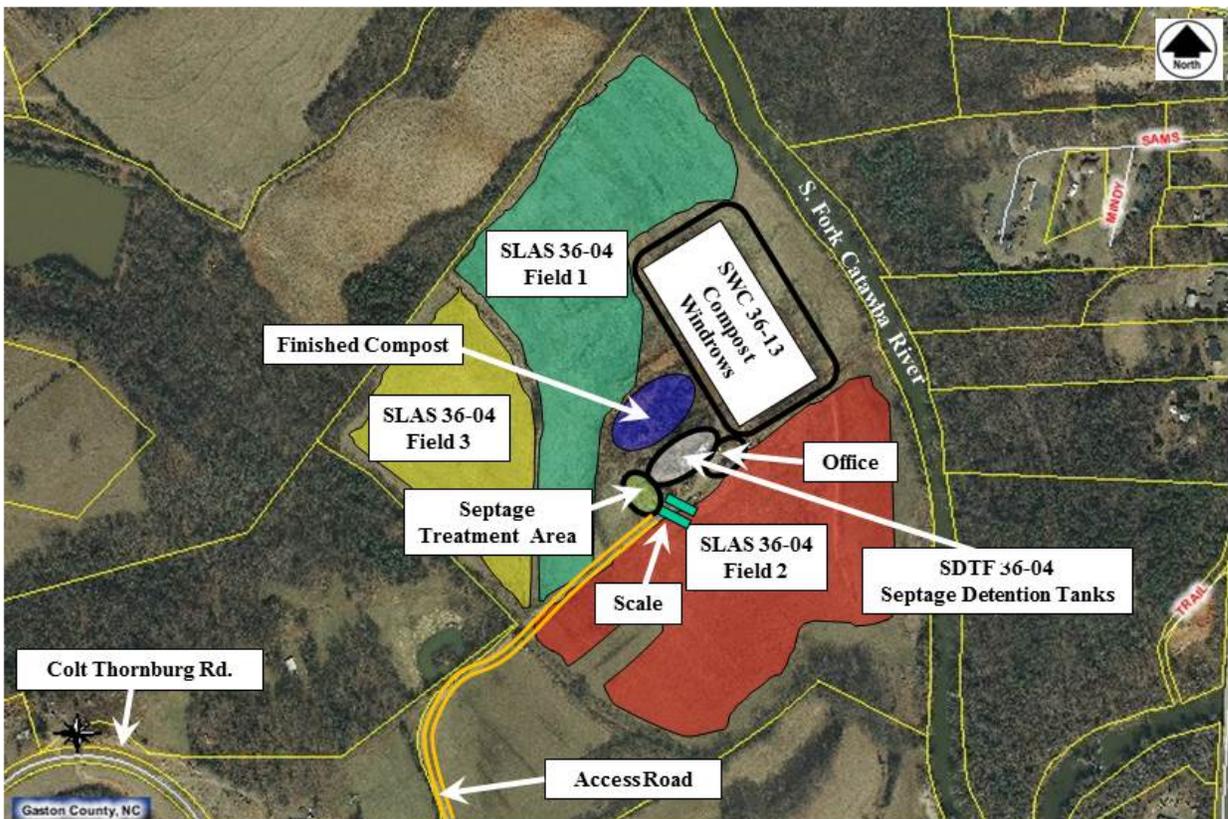
Figure 1: Site Map – Stanley Environmental Solutions, Inc.
351 Colt Thornburg Rd. (SR-1802), Dallas, NC
SLAS 36-04, SDTF 36-04 and SWC 36-13

3. Waste treatment is done on-site at SDFT-36-04. (Figure 1)
4. Waste treatment consists of: screening the wastes to remove large debris and other foreign matter; dewatering the waste to remove solid material; pH adjusting the waste with lime to a pH of 12 for at least 2-hours.

9. The facility consists of three septage application fields. (Figure 1 and Photos #1 and #2) Field #1 is approximately 22.9-acres. Field #2 is approximately 17.32-acres. Field #3 is approximately 6.31-acres.

16. There was a slight odor detected during the inspection.
17. Septage application records were reviewed.
18. Waste water storage is available on-site at SDTF-36-04 (Figure 1), or in Stanley, NC at SDTF-36-05

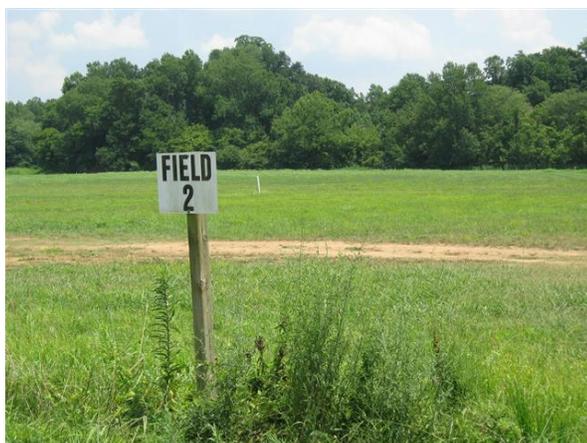
3. Looking east across the southern portion of septage land application field #2.

12. At the time of the inspection field #2 was the only field that was being used to accept wastes.
13. Septage appears to have been properly applied in an even manner with no evidence of any ponding or over application of waste.

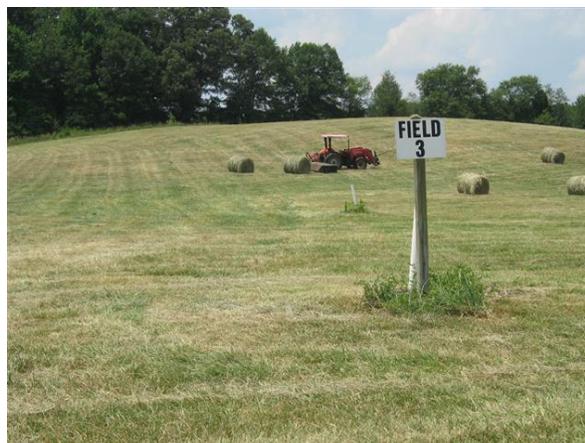
4. Looking north across septage land application field #3.

10. There was no evidence of overspray or application of septage outside of the permitted application fields.
11. All three fields were well maintained. Fields #1 and #3 were being mowed at the time of the inspection. (Photos # 4)

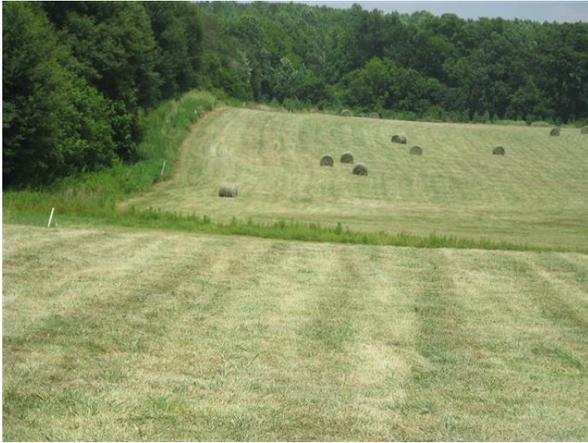
5. Looking (NE) along the NW border of Field #3 to Field #1 in the background.

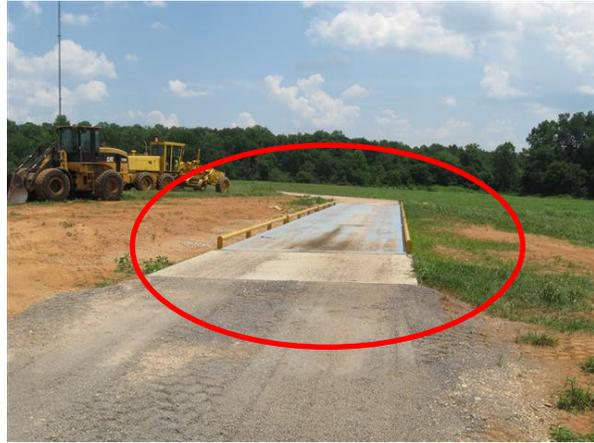
20. There is a new scale located on the western edge of Field #2. (Photo #6) The scale is to ensure that the facility's trucks do not exceed NCDOT load limits.

6. Looking at the new scale located south of the office and on the western edge of Filed #2
