FACILITY COMPLIANCE INSPECTION REPORT
Division of Waste Management
Solid Waste Section

Date of Site Inspection: 8/27/13

Stanley Environmental Solutions, Inc.
 351 Colt Thornburg Rd. (SR-1802)
 Dallas, NC

Comprehensive Audit

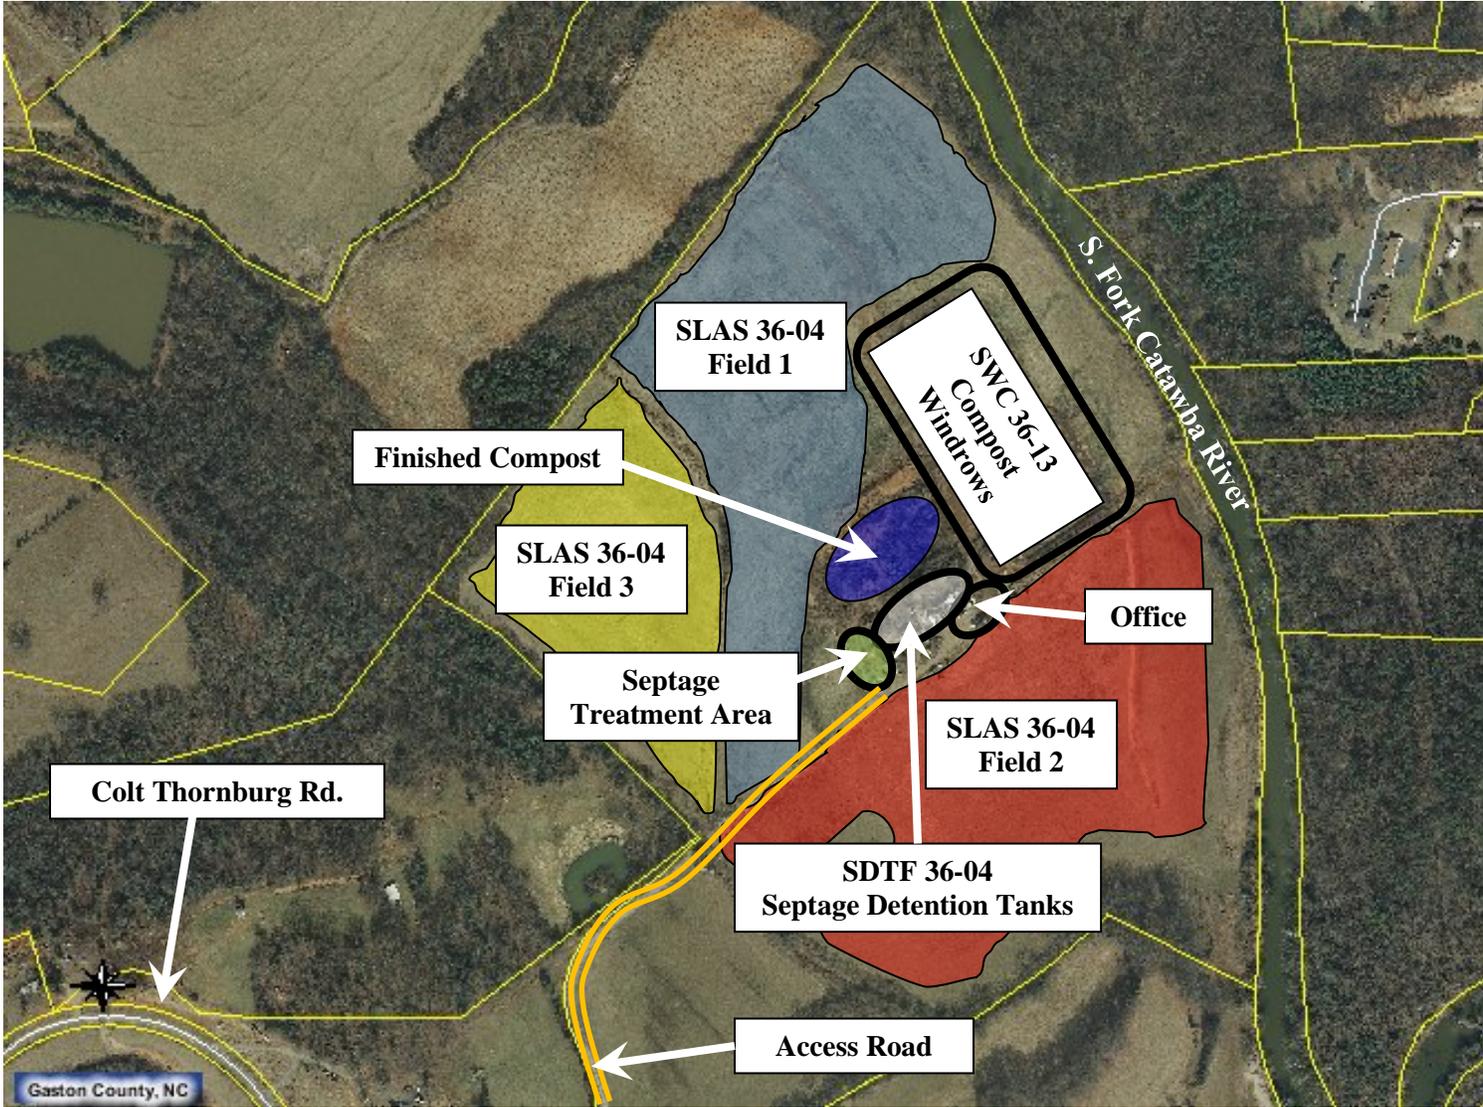
Figure 1: Site Map - Septage Land Application 36-04, Septage Detention & Treatment 36-04; and Compost 36-13

9. The facility consists of three septage application fields. (Figure 1 and Photos #1 and #2) Field #1 is approximately 22.9-acres. Field #2 is approximately 17.32-acres. Field #3 is approximately 6.31-acres.

3. Waste treatment is done on-site at SDFT-36-04. (Figure 1)
4. Waste treatment consists of: screening the wastes to remove large debris and other foreign matter; de-watering the waste to remove solid material; pH adjusting the waste with lime to a pH of 12 for at least 2-hours.

15. There were no objectionable odors detected during the inspection.
16. Septage application records were reviewed.
17. Waste water storage is available on-site at SDTF-36-04 (Figure 1), or in Stanley, NC at SDTF-36-05

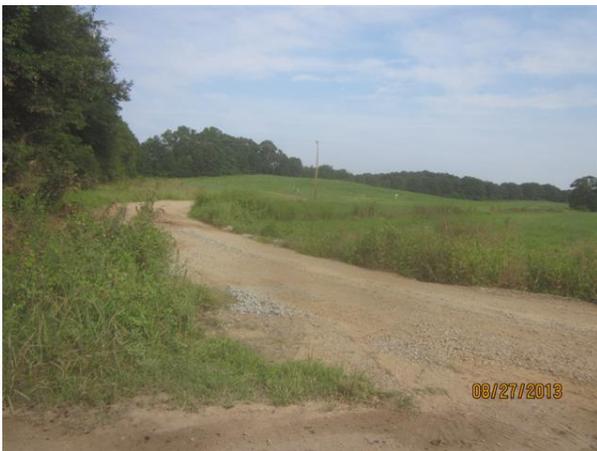
1. Access road along the (SW) side of field #3.

5. The access road to the facility was well maintained. (Photo #1)
6. Proper signage was displayed at the entrance to the site. Each of the three septage application fields is marked with ID signs.

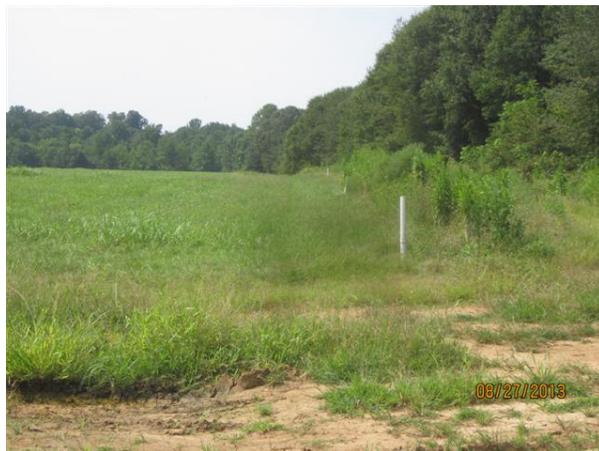
2. Looking (SW) down the (NW) side of Septage application field #1. (Note the white PVC edge-of-waste markers on the right.)

7. The limits of the waste application areas of each field are marked with PVC pipes. (Photo #2)
8. Approved setbacks are being maintained. (i.e. distances from wells, homes, etc.)
