**FACILITY COMPLIANCE INSPECTION REPORT**  
**Division of Waste Management**  
**Solid Waste Section**

Lined MSWLF	LCID	YW	Transfer	Compost	SLAS	<b>X</b>	<b>COUNTY: GASTON</b> <b>PERMIT NO.: SLAS-36-04</b> <b>FILE TYPE: COMPLIANCE</b>
Closed MSWLF	HHW	White goods	Incin	T&P	FIRM		
CDFL	Tire T&P / Collection	Tire Monofill	Industrial Landfill	DEMO	SDTF

Stanley Environmental Solutions, Inc.  
 351 Colt Thornburg Rd. (SR-1802)  
 Dallas, NC

Comprehensive Audit

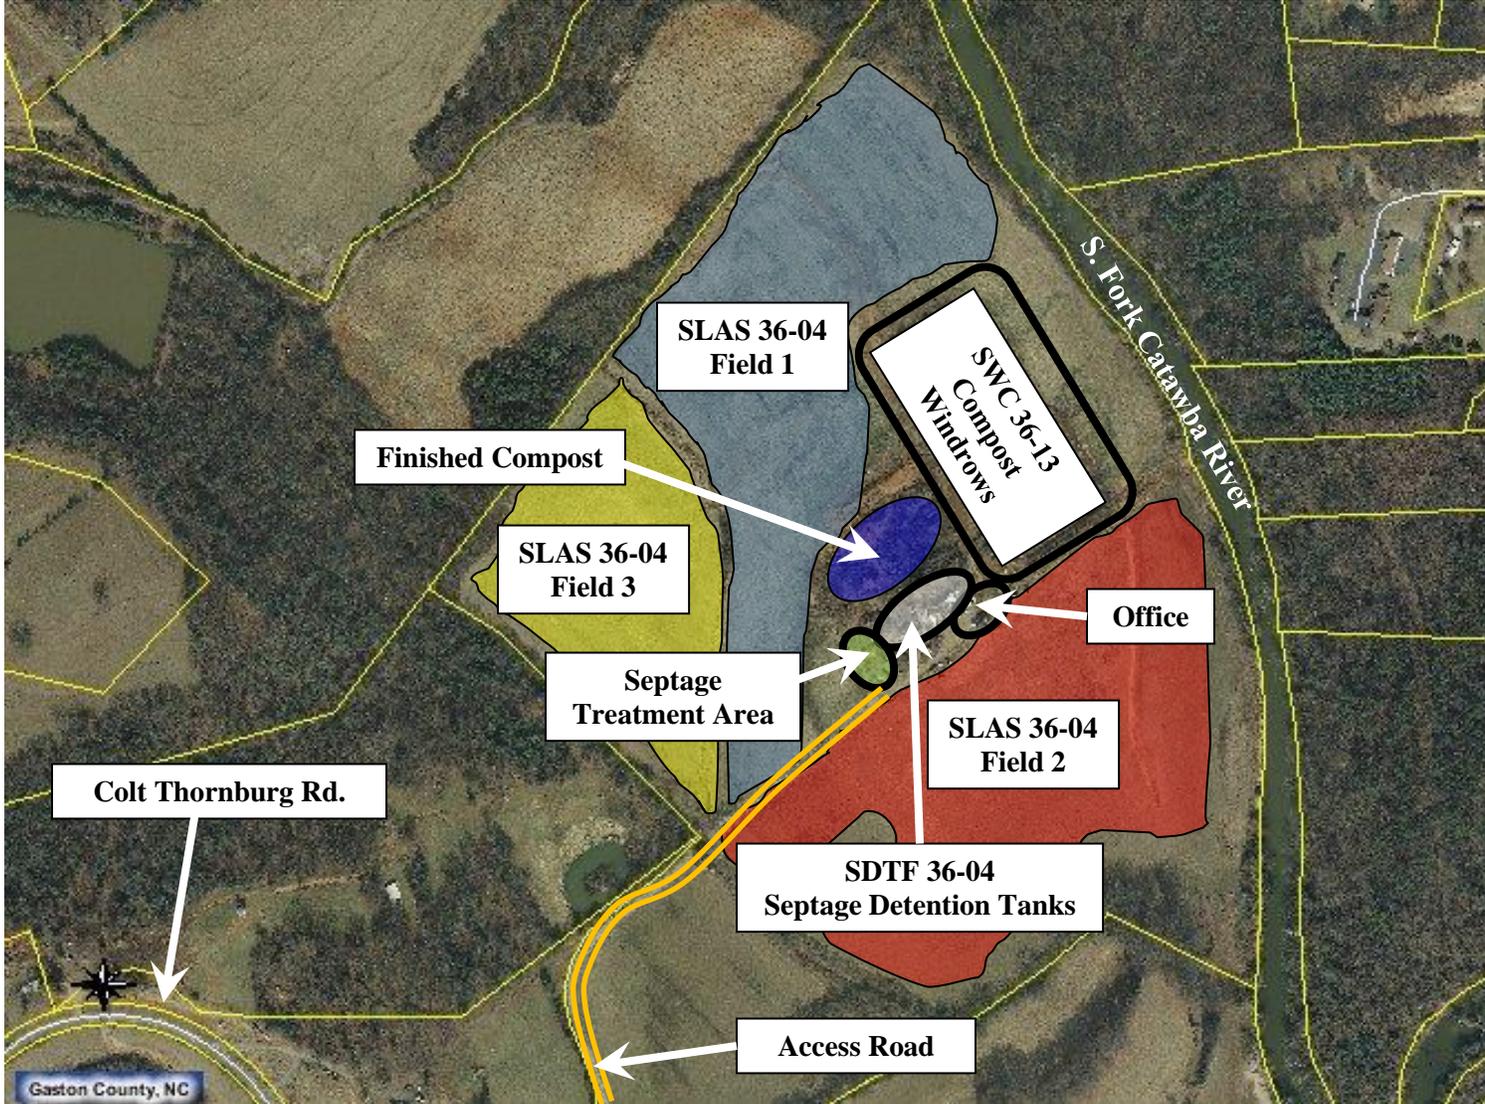
Figure 1: Site Map - Septage Land Application 36-04, Septage Detention & Treatment 36-04; and Compost 36-13

3. Waste treatment is done on-site at SDFT-36-04. (Figure 1)
4. Waste treatment consists of: screening the wastes to remove large debris and other foreign matter; de-watering the waste to remove solid material; pH adjusting the waste with lime to a pH of 12 for at least 2-hours.

9. The facility consists of three septage application fields. (Figure 1 and Photos #1 and #2) Field #1 is approximately 22.9-acres. Field #2 is approximately 17.32-acres. Field #3 is approximately 6.31-acres.

15. There were no objectionable odors detected during the inspection.
16. Septage application records were reviewed.
17. Waste water storage is available on-site at SDTF-36-04 (Figure 1), or in Stanley, NC at SDTF-36-05

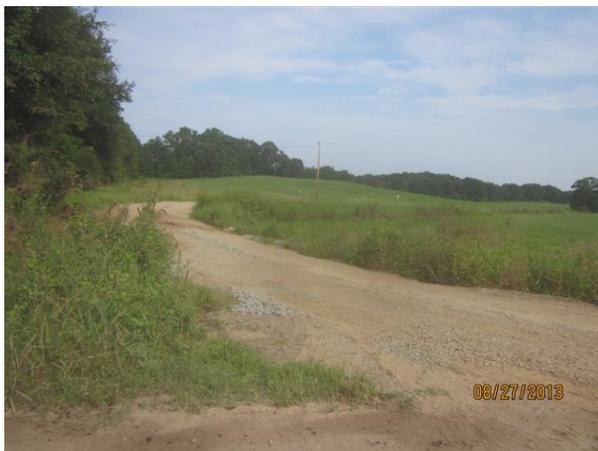
1. Access road along the (SW) side of field #3.

5. The access road to the facility was well maintained. (Photo #1)
6. Proper signage was displayed at the entrance to the site. Each of the three septage application fields is marked with ID signs.

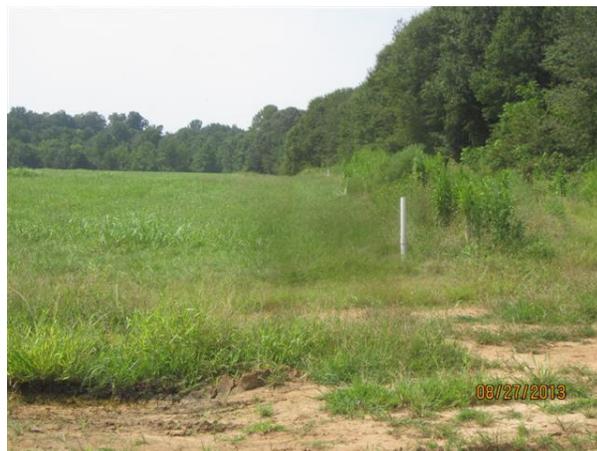
2. Looking (SW) down the (NW) side of Septage application field #1. (Note the white PVC edge-of-waste markers on the right.)

7. The limits of the waste application areas of each field are marked with PVC pipes. (Photo #2)
8. Approved setbacks are being maintained. (i.e. distances from wells, homes, etc.)
