**FACILITY COMPLIANCE INSPECTION REPORT**  
**Division of Waste Management**  
**Solid Waste Section**

Dennis Willis Septic Service  
 767 Hephzibah Church Road  
 Cherryville, NC

Comprehensive Site Inspection

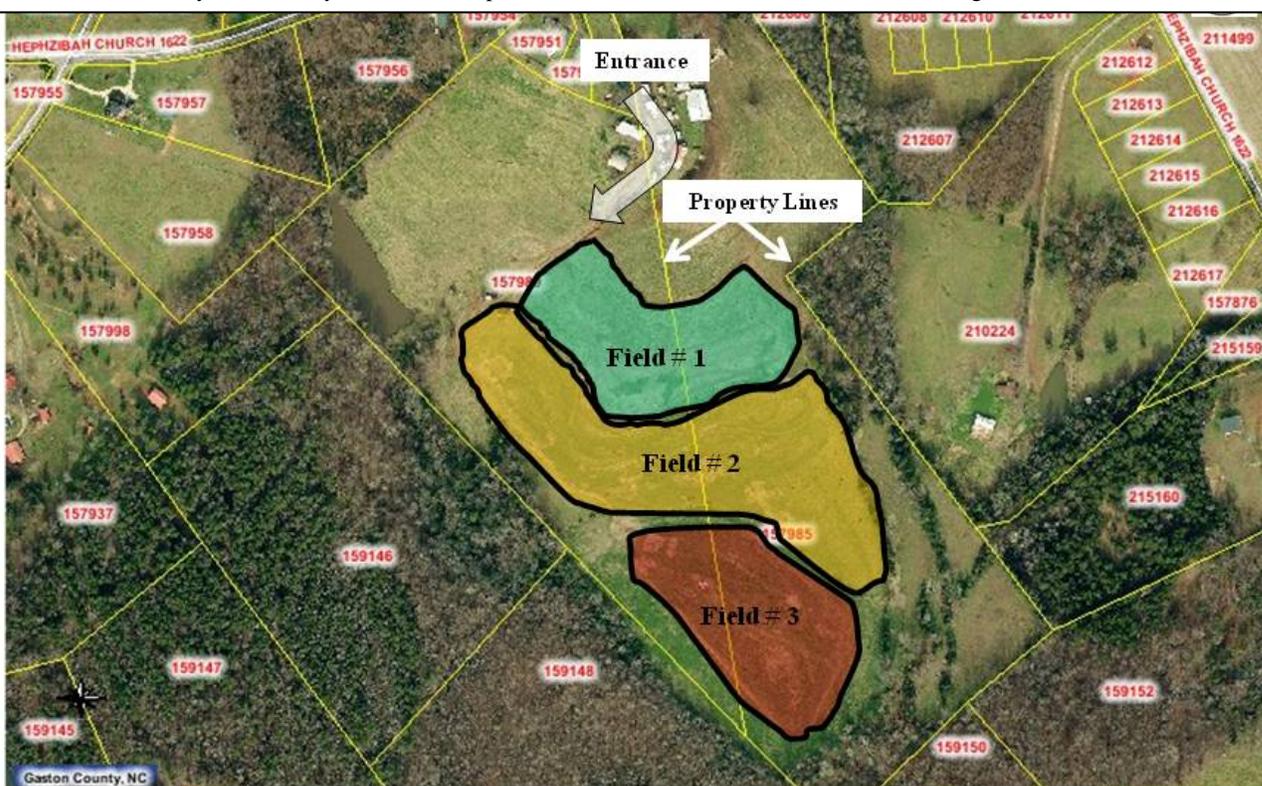
All three septage land application fields are bisected by a property line between two parcels under separate ownership. This parcel line runs essentially north and south. (Figures #1 and #2) The western most parcel (PIN 157989) is currently listed by Gaston County as being owned jointly by Herman and Janice Kiser. The eastern most parcel (PIN 157985) is currently listed by Gaston County as being owned jointly by Bruce and Gary Kiser.

Figure 1: Gaston Co. GIS site Aerial with property lines and approximate locations of three septage land application fields.

**This violation had not been corrected at the time of the first inspection on 9/05/13 but was corrected at the time of the second inspection on 10/01/13.**

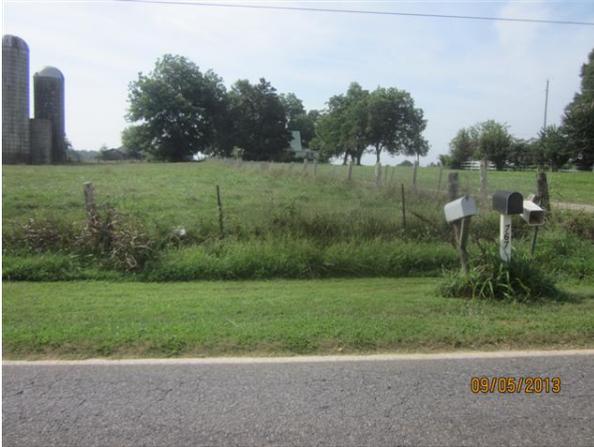
1. Looking (S) from Hephzibah Church Road at the facility: driveway entrance to site is to the right of the mail boxes.

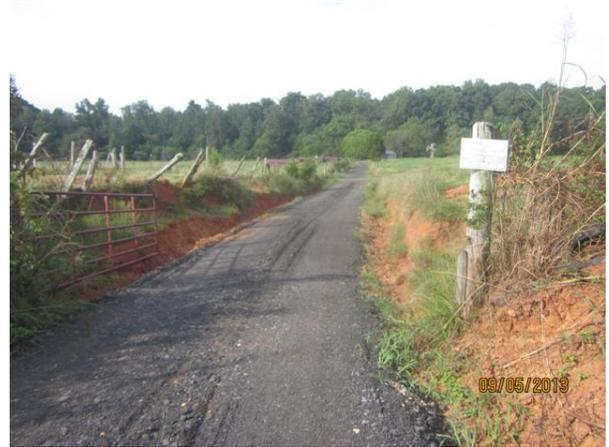
1. The required signage appeared adequate and access roads were maintained. (Photo #2)
2. The disposal area boundaries are not clearly marked. All visible septage discharges appeared to be within permitted boundaries.
3. The three fields are separated from each other by fencing.
4. The three septage fields lay across a property line (running north to south). The property to the west of the property line is owned by Herman and Janice Kiser. The property to the east of the property line is owned by Bruce and Gary Kiser. (Figures #1 and #2)
5. The 50-ft. buffer on each side of property line (running north to south) that bisects each of the three fields was not clearly marked at the first inspection on September 5, 2013.

2. Proper signage at entrance gate to the septage land application fields. (The NW edge of Field #1 is on the left side of the road.)

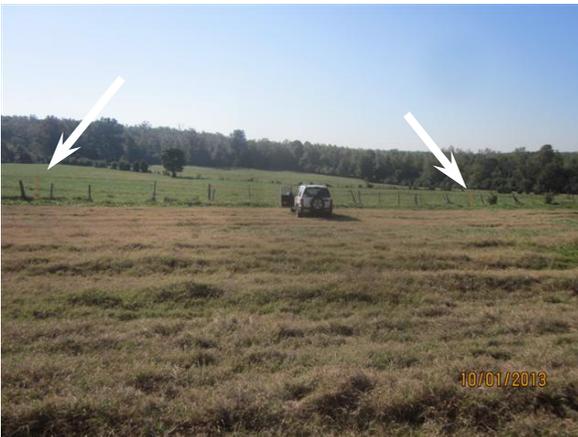
6. The 50-ft. buffers on each side of property line (running north to south) that bisects each of the three fields were marked at the second inspection on October 1, 2013. (Photos #3 and #4) Yellow stakes marking the 50-ft. buffer on both sides of the property line have been placed in each fence line that surrounds the fields.)

3. Looking (S) from the center of #1 at the fence line separating fields #1 and #2. White arrows indicate the yellow stakes that mark the limits of the 50-ft. buffer on each side of the property line. (10/01/13)

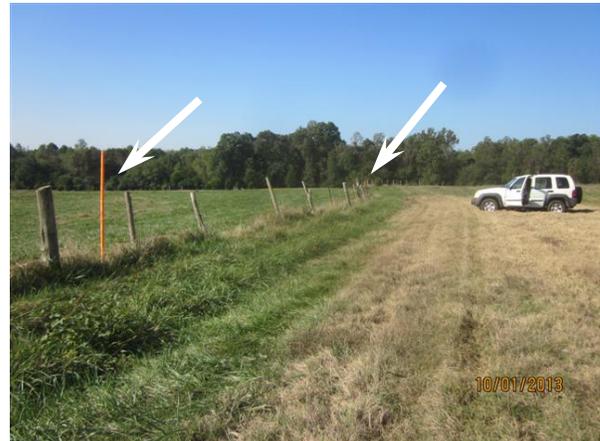
4. Looking (W) down the fence line separating fields #1 and #2. White arrows indicate the yellow stakes that mark the limits of the 50-ft. buffer on each side of the property line. (10/01/13)

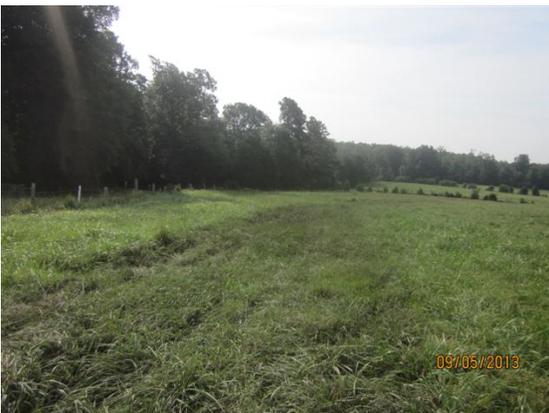
3. Looking (SE) a recently applied septage down the (E) side of field #2. (9/05/13)

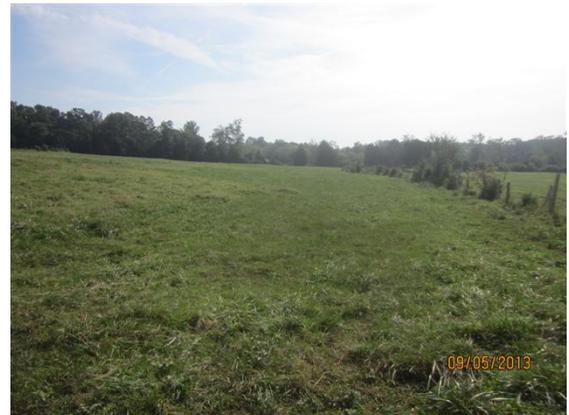
4. Looking (W) down the (N) edge of field #2. (9/05/13)

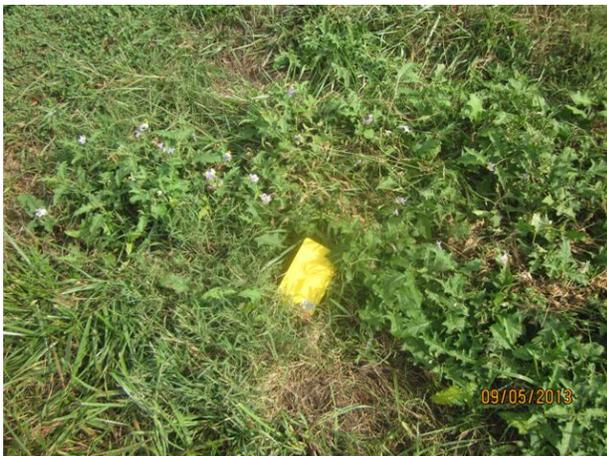
5. Weeds (believed to be *Horsenettle*) in field #2.  
 (Yellow 4 1/2" X 7 1/2" Field Book for scale.)

7. While all three septage fields are in use, Field #1 and #3 appeared to be fallow with only Field #2 actively taking septage. (Photos #3 and #4)
8. At the time of both inspections cattle were actively grazing on field #3.
9. The application of septage appeared to have been in accordance with permit conditions and application rates.
10. The cover crop was well established on all three fields and appeared stable and no ruts greater than 3-inches were noted at the time of the inspection.
11. Various weeds and woody vegetation (Photos #5 and #6) are becoming established in the fields (especially field #2). Please ensure that all fields, including buffer zones, must be maintained at least 90% ground coverage by fescue, in accordance with your approved nutrient management plan.

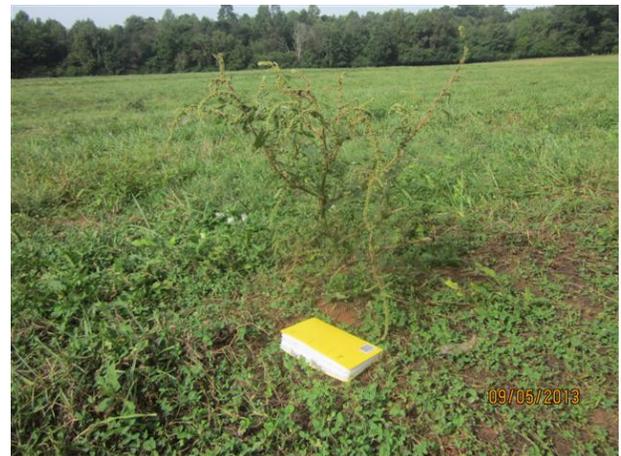
5. Unidentified woody vegetation in field #2.  
 (Yellow 4 1/2" X 7 1/2" Field Book for scale.)
