**FACILITY COMPLIANCE INSPECTION REPORT**  
**Division of Waste Management**  
**Solid Waste Section**

**Date of Site Inspection:** May 29, 2015

Coble's Sandrock, Inc. C&D Landfill  
 5833 Foster Store Road  
 Liberty, NC 27298

Comprehensive Inspection

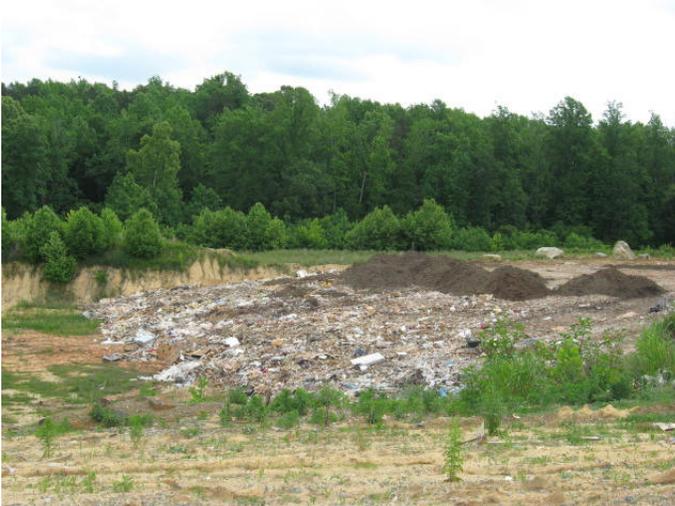
Working face – view from rear area

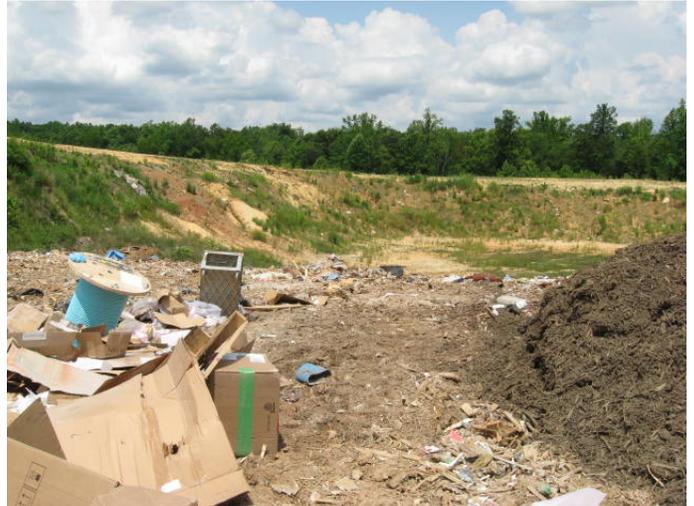
Working face – left side

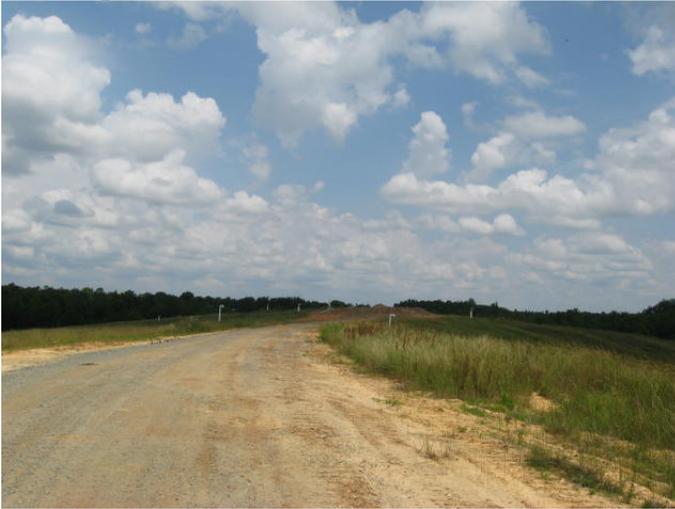
19. Phases 1A, 2A, and 2B are at final contour.
20. Ensure erosion rills along the landfill cap are repaired accordingly.
21. The facility shall cover solid waste with six-inches of soil when the waste disposal area exceeds one-half acre and at least once weekly. Solid waste shall not be visible when covered.

Area atop Phases 1A and 2B

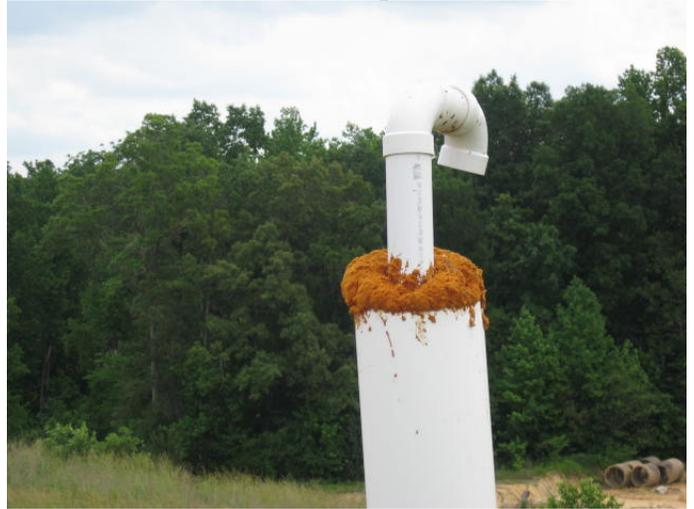
28. The landfill gas (LFG) vents atop Phases 1 and 2 each terminate with a 90° elbow. Six of the LFG vent elbows are secured to vertical vent pipes with foam sealant. The six vertical vent pipes are wider/greater diameter than the elbows. It is required that the LFG vents are constructed in conformance with permitted plans and specifications (Construction Quality Assurance Certification Report – 08/16/13).

LFG vent w/foam sealant – representative

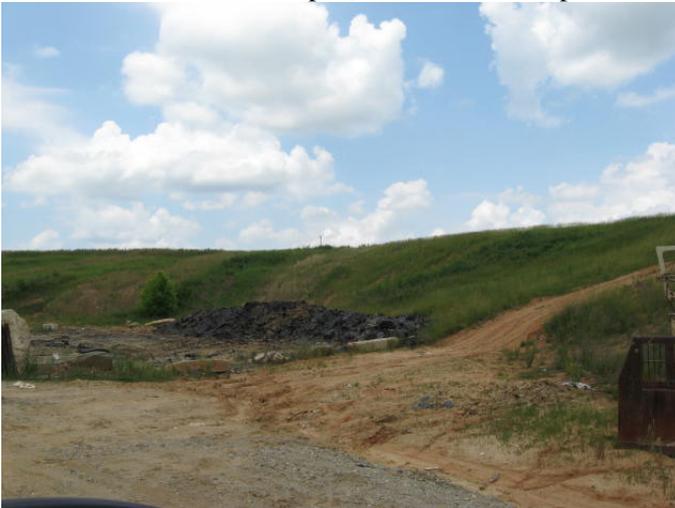
3. The PRAS operation is located at the toe of the east side slope of Phase 2B.
4. The approved area allotted for the PRAS operation is 100' x 100'.
5. The location of the PRAS operation will migrate as the landfill expands into future phases.

8. Asphalt shingles are picked-up by S.T. Wooten Corporation.
9. The PRAS operation area uses boulders as barriers. Asphalt shingles are stored atop the ground.

10. A sign is posted at the PRAS operation area, spray painted on a boulder.
11. Ms. Coble stated that the amount of asphalt shingles received for the PRAS operation has declined.

Phase 2B external side slope (east) and PRAS operation

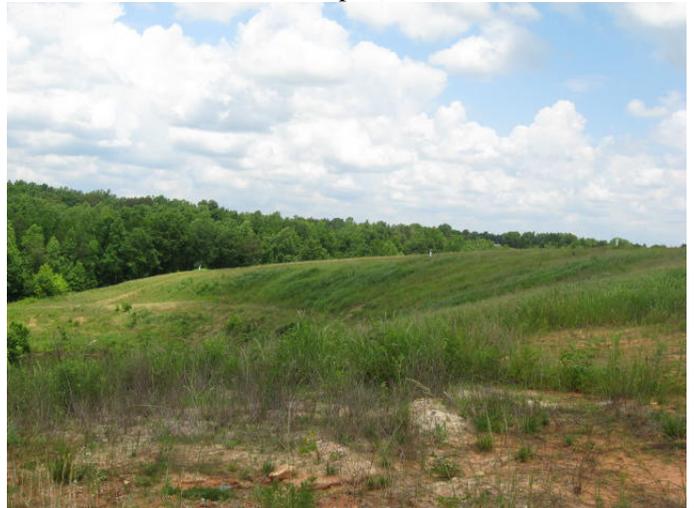
Phase 1A external side slope (west)

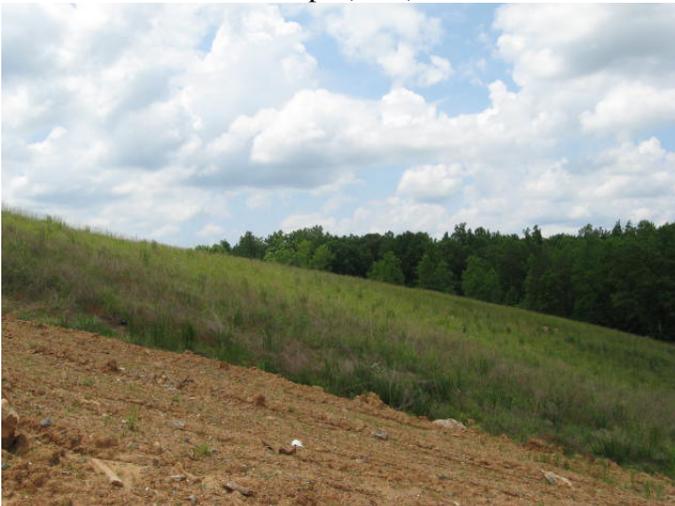
Phase 2B external side slope (west)

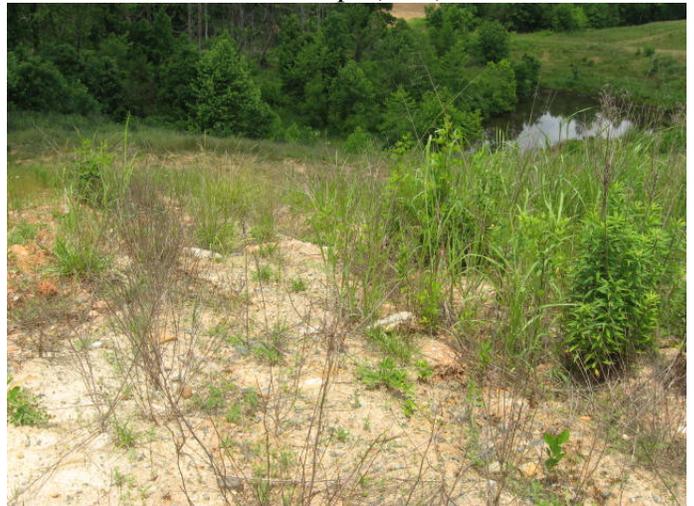
Phase 2B external side slope (west) – erosion rills

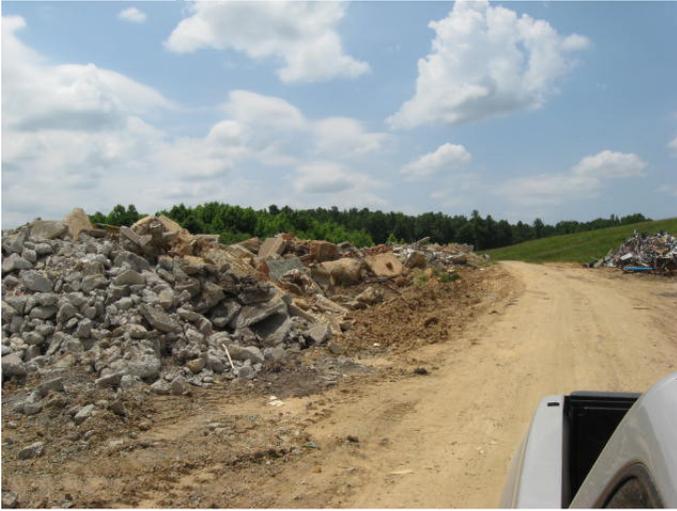
7. The facility has a large stockpile of concrete on site (much of the concrete is covered with vegetation). Ms. Coble stated that ~ 153 tons was crushed July through August 2014. All crushed concrete has been removed/sold. Mr. Coble stated that he plans to crush the concrete.

Concrete stockpile

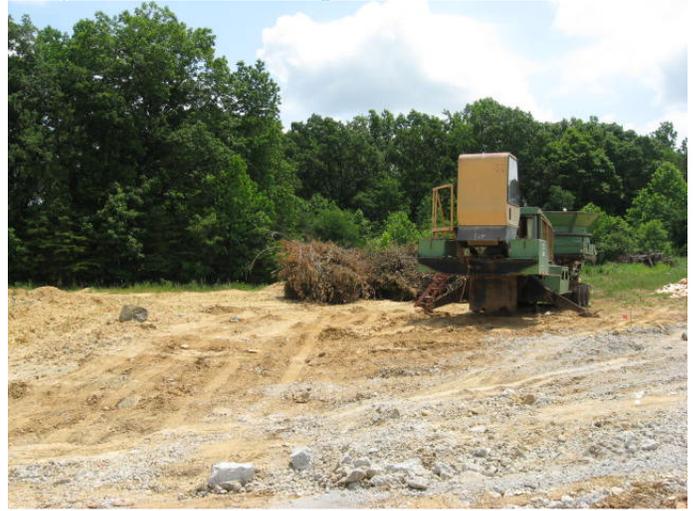
5. The facility grinds vegetative material, clean wood, and engineered wood together. It is commonly stockpiled on site until ground. Ensure only high carbon nitrogen ratio material is ground. Mr. Coble stated that mulch is sold for boiler fuel. Mr. Patrone reminded Mr. Coble that mulch containing engineered wood shall not be distributed for public use.

Vegetative material stockpile

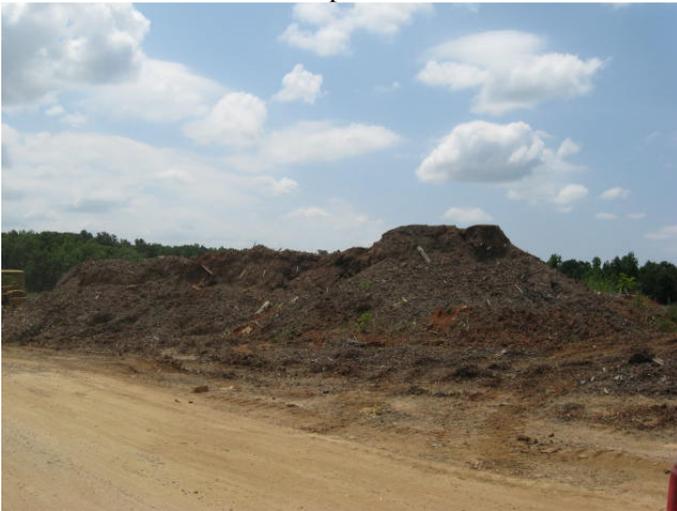
9. The facility has a pile of soil mixed with wood stored on site. Mr. Coble stated that the soil wood mix will be screened.
10. Ms. Coble stated that the facility does not plan to recover sheetrock for reuse.

Soil mixed with wood stockpile

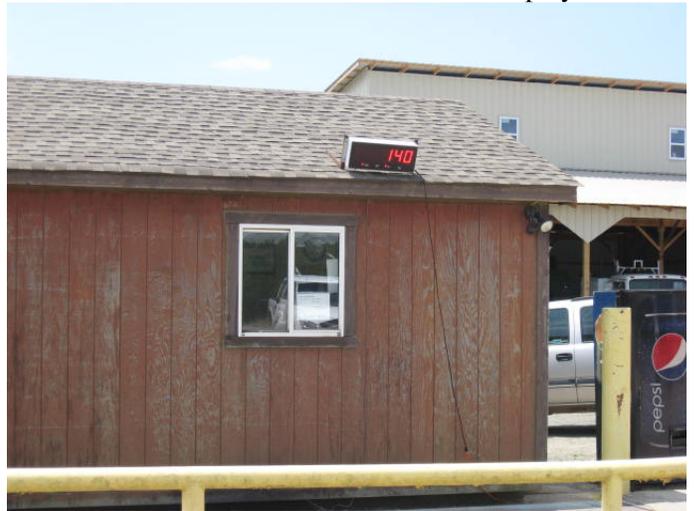
17. Vehicle scale test was conducted by North Carolina Department of Agriculture & Consumer Services on February 11, 2015. It was approved.
18. The facility installed an outdoor vehicle scale display unit.

Scale house with outdoor vehicle scale display unit
