FACILITY COMPLIANCE INSPECTION REPORT

Date of Inspection: 4 February 2015

Beaufort County Closed MSW Landfill
 1342 Hawkins Beach Road
 Bath, NC 27808

0702-20150204INSP

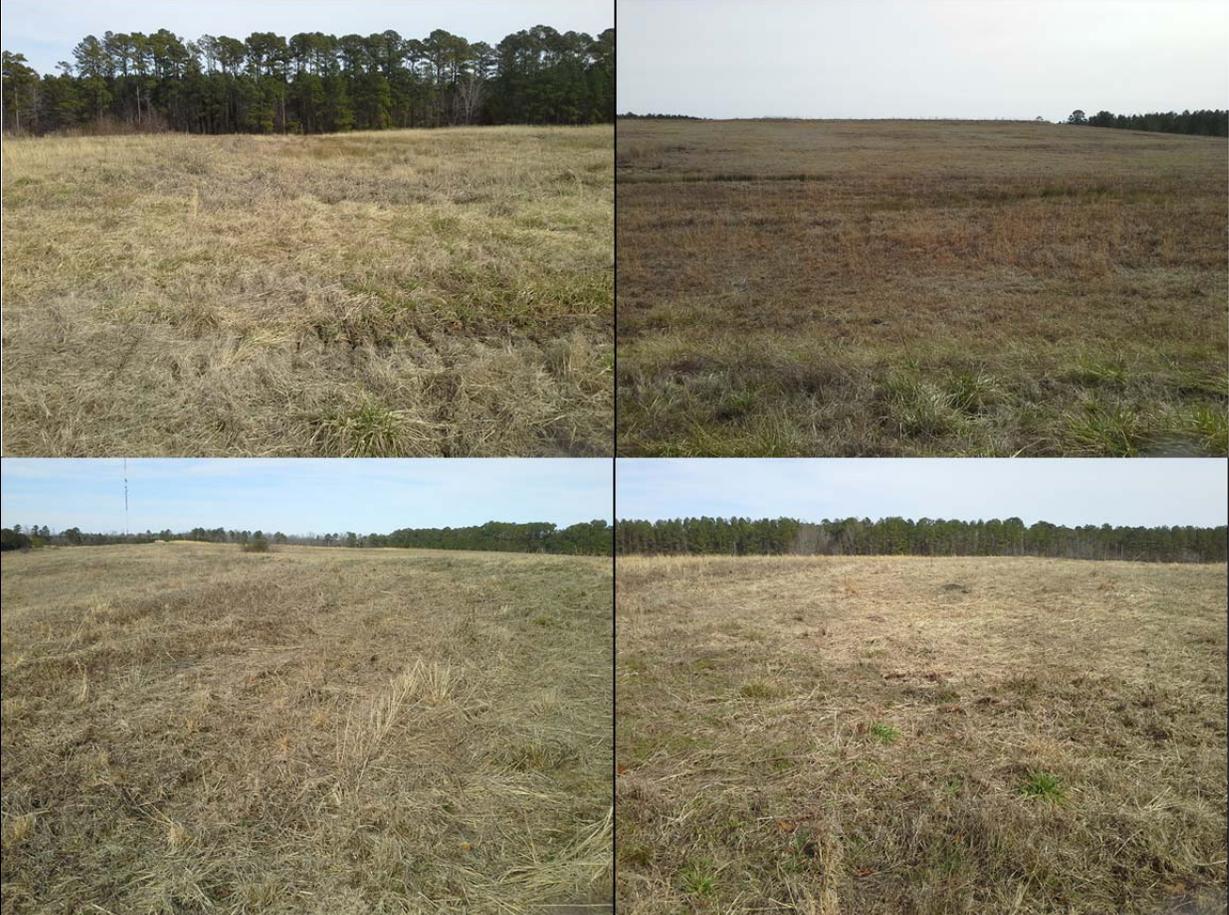
- 11) Areas of differential settlement were observed in several areas around the landfill. Some of these areas are restricting the positive flow of surface waters from the landfill during and following rain events. *Please fill and grade these areas to promote positive drainage of all surface waters away from the landfill. All filled areas should be graded at a slope not greater than 3:1 and seeded and mulched to establish a cover crop suitable to prevent erosion of your landfill cap system.

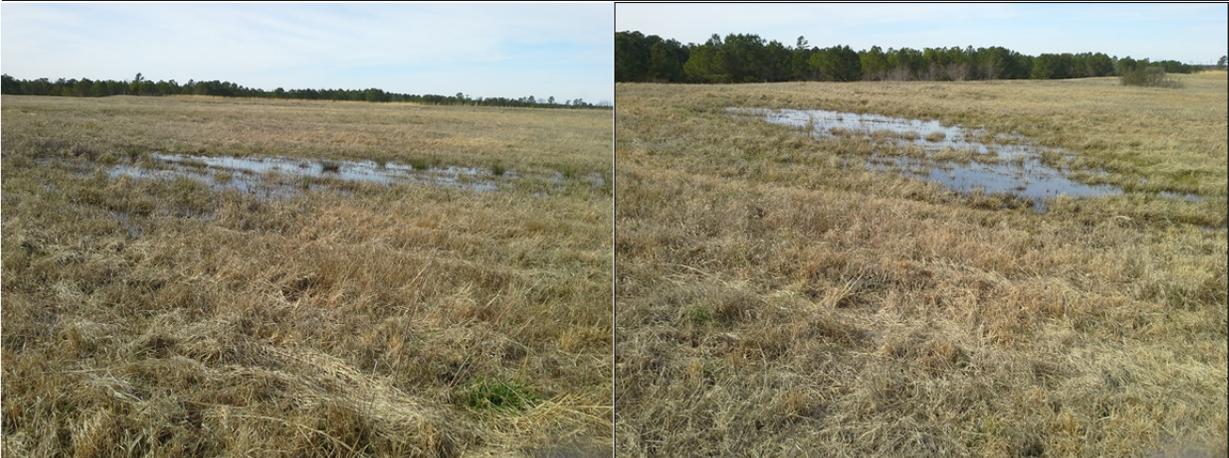
- 12) ATV traffic has caused damage to the cover crop and cap in several areas of the landfill along the tow of the slope near the western surface water ditch. *Please repair these areas by grading, seeding, and mulching to establish a groundcover suitable to prevent erosion of your landfill cap system.

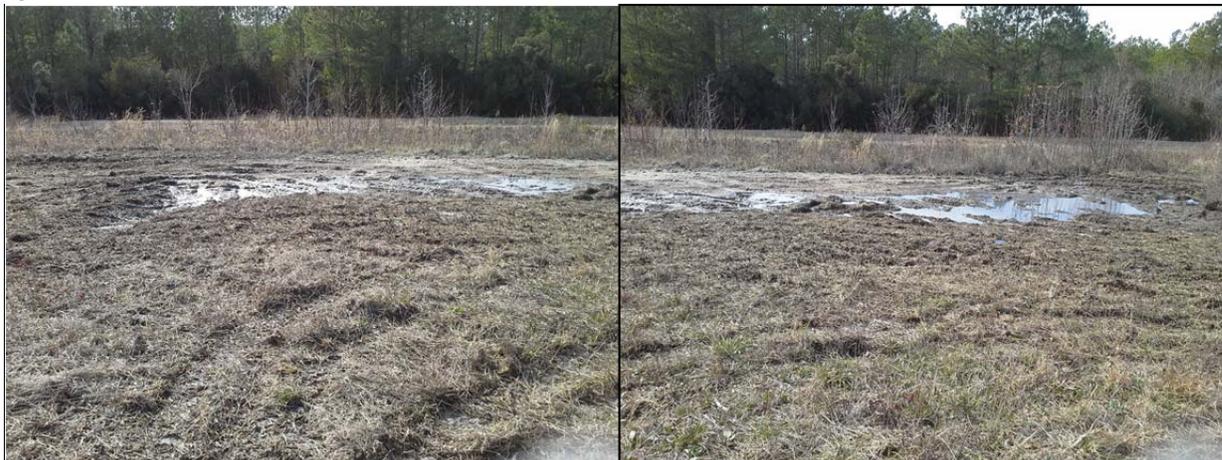
- 13) *Efforts need to be made to better restrict the unauthorized access to the landfill and to block the point of entry utilized by the ATV traffic.
- 14) Facility monitoring wells were reviewed. *Please ensure that the area around all monitoring wells is maintained clear of brush and that all wells are properly labelled and secured with functioning locks.
