FACILITY COMPLIANCE INSPECTION REPORT
Division of Waste Management
Solid Waste Section

Beaufort County Closed MSW Landfill
 1342 Hawkins Beach Road
 Bath, NC 27808

Partial Facility Compliance Inspection without records review

0702-20140724INSP

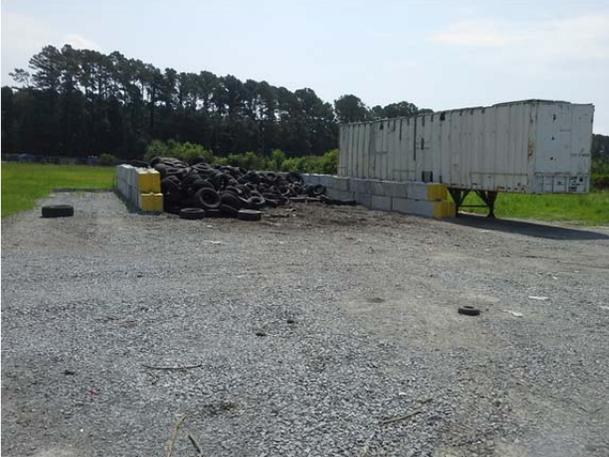
- 9) An adequate number of trailers are maintained on-site for the volume of tires managed by this Facility.
- 10) The Scrap Tire Management Area is being well maintained at this time.
- 11) Overall, the closed areas of the landfill are covered with a well-established cover crop of native warm season grasses.

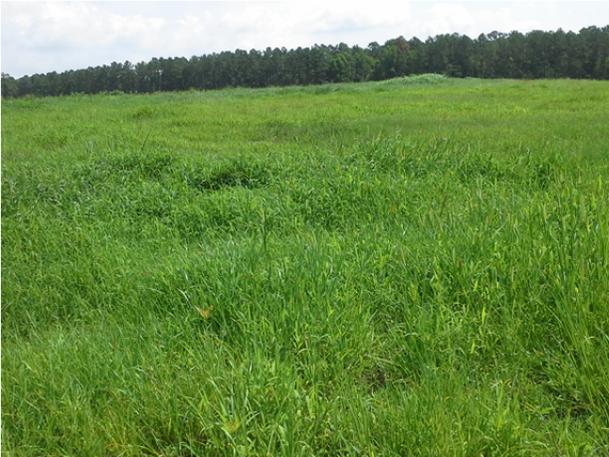
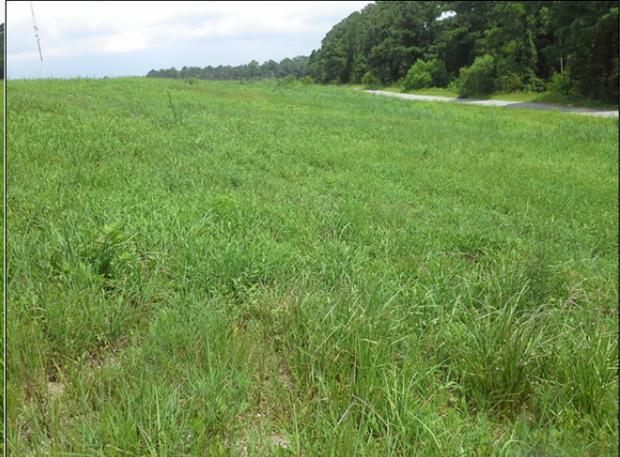
- 12) Some small areas of sparse cover were observed in various areas around the landfill. *Please seed and mulch all areas of sparse cover to establish a groundcover suitable to prevent erosion of your landfill cap system.

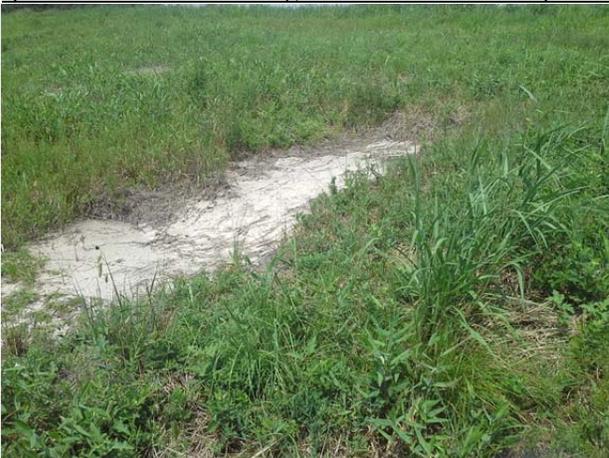
- 13) No ponding water was observed on the landfill during this Facility Compliance Inspection.
- 14) Brush, small trees, and other woody vegetation were observed growing in the surface water ditch on the western side of the landfill. *Please removed all brush, trees, and other woody vegetation from this area and ensure that all Facility surface water ditches are maintained clear of brush and other obstructions.
