**FACILITY COMPLIANCE INSPECTION REPORT**  
**Division of Waste Management**  
**Solid Waste Section**

<b>UNIT TYPE:</b>											
Lined MSWLF		LCID		YW Collection		Transfer	<input checked="" type="checkbox"/>	Compost		SLAS	<b>COUNTY: Beaufort</b> <b>PERMIT NO.: 0703T-TRANSFER-2012</b> <b>FILE TYPE: COMPLIANCE</b>
Closed MSWLF		HHW		White goods		Incin		T&P		FIRM	
CDLF		Tire Collection	<input checked="" type="checkbox"/>	Tire Monofill		Industrial Landfill		DEMO		SDTF

Beaufort County Transfer Station  
500 Flanders Filters Road  
Washington, NC

0703T-20150204INSP

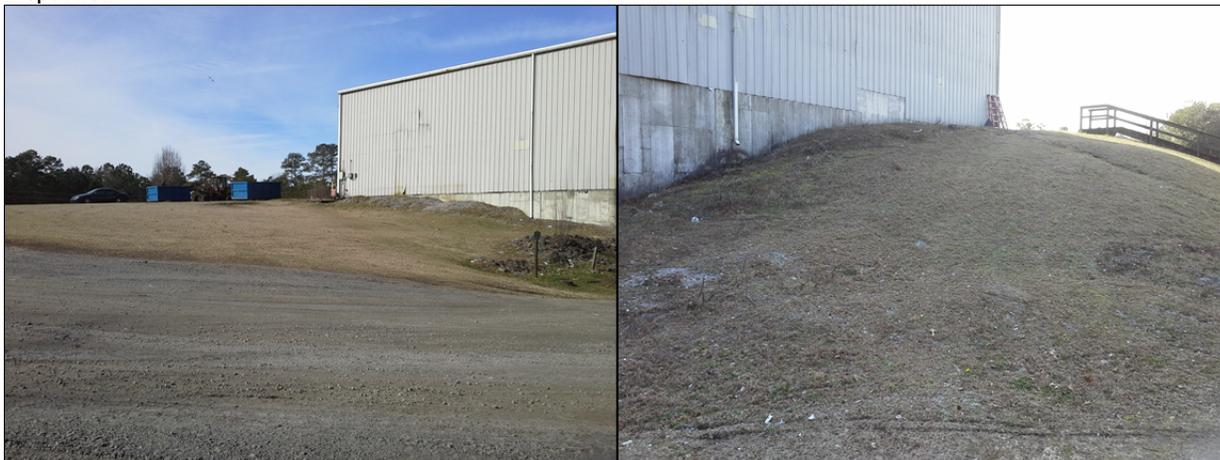
- 7) The Facility access road is of all-weather construction and is being maintained in overall good condition.
- 8) This Facility does not accept asbestos containing wastes.
- 9) This Facility screens all incoming loads for unpermitted materials. One waste screening is being recorded in a log per week. The waste screening log was in order and presented for review during this Facility Compliance Inspection.
- 10) This Facility is currently receiving +/- 150 tons of waste per day.
- 11) Access around the Facility overall is generally stable and no areas of erosion were noted during this Facility Compliance Inspection.

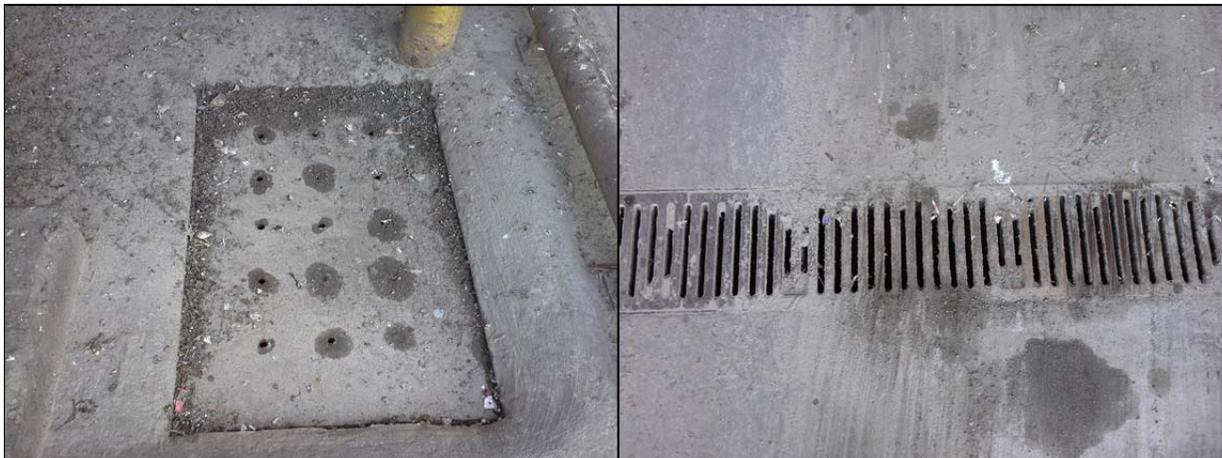
- 13) No windblown debris was observed outside of the Facility perimeter fence.
- 14) There is one manhole present in the tipping floor for access to the leachate collection system and to provide for additional drainage and collection as needed.
- 15) Leachate is collected on-site and stored in an underground tank which is pumped down and hauled for treatment as needed. The leachate tanks have recently been pumped down and the leachate hauled to the City of Washington Wastewater Treatment Plant for disposal.
- 16) Leachate is restricted to the tipping floor and directed to the collection system by a small berm at the entryway edge of the tipping floor.
- 17) The Leachate collection drains were clear of debris and appear to be functioning as designed.

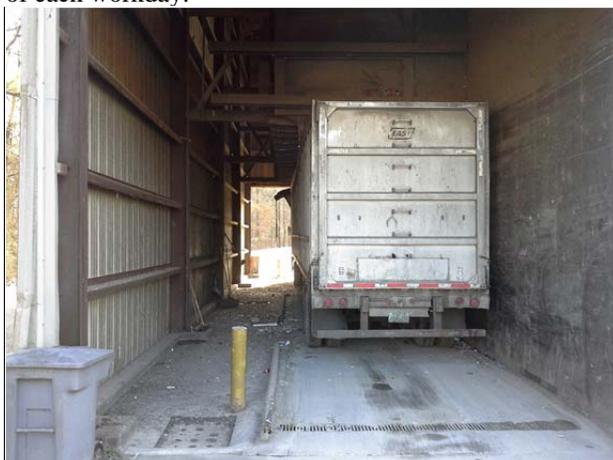
- 18) Leachate and the leachate collection system appear to be well managed at this time.
- 19) The trailer loading area is cleaned of any waste overflow as trailers are removed from the bays for transfer and at the end of each workday.

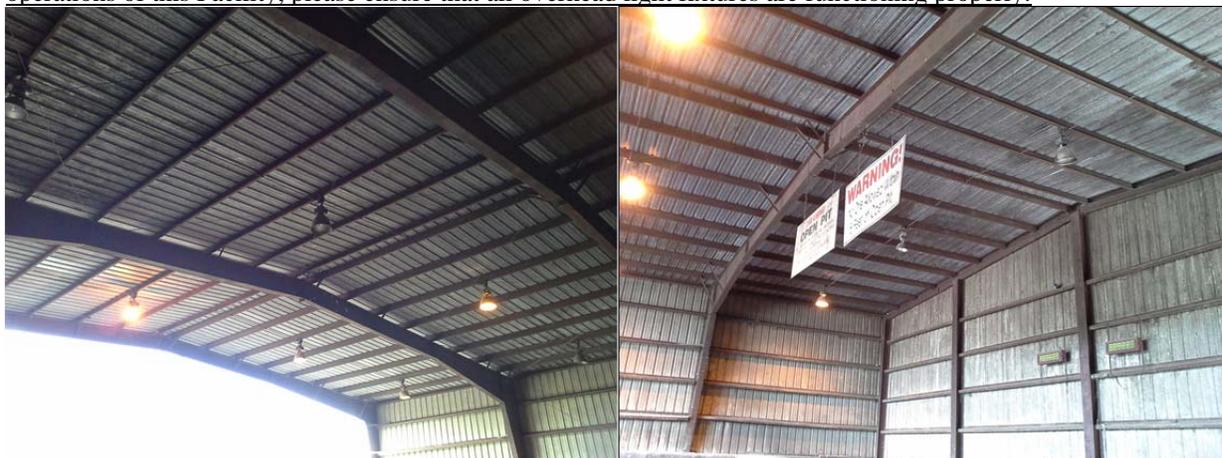
- 20) There are five fire extinguishers; three in the transfer station, one in the loader, and one in the yard dog, for fire control.
- 21) There are two hose-bibs, one located at the front corner of the Transfer Station and one located at the loading bay exit for wash-down and fire suppression.
- 22) The tipping floor is cleaned and washed down daily and the interior walls are pressure washed quarterly.
- 23) The concrete push walls are cleaned of waste daily.
- 24) Several of the overhead lights were observed to be non-functioning during this Facility Compliance Inspection. \*For safe operations of this Facility, please ensure that all overhead light fixtures are functioning properly.

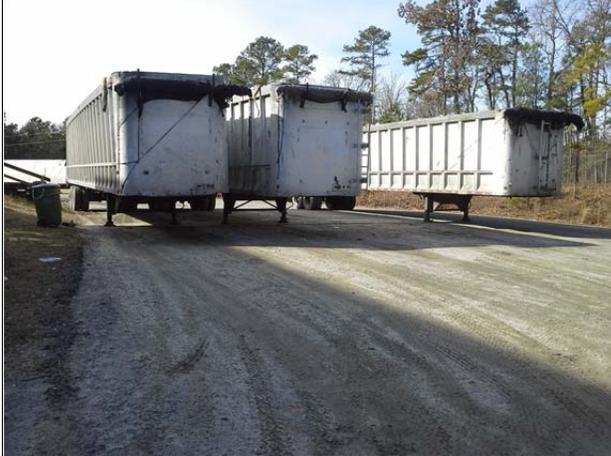
- 27) This Facility maintains an adequate number of trailers on site to properly manage the volume of waste received during operating hours.
