FACILITY COMPLIANCE INSPECTION REPORT
Department of Environmental Quality
Division of Waste Management - Solid Waste Section

Chatham County Closed MSW Landfill
 28 County Services Road
 Pittsboro, NC 27312

Post Closure Inspection

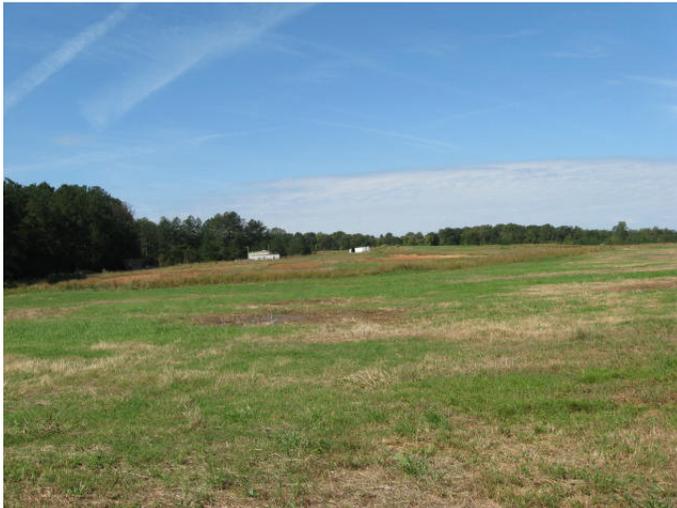
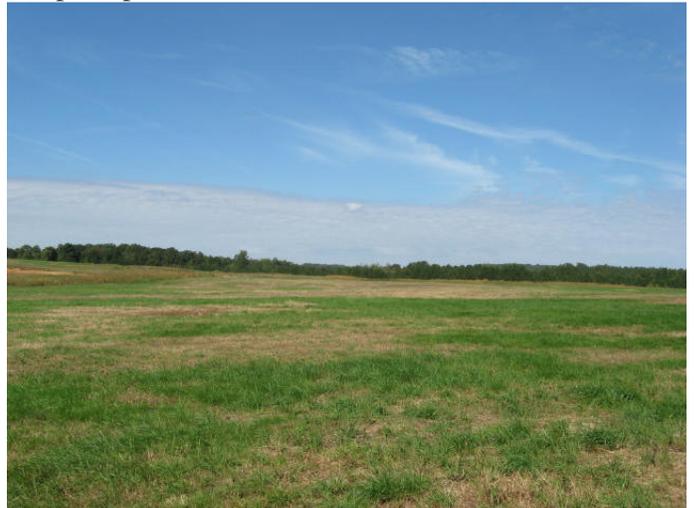
Closed MSW landfill cap – representative

11. The facility maintains records of the scrap tires received.
12. Edge of waste is delineated by red PVC pipe installed at the waste boundary.
13. The landfill cap is covered with native grasses. Hay is harvested on top and the side slopes mowed annually.

14. Mr. LaMontagne stated that soil will be added to low areas and bare areas will be sown with grass seed.
15. There was no indication of erosion or runoff.

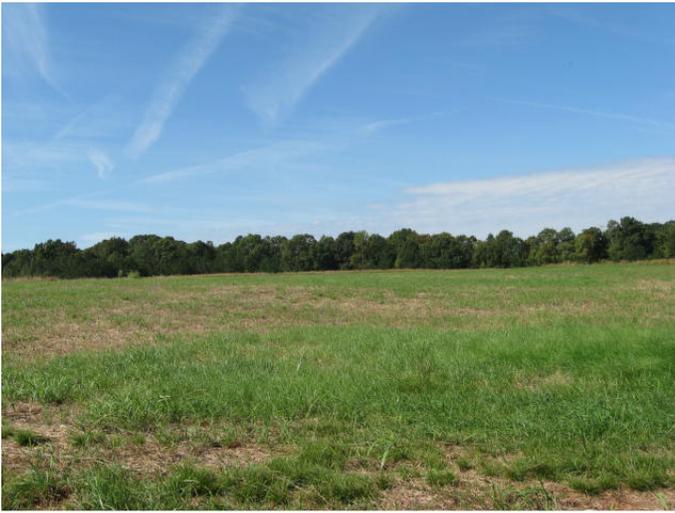
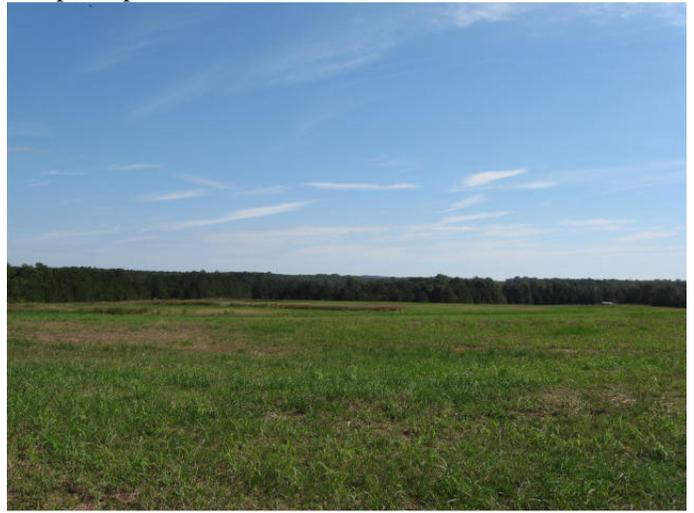
Closed MSW landfill cap – representative

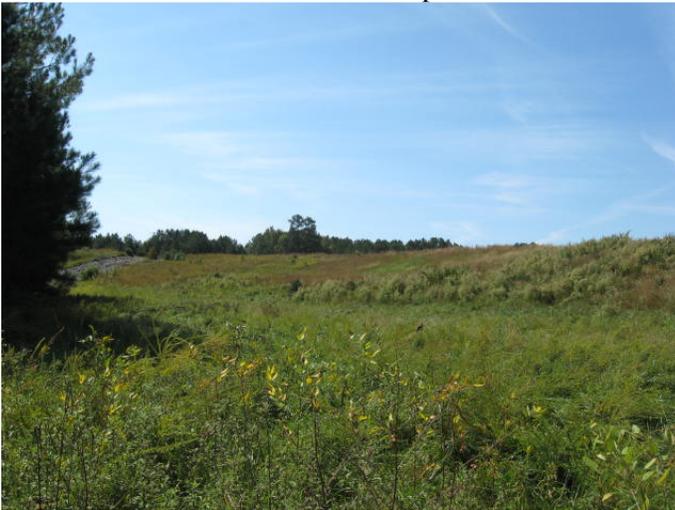
Closed MSW landfill – east side slope area

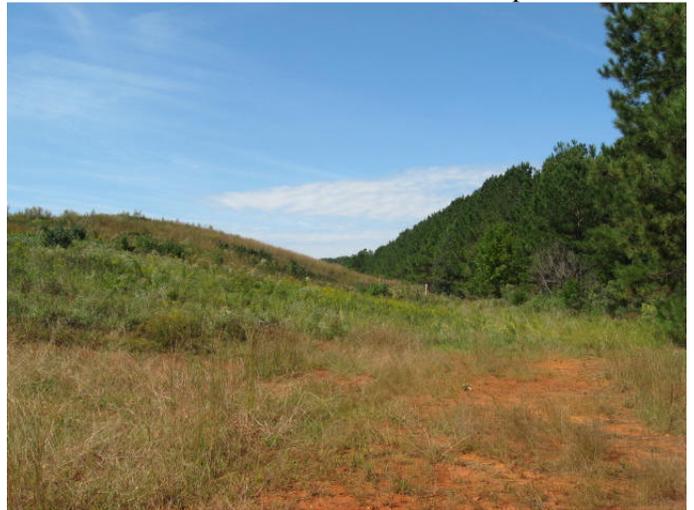
Closed MSW landfill – northeast side slope area

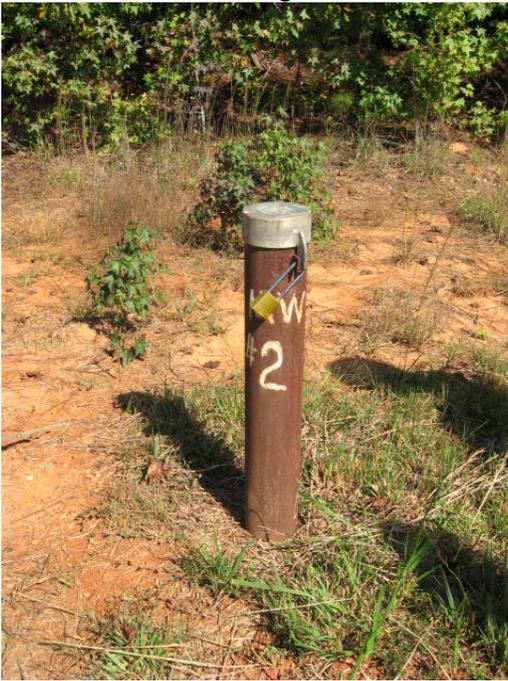
8. The facility uses five groundwater monitoring wells: MW-1, MW-2, MW-3, MW-4, and MW-5 and two surface water locations: SW-1 and SW-2. Monitoring well MW-2/MW-2N was observed.

Groundwater monitoring well MW-2/MW-2N

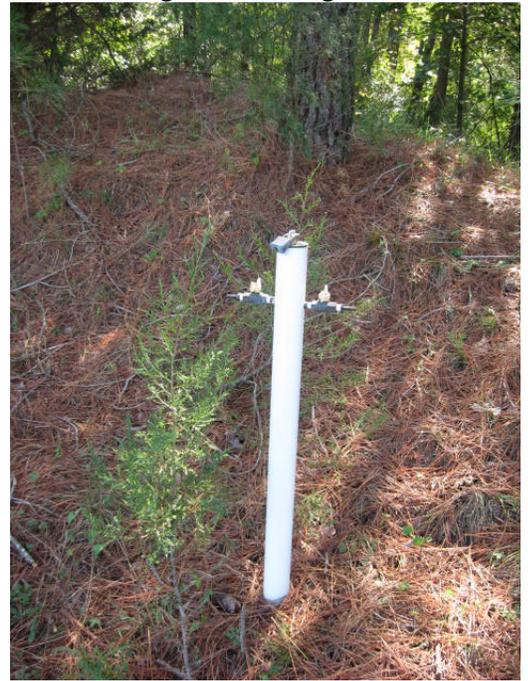
10. The facility uses fourteen landfill gas monitoring wells: MP-1, MP-2, MP-3, MP-4, MP-5, MP-6, MP-7, MP-8, MP-10, MP-11, MP-12, MP-15, MP-18, and MP-19. Landfill gas wells MP-8, MP-10, MP-11, and MP-19 were observed. The landfill gas wells observed had a locking cap and barbed connector stopcock valves. Ensure landfill gas wells have identification plates.

Landfill gas monitoring well MP-8

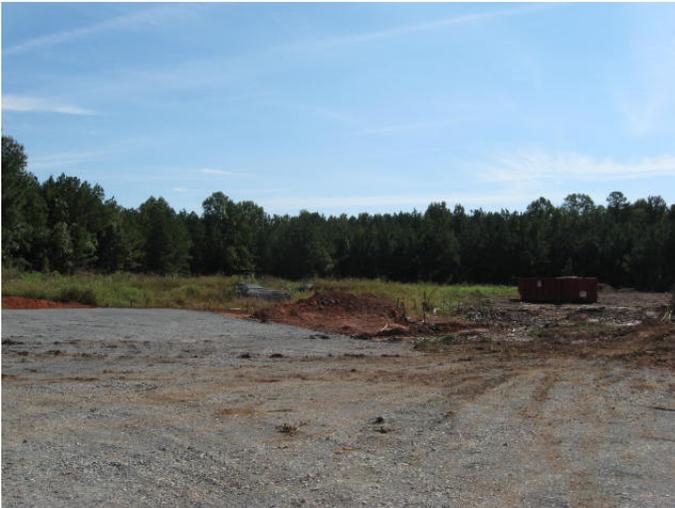
19. A second TDDSS is located on the property, adjacent to the yard waste compost operation site, (DS19-004). The TDDSS has six acres allotted to it but only ~ two acres has been cleared of trees. It is suggested that the two acres available is maintained for immediate use and that the remaining four acres is cleared of trees when practical.

TDDSS DS19-004, includes treed area on left

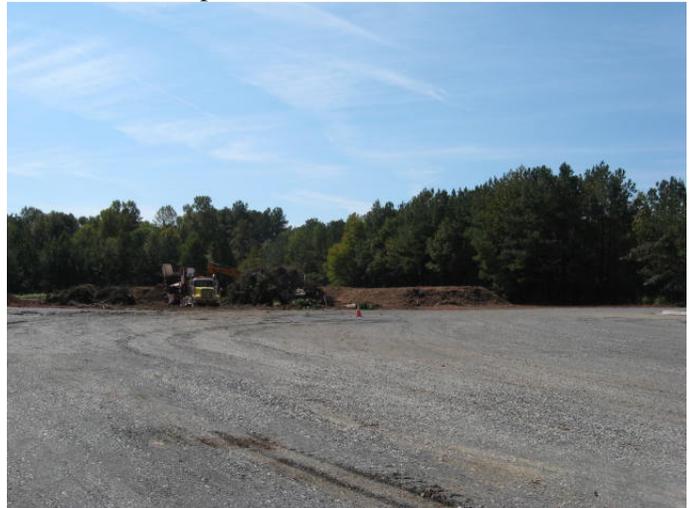
17. The yard waste compost operation is located adjacent to the Solid Waste & Recycling Division office. The area allotted for the yard waste compost operation is ~ 2 acres. High carbon nitrogen ratio material is ground annually or when ~ 1,000 tons of material is received. Material was ground October 1-7, 2015. All material received is expected to be ground by October 9, 2015, totaling ~ 1,005 tons. Mr. LaMontagne stated that mulch is sold to the public and a portion provided to a local compost facility.

18. The area allotted for the yard waste compost operation is also a Temporary Disaster Debris Staging Site (TDDSS, DS19-003). The yard waste compost operation site should be operated such that as much area as possible is maintained to collect/store disaster debris.

Yard waste compost area and TDDSS DS19-003
