**FACILITY COMPLIANCE INSPECTION REPORT**  
**Division of Waste Management**  
**Solid Waste Section**

**Date of Site Inspection:** April 6, 2015

M<sup>c</sup>Gill Environmental Systems of NC, Inc. – Merry Oaks Facility Large, Type 4 SWC Facility  
 634 Christian Chapel Church Road  
 New Hill, NC 27562

Odor Complaint Investigation

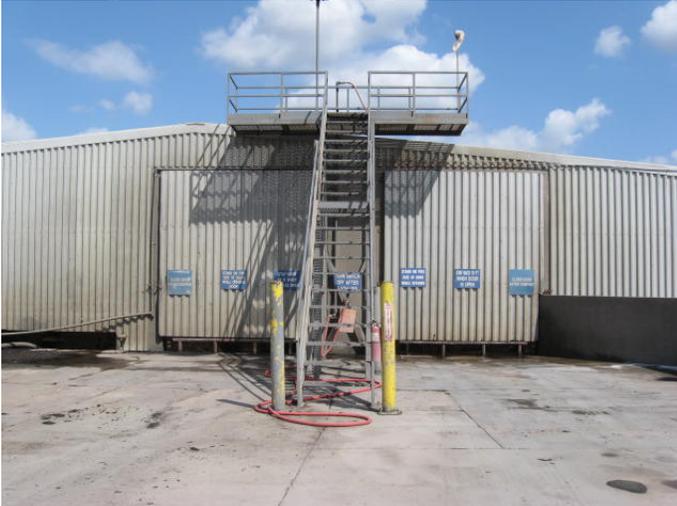
25. The off-load pit bay door(s) are required to be closed by the truck driver. A sign is posted on each bay door.
  26. As discussed with Mr. Cockman, if the facility is the source of the odor, perhaps the three trucks off-loading odorous material in short succession presented a situation that made it difficult to incorporate bulking agent in a timely manner. Alternatively, the off-load pit bay door(s) may have been left open longer than intended.

Off-load pit bay doors and truck pad

29. Mr. Patrone recommends that the procedure for incoming sludge be reviewed with facility staff and that drivers be reminded to close the off-load pit bay door(s). If necessary, an employee could be assigned the task, when odorous trucks are received, to ensure the truck pad is quickly washed-off and the bay doors closed. Perhaps a mechanical system to close the bay doors could be installed.

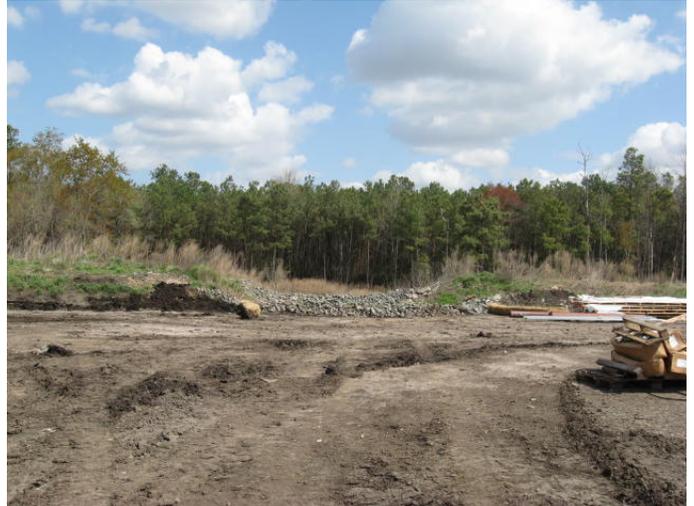
31. During the inspection there was no odor detected at the facility boundary.
  32. The facility has conducted maintenance on the stormwater basin inlet of pond No. 1. The area has been graded and the check dam reconstructed/silt removed. Mr. Cockman stated that stormwater no longer ponds in the area.

Stormwater basin inlet pond No. 1 check dam

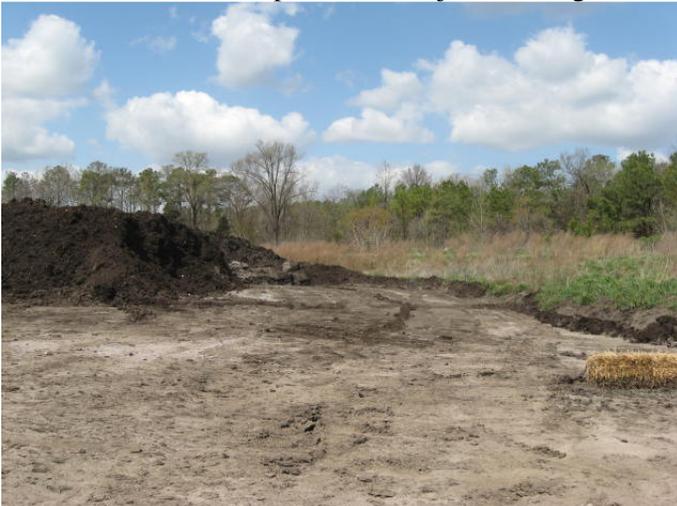
Stormwater basin inlet pond No. 1 adjacent area graded

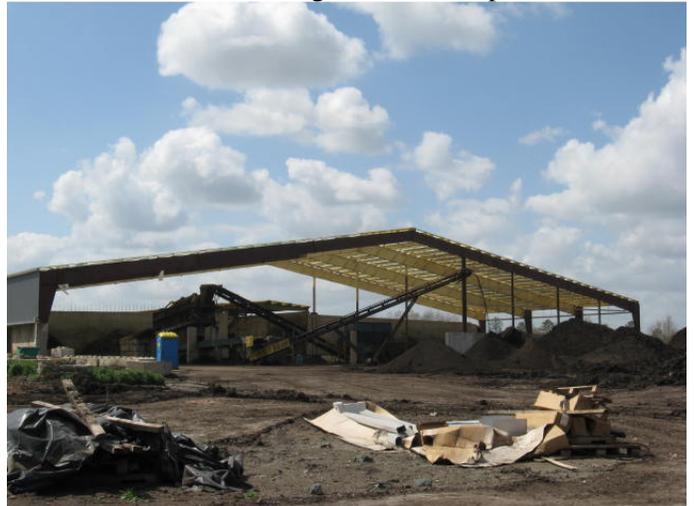
33. The facility has constructed the roof over the curing area and compost screener.
  34. The PTO expiration date is December 8, 2015.
  35. The PTO renewal application shall be submitted to the SWS by August 8, 2015.

New roof over the curing area and compost screener.
