FACILITY COMPLIANCE INSPECTION REPORT

Division of Waste Management Solid Waste Section

Date of Site Inspection: 30 January 2015

Coastal Environmental Partnership
 7400 Old Hwy 70
 New Bern, NC 28560

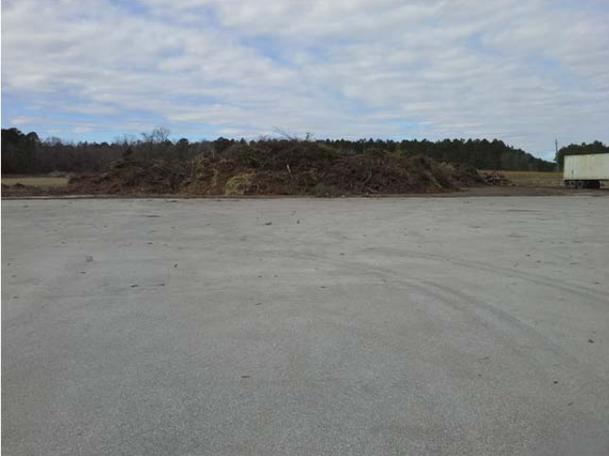
- 7) The stormwater/sedimentation control basins were clear of vegetation and wind-blown debris and appear well maintained.
- 8) The compost element of this Facility was reviewed during this Facility Compliance Inspection.
- 9) Composting operations were underway during this Facility Compliance Inspection.
- 10) All composting activities are maintained on the concrete pad.
- 11) All unprocessed vegetative materials are maintained separate from the compost windrows.

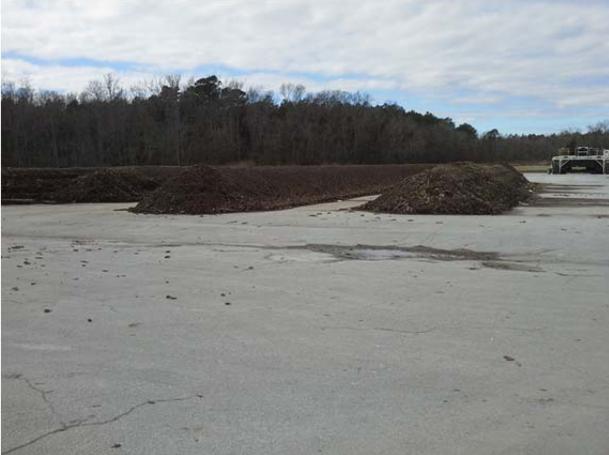
- 12) All compost piles are maintained with adequate space around the piles for maintenance and fire suppression.

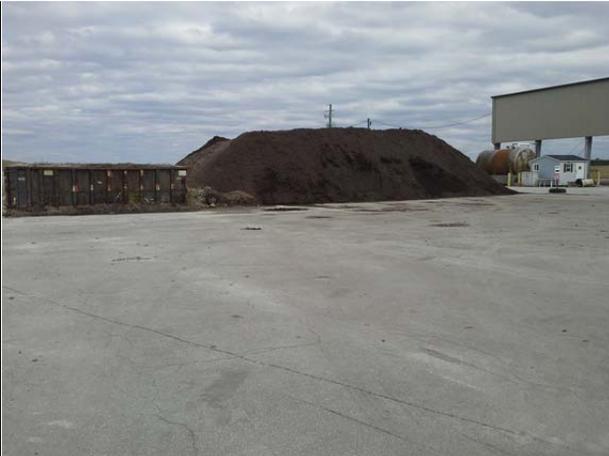
- 13) Finished compost is maintained in separate piles in an area away from the compost windrows to prevent contamination from uncomposted materials.

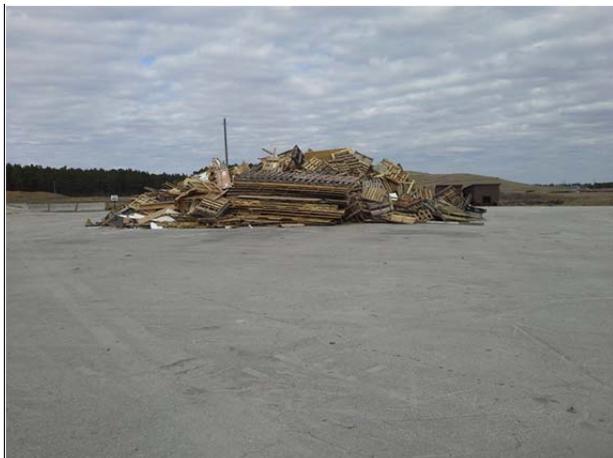
- 14) All dimensional lumber is maintained separate from the vegetative debris piles. All dimensional lumber is ground for removal from the site and used as boiler fuel.

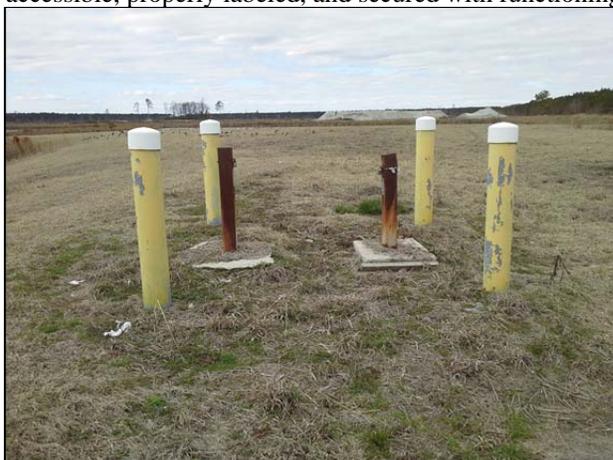
- 15) Facility monitoring wells were reviewed during this Facility Compliance Inspection. All reviewed wells were readily accessible, properly labeled, and secured with functioning locks.

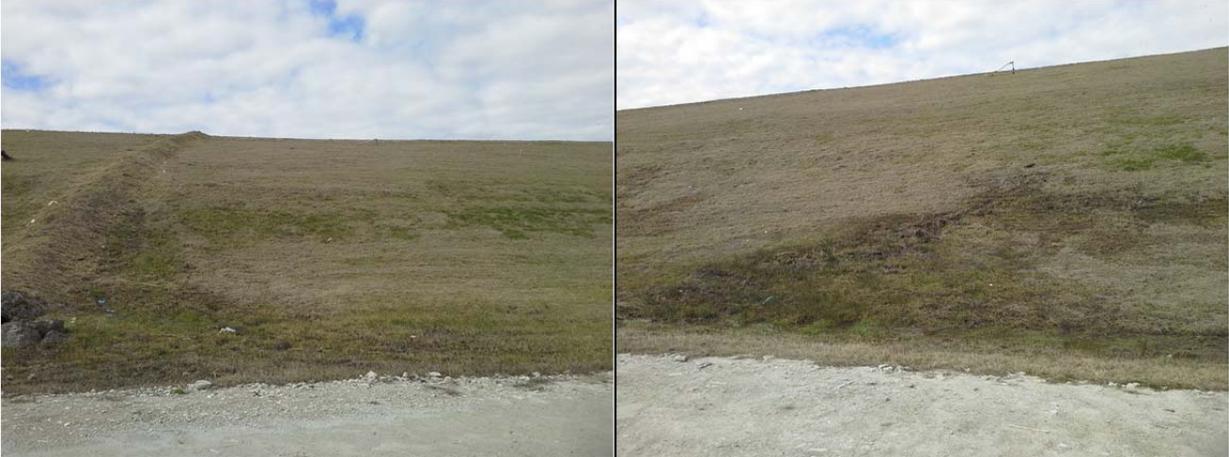
- 29) No areas of differential settlement or ponding water were observed in the closed areas of the landfill during this Facility Compliance Inspection.
- 30) The inert debris storage area was reviewed. No unpermitted waste types were observed in this area during this Facility Compliance Inspection.
- 31) No violations were observed during this Facility Compliance Inspection.
