**FACILITY COMPLIANCE INSPECTION REPORT**  
**Division of Waste Management**  
**Solid Waste Section**

**Date of Inspection:** 13 August 2014

Cieszko Construction Company LCID Landfill  
 NC Hwy 101 Havelock, NC

Comprehensive Facility Compliance Inspection

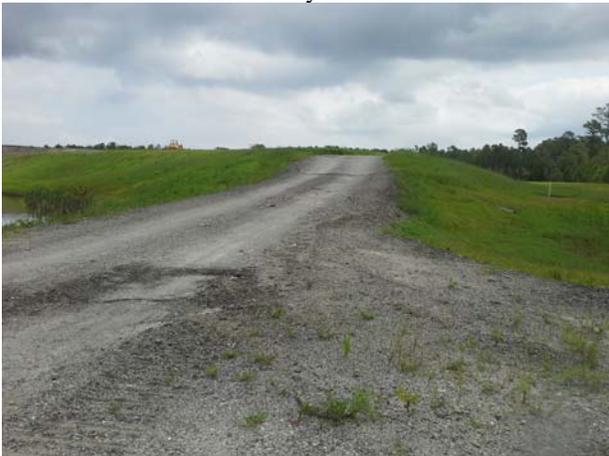
- 4) The access road to the facility is of all weather construction and is being managed properly at this time.

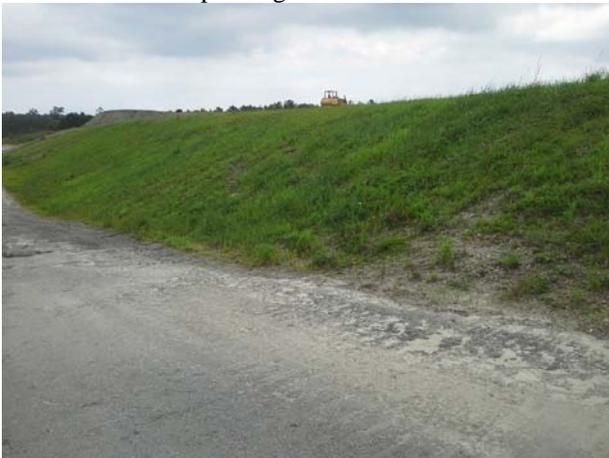
- 9) Portions of the landfill sideslopes have recently been covered, graded, and seeded. \*Please monitor these areas to ensure that a cover crop suitable to prevent erosion of your landfill cap system is properly established. Please re-seed and mulch any areas where the cover crop fails to properly establish and prevent erosion.

- 10) Overall, the Facility sideslopes have a well-established cover crop of native warm season grasses and are being maintained at a slope not greater than 3:1. No areas of erosion were noted during this Facility Compliance Inspection.

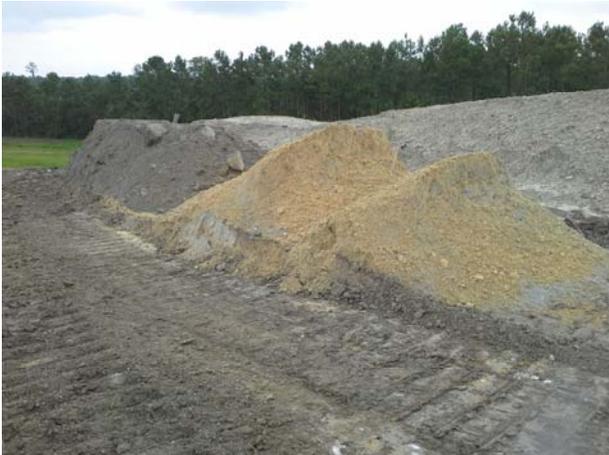
- 11) The waste type being disposed is LCID waste only. There were no unacceptable waste streams noted during this Facility Compliance Inspection.
- 12) Soil is stockpiled adjacent to the landfill and on the top lift in an area adjacent to the active working face for use as cover.

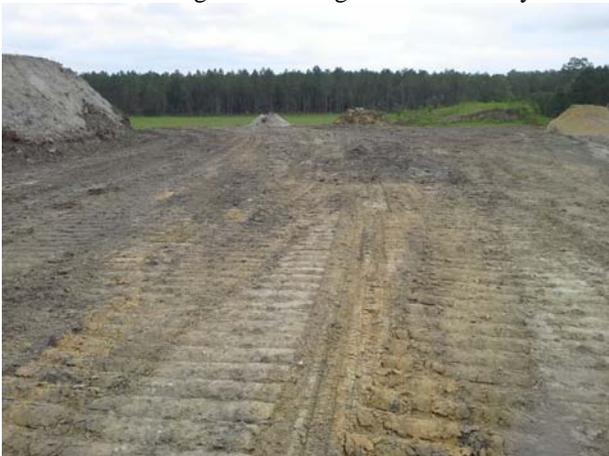
- 13) The active working area is compact and well managed at this time.
- 14) The active working area is being covered monthly or when it reaches one acre in size, whichever occurs first.
