**FACILITY COMPLIANCE INSPECTION REPORT**  
**Division of Waste Management**  
**Solid Waste Section**

**Date of Site Inspection:** May 6, 2015      **Date of Last Inspection:** February 5, 2015

**FACILITY NAME AND ADDRESS:**  
 Fort Bragg C&D Landfill, Lamont Road, Fort Bragg

**PURPOSE OF SITE VISIT:**  
 NOV follow up inspection

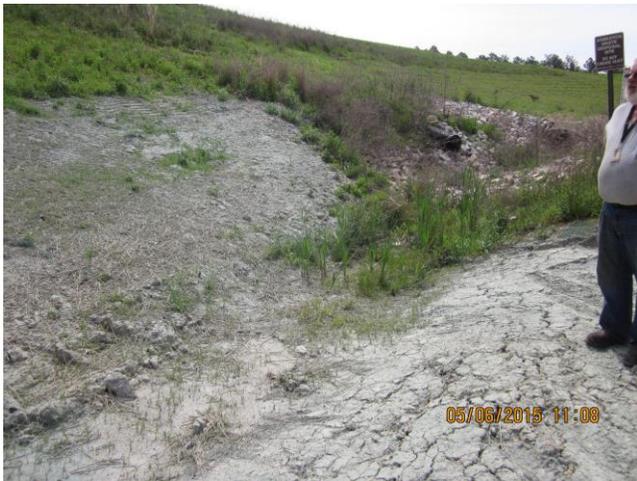
Leachate release site along perimeter channel repaired.

1. Inspection to check conditions of compliance from previous inspection.
2. The leachate release had been stopped and the area repaired by facility staff.

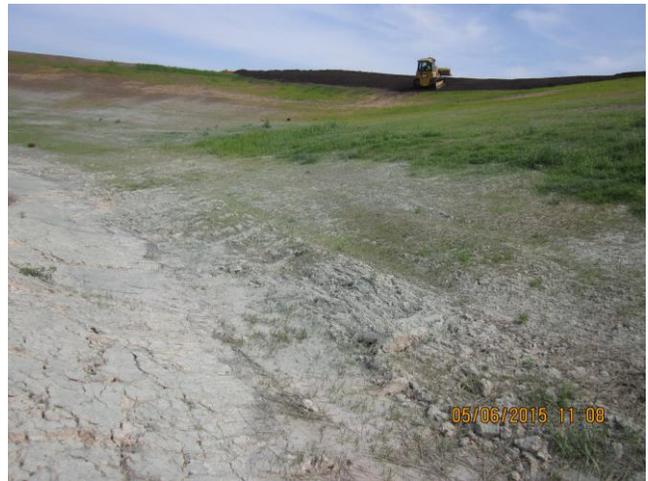
Perimeter channel flow toward Phase south west end of Phase II.

7. **The perimeter channels had not been fully repaired and constructed to plan specifications at the time of this inspection. Additional work needs to occur in this area.**

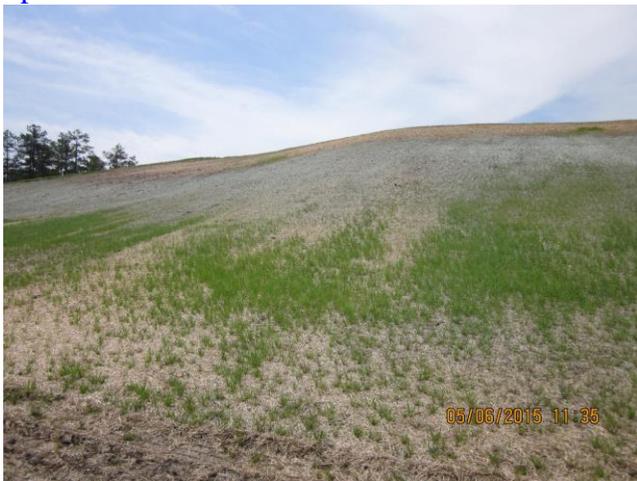
North west corner of Phase II.

11. The two seeps observed during the last inspection had been repaired. However, another one was observed in the NW side slope. **Seeps should be repaired as soon as they are observed. This area seems to be prone to this problem. Additional investigation to determine the cause may lead to a more permanent fix.**

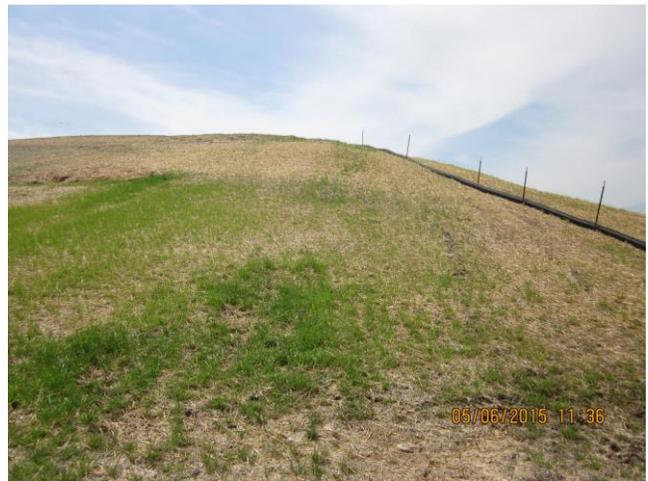
North west corner of Phase II

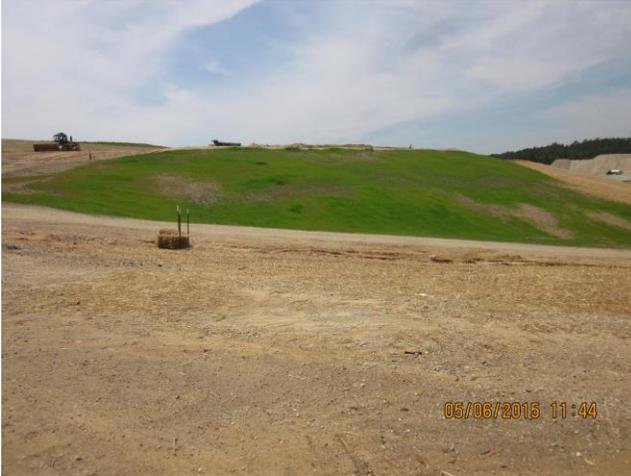
West side of Phase II.

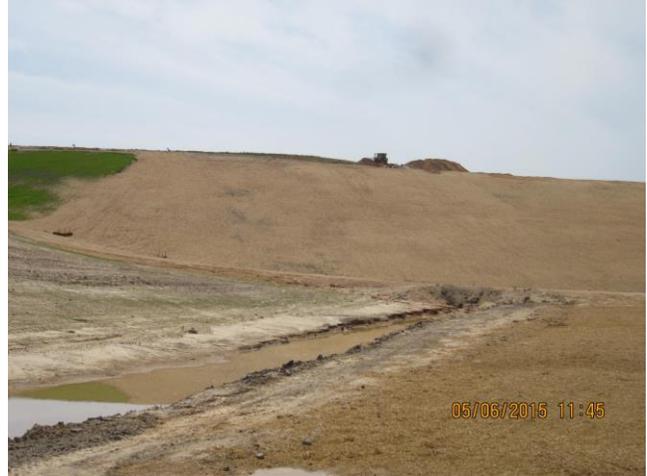
Facing the west side slope of phase II from new road, rutting on phase II repaired.

12. The large rills observed during the last inspection had been repaired, seeded and mulched with some grass coming up at the time of this inspection.

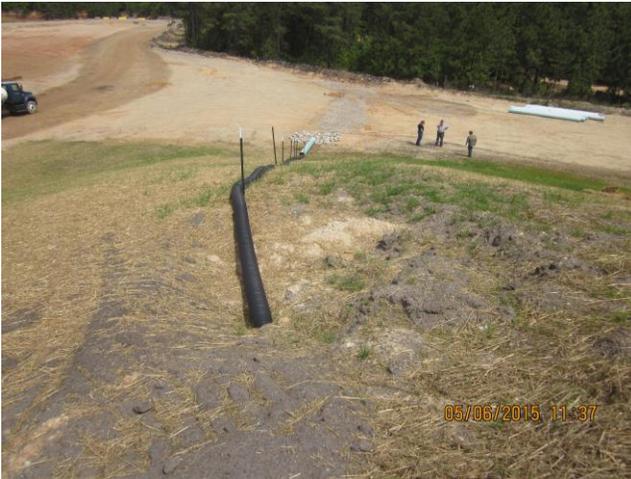
Slope drain installed NW corner of phase I. Drains across LF road to perimeter channel lined with asphalt.

8. **The sediment retention pond was beige in color at the time of the inspection too.**
9. Adequate sedimentation control measures consisting of vegetative cover, materials, structures or devices must be utilized to prevent excessive on-site erosion of the C&DLF facility or unit. **A slope drain had been installed by facility staff to assist in moving water off the top of the closed portion of phase II.**

13. **Do not place or use asphalt in water or where it may be pushed into the water and remove the asphalt that is in the pond on the north east corner.**

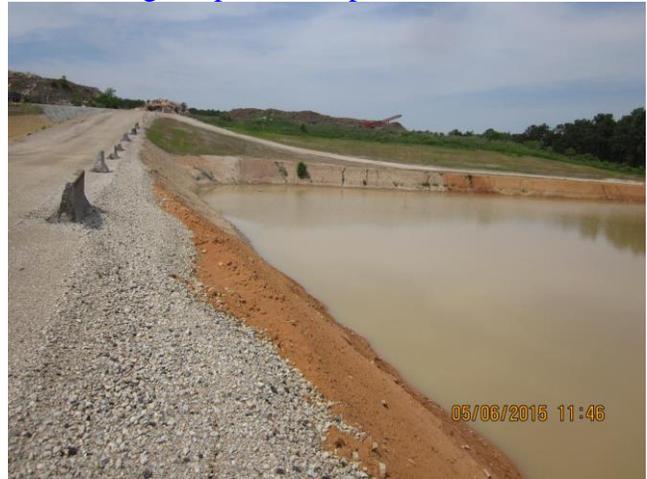
New road west of phase II adjacent to sediment pond.

6. **Facility staff mentioned removing the approved haul road for Phase II. Again, facilities should be operated and constructed in accordance with permits and plans per 15A NCAC 13B .0542. Any changes to the operations plan or design for this facility must first be submitted to the Division for review and approval.**
