FACILITY COMPLIANCE INSPECTION REPORT
Division of Waste Management
Solid Waste Section

Lined MSWLF		LCID		YW		Transfer	X	Compost		SLAS		COUNTY: Cumberland PERMIT NO.: 2613-Transfer-2010 FILE TYPE: COMPLIANCE
Closed MSWLF		HHW		White goods		Incin		T&P		FIRM		
CDLF		Tire T&P / Collection		Tire Monofill		Industrial Landfill		DEMO		SDTF

AAA Hauling of NC, Inc., 1171 S. Eastern Blvd, Fayetteville, North Carolina

PURPOSE OF SITE VISIT: NOCV extension and compliance follow up inspection.

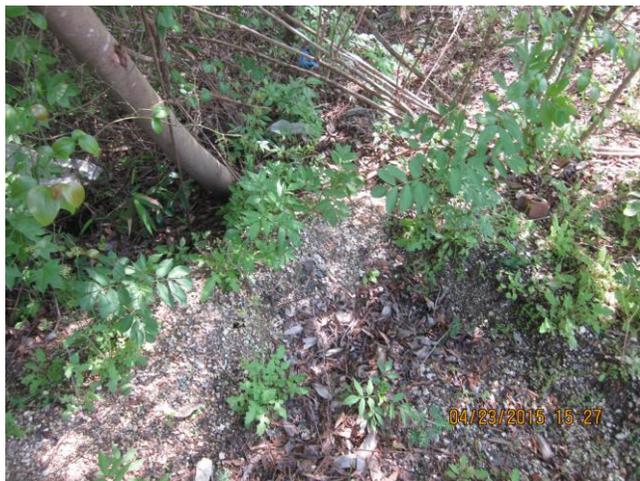
C&D fines waste not removed from area.

3. C&D fines waste was visible along an area where the operator had removed some of the waste and then graded and seeded the area. Remove the remaining fines from this area and stabilize the area to prevent on-site erosion.

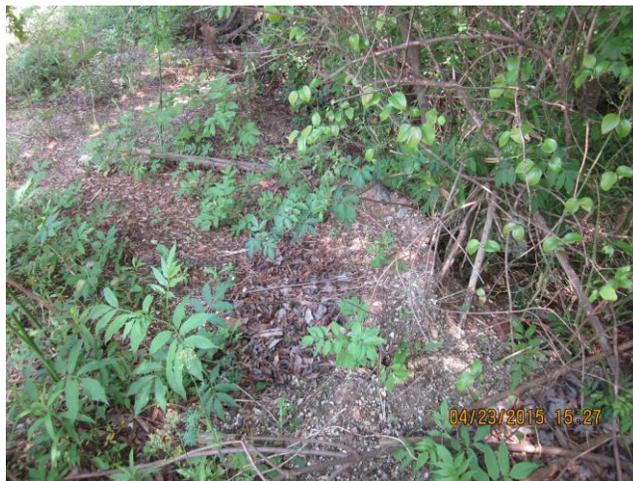
C&D fines fill along area not removed.

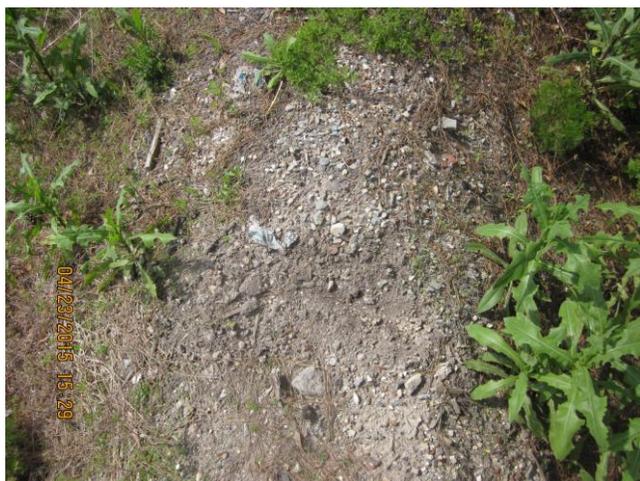
C&D fines east berm of transfer site.

5. The berm constructed of C&D fines waste at the front of the property adjacent to the building had not been removed at the time of this inspection. The berm along the east side of the property in the transfer station boundary appears to contain some of this waste as well. The remaining berms of C&D fines waste and soil comingled with waste need to be removed and properly disposed of as well at a permitted landfill.

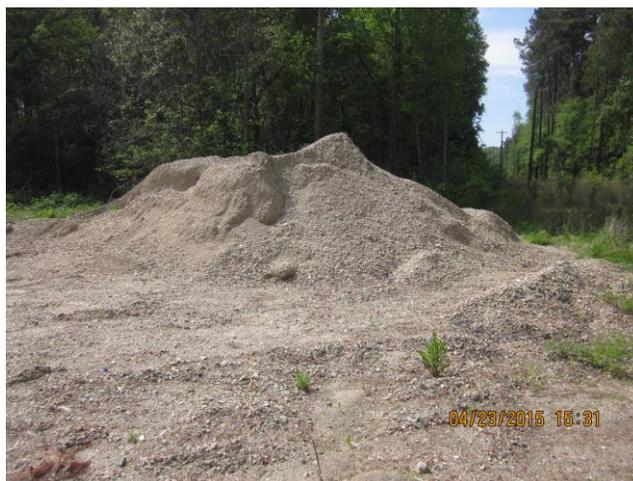
Comingled crushed waste pile.

- 1. Facility staff collected a sample of the comingled crushed waste for analysis of metals and provided the results which were reviewed by one of the Solid Waste Section Hydrogeologists.

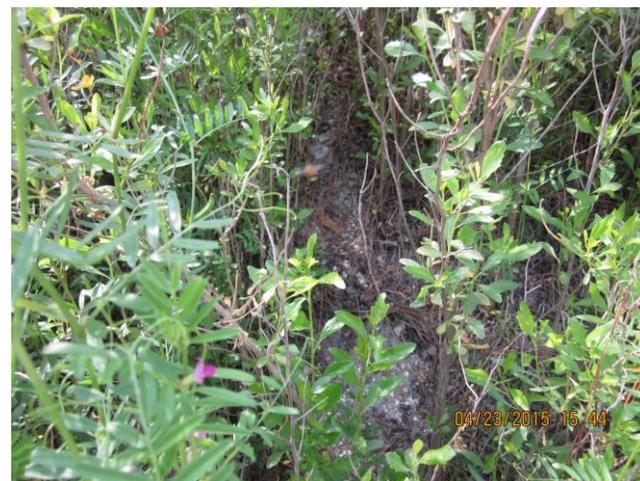
Close of berm waste adjacent to office.

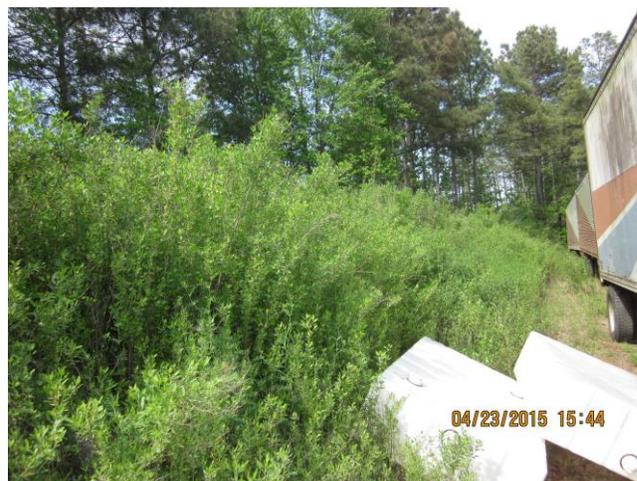
Overgrown berm waste adjacent to building.
