Re: LCID Phase I
Closure- Letter of Certification

FACILITY COMPLIANCE INSPECTION REPORT
Division of Waste Management
Solid Waste Section

City of Durham LCID Landfill
 1833 Camden Avenue
 Durham, NC 27704

Re: Durham Solid Waste LCID
Durham, North Carolina
Terracon Project No. 70095022

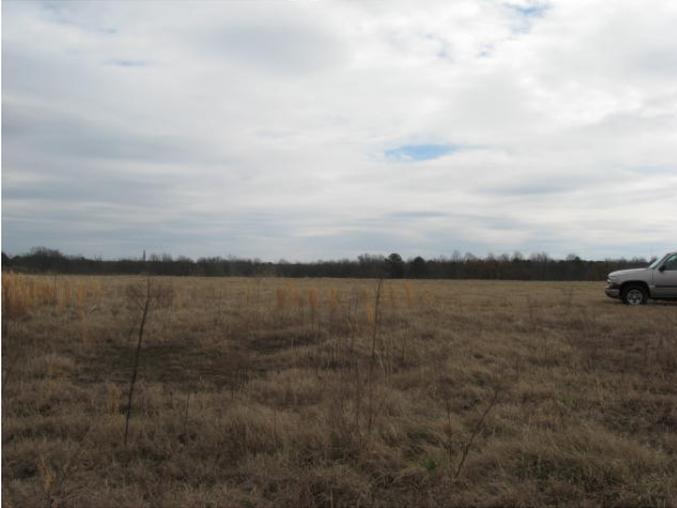
Phase II – view across top portion of landfill cap

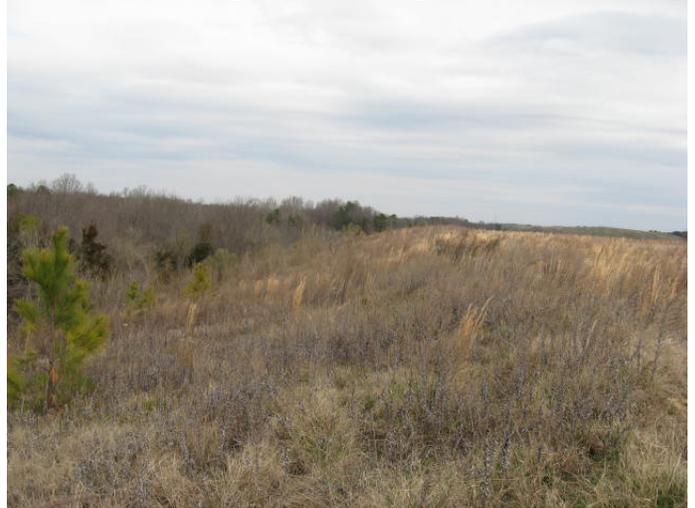
Phase II – view typical of side slope

2. The facility is located adjacent to the City of Durham Solid Waste Management Department (office building).
3. The landfill cap is covered with native vegetation and mowed twice a year, in the spring and fall. Ensure the LCID landfill side slopes are routinely mowed.

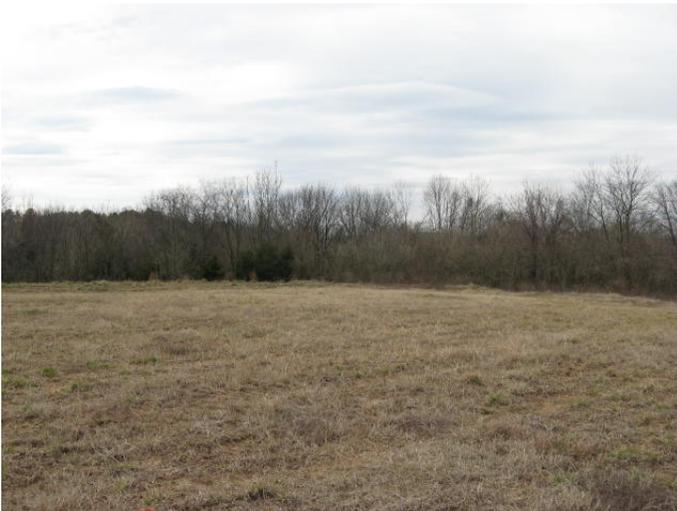
Phase I – view across top portion of landfill cap

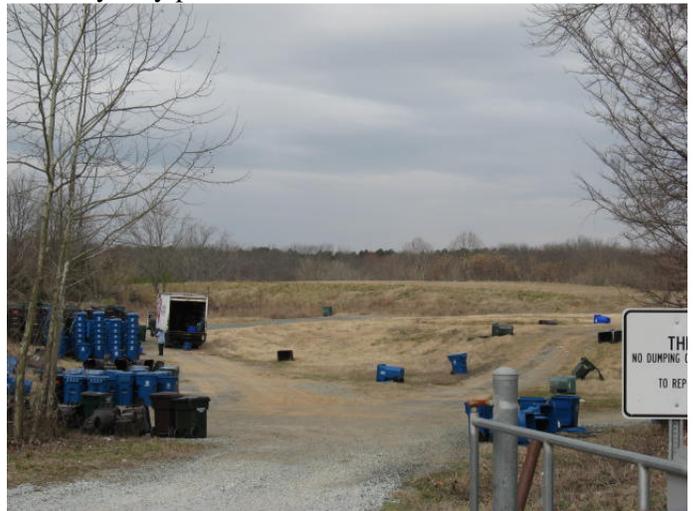
Entrance to facility, portion of landfill property actively used by City personnel

13. Ensure that the facility identification number is posted at the entrance.
14. The site is secured by a locked metal gate. The gate is kept open during workdays for City of Durham personnel to access the property for its container storage area, etc. Mr. Marriott stated that the gate is closed each night and on weekends.

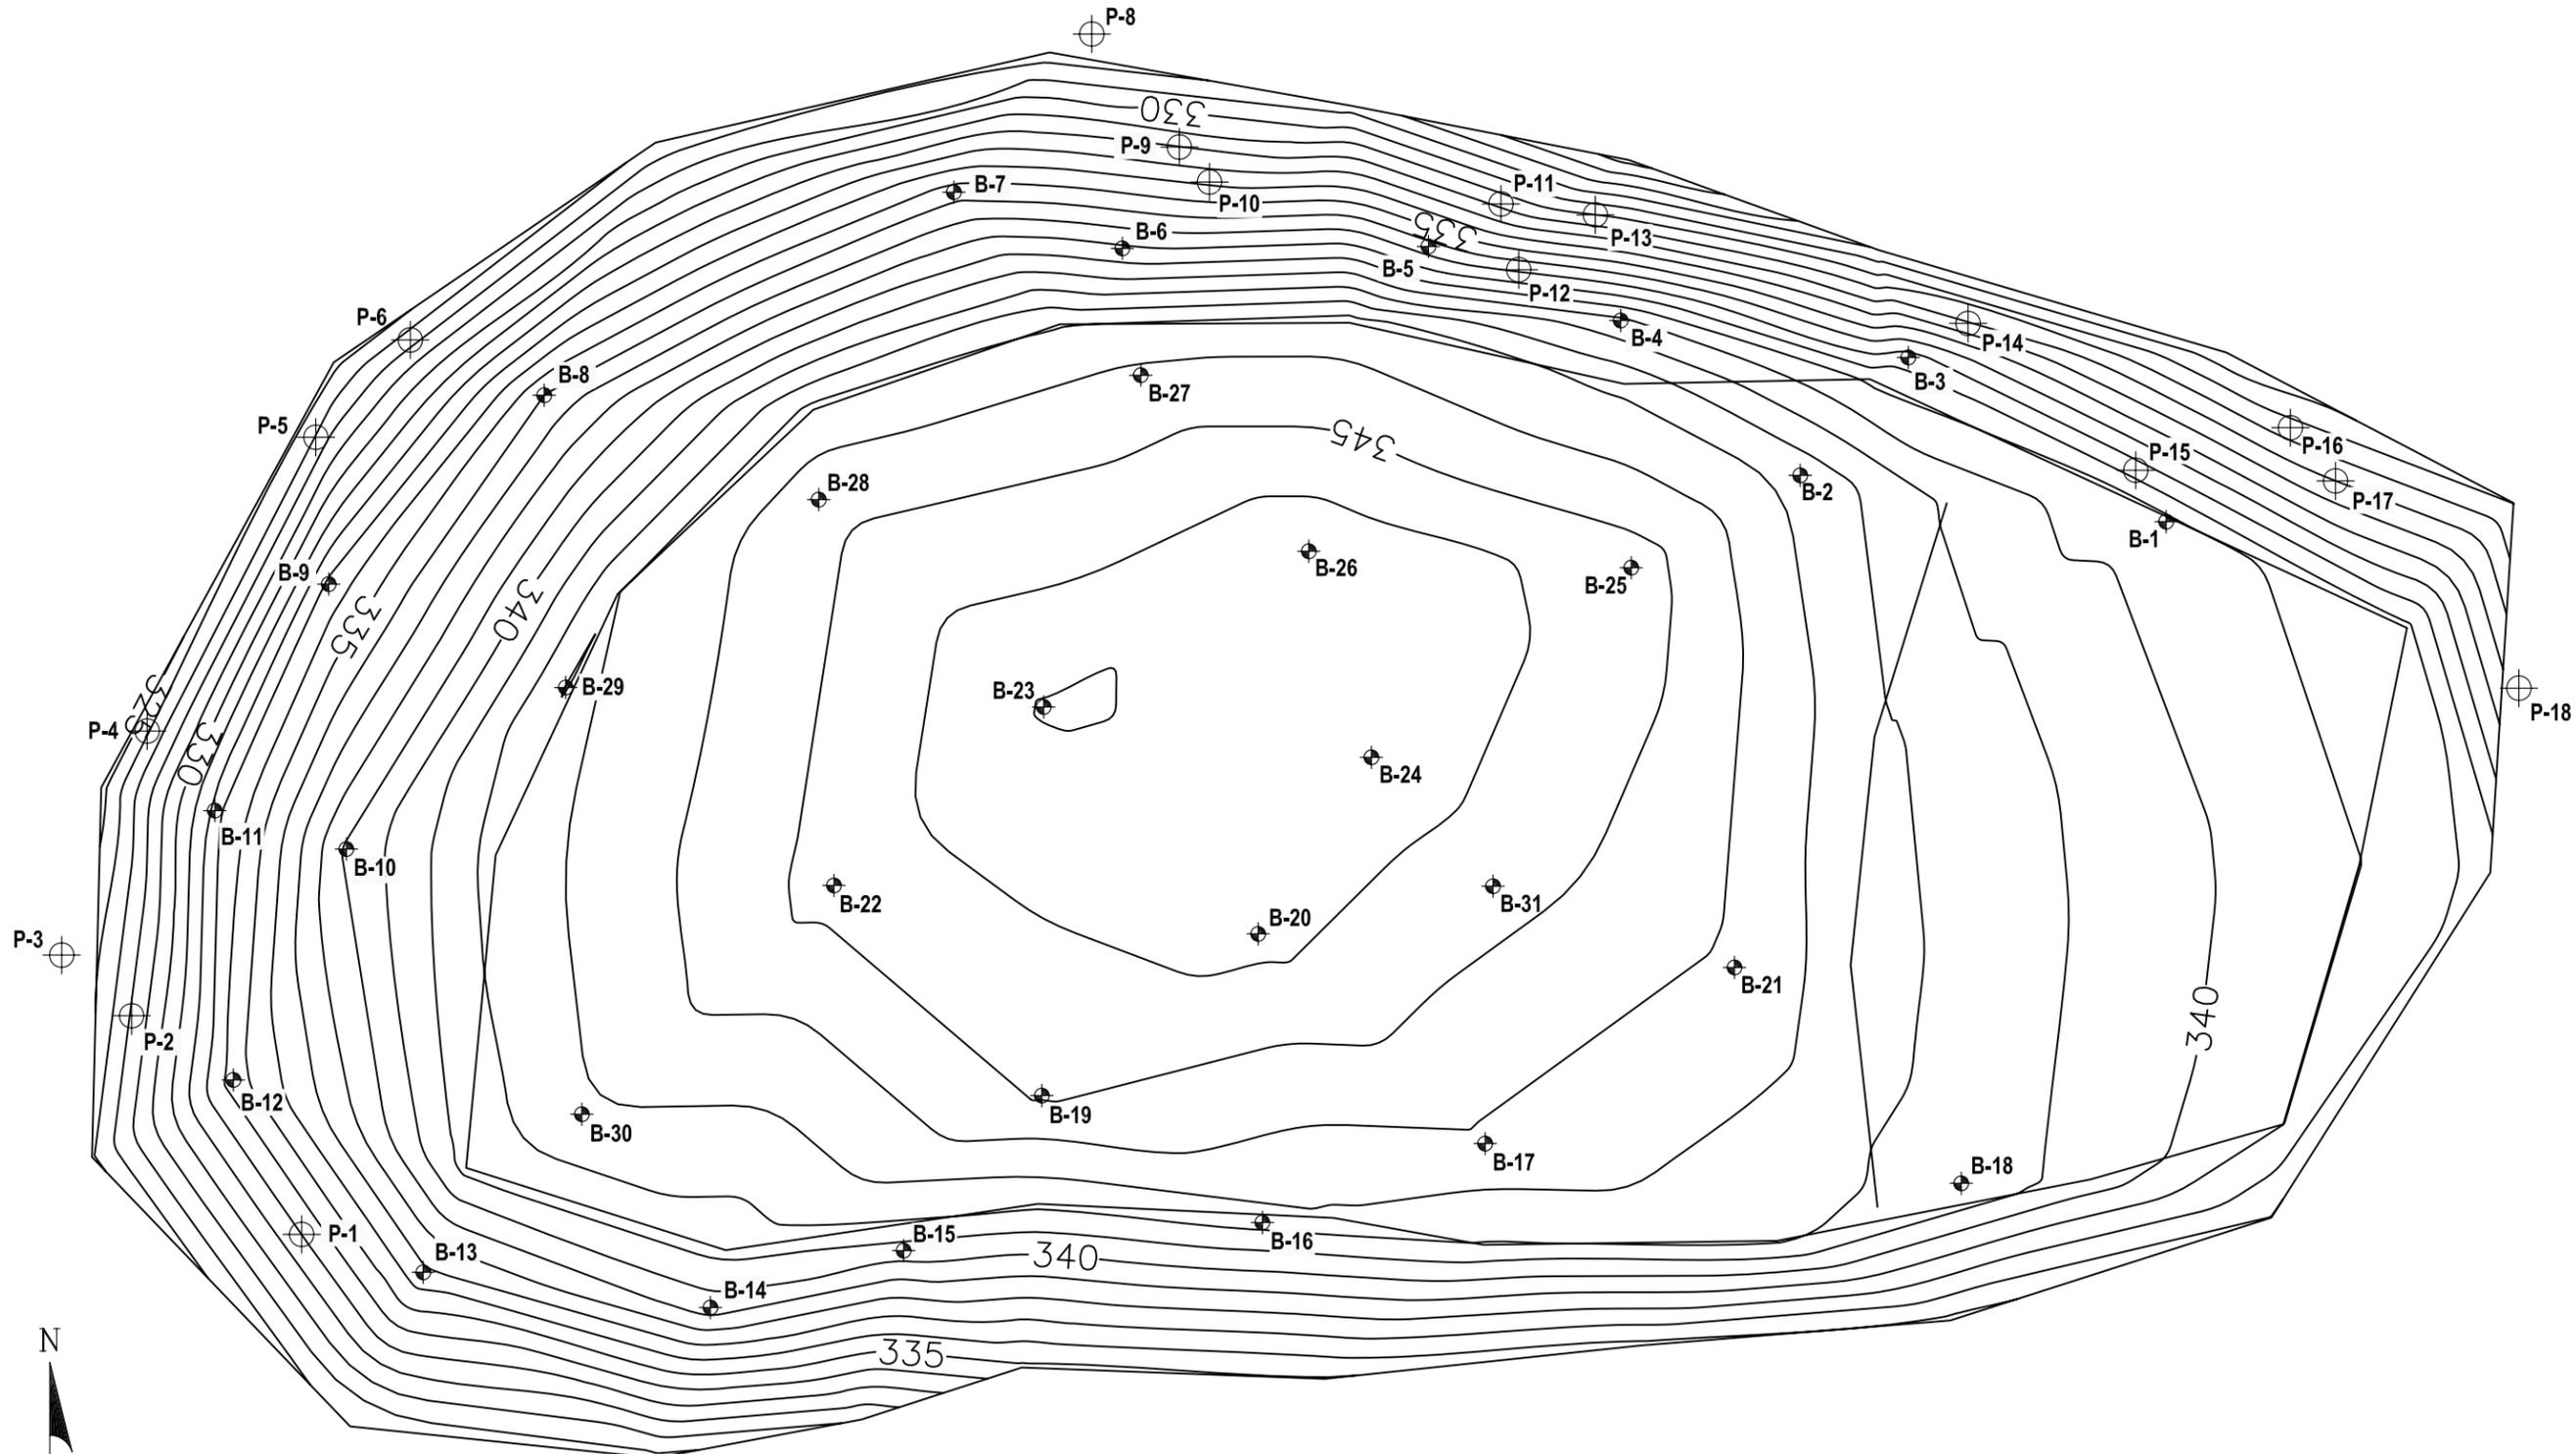
FIG. No.
1

A total of 32 hand auger test borings (B-1 through B-32) were performed on May 7, 2009 to hand-auger refusal depths of about 4 to 28 inches. We interpret hand-auger refusal as the depth to the soil cover / solid waste interface. GPS coordinates were also collected at an additional 18 locations (P-1 through P-18) where no soil cover or boulder-sized debris was observed at the surface. The locations are shown on the Boring Location Diagram, Figure 1. The borings were located in the field using a Garmin eTrex Legend hand-held GPS receiver with WAAS technology. Subsequent to the field exploration, CH Engineering surveyed the boring locations and provided a base map with these locations. The locations of the borings should be considered accurate only to the degree implied by the means and methods used.

BORING LOCATION DIAGRAM WITH EXISTING TOPOGRAPHIC CONTOURS
GEOTECHNICAL ENGINEERING REPORT
DURHAM SOLID WASTE LCID

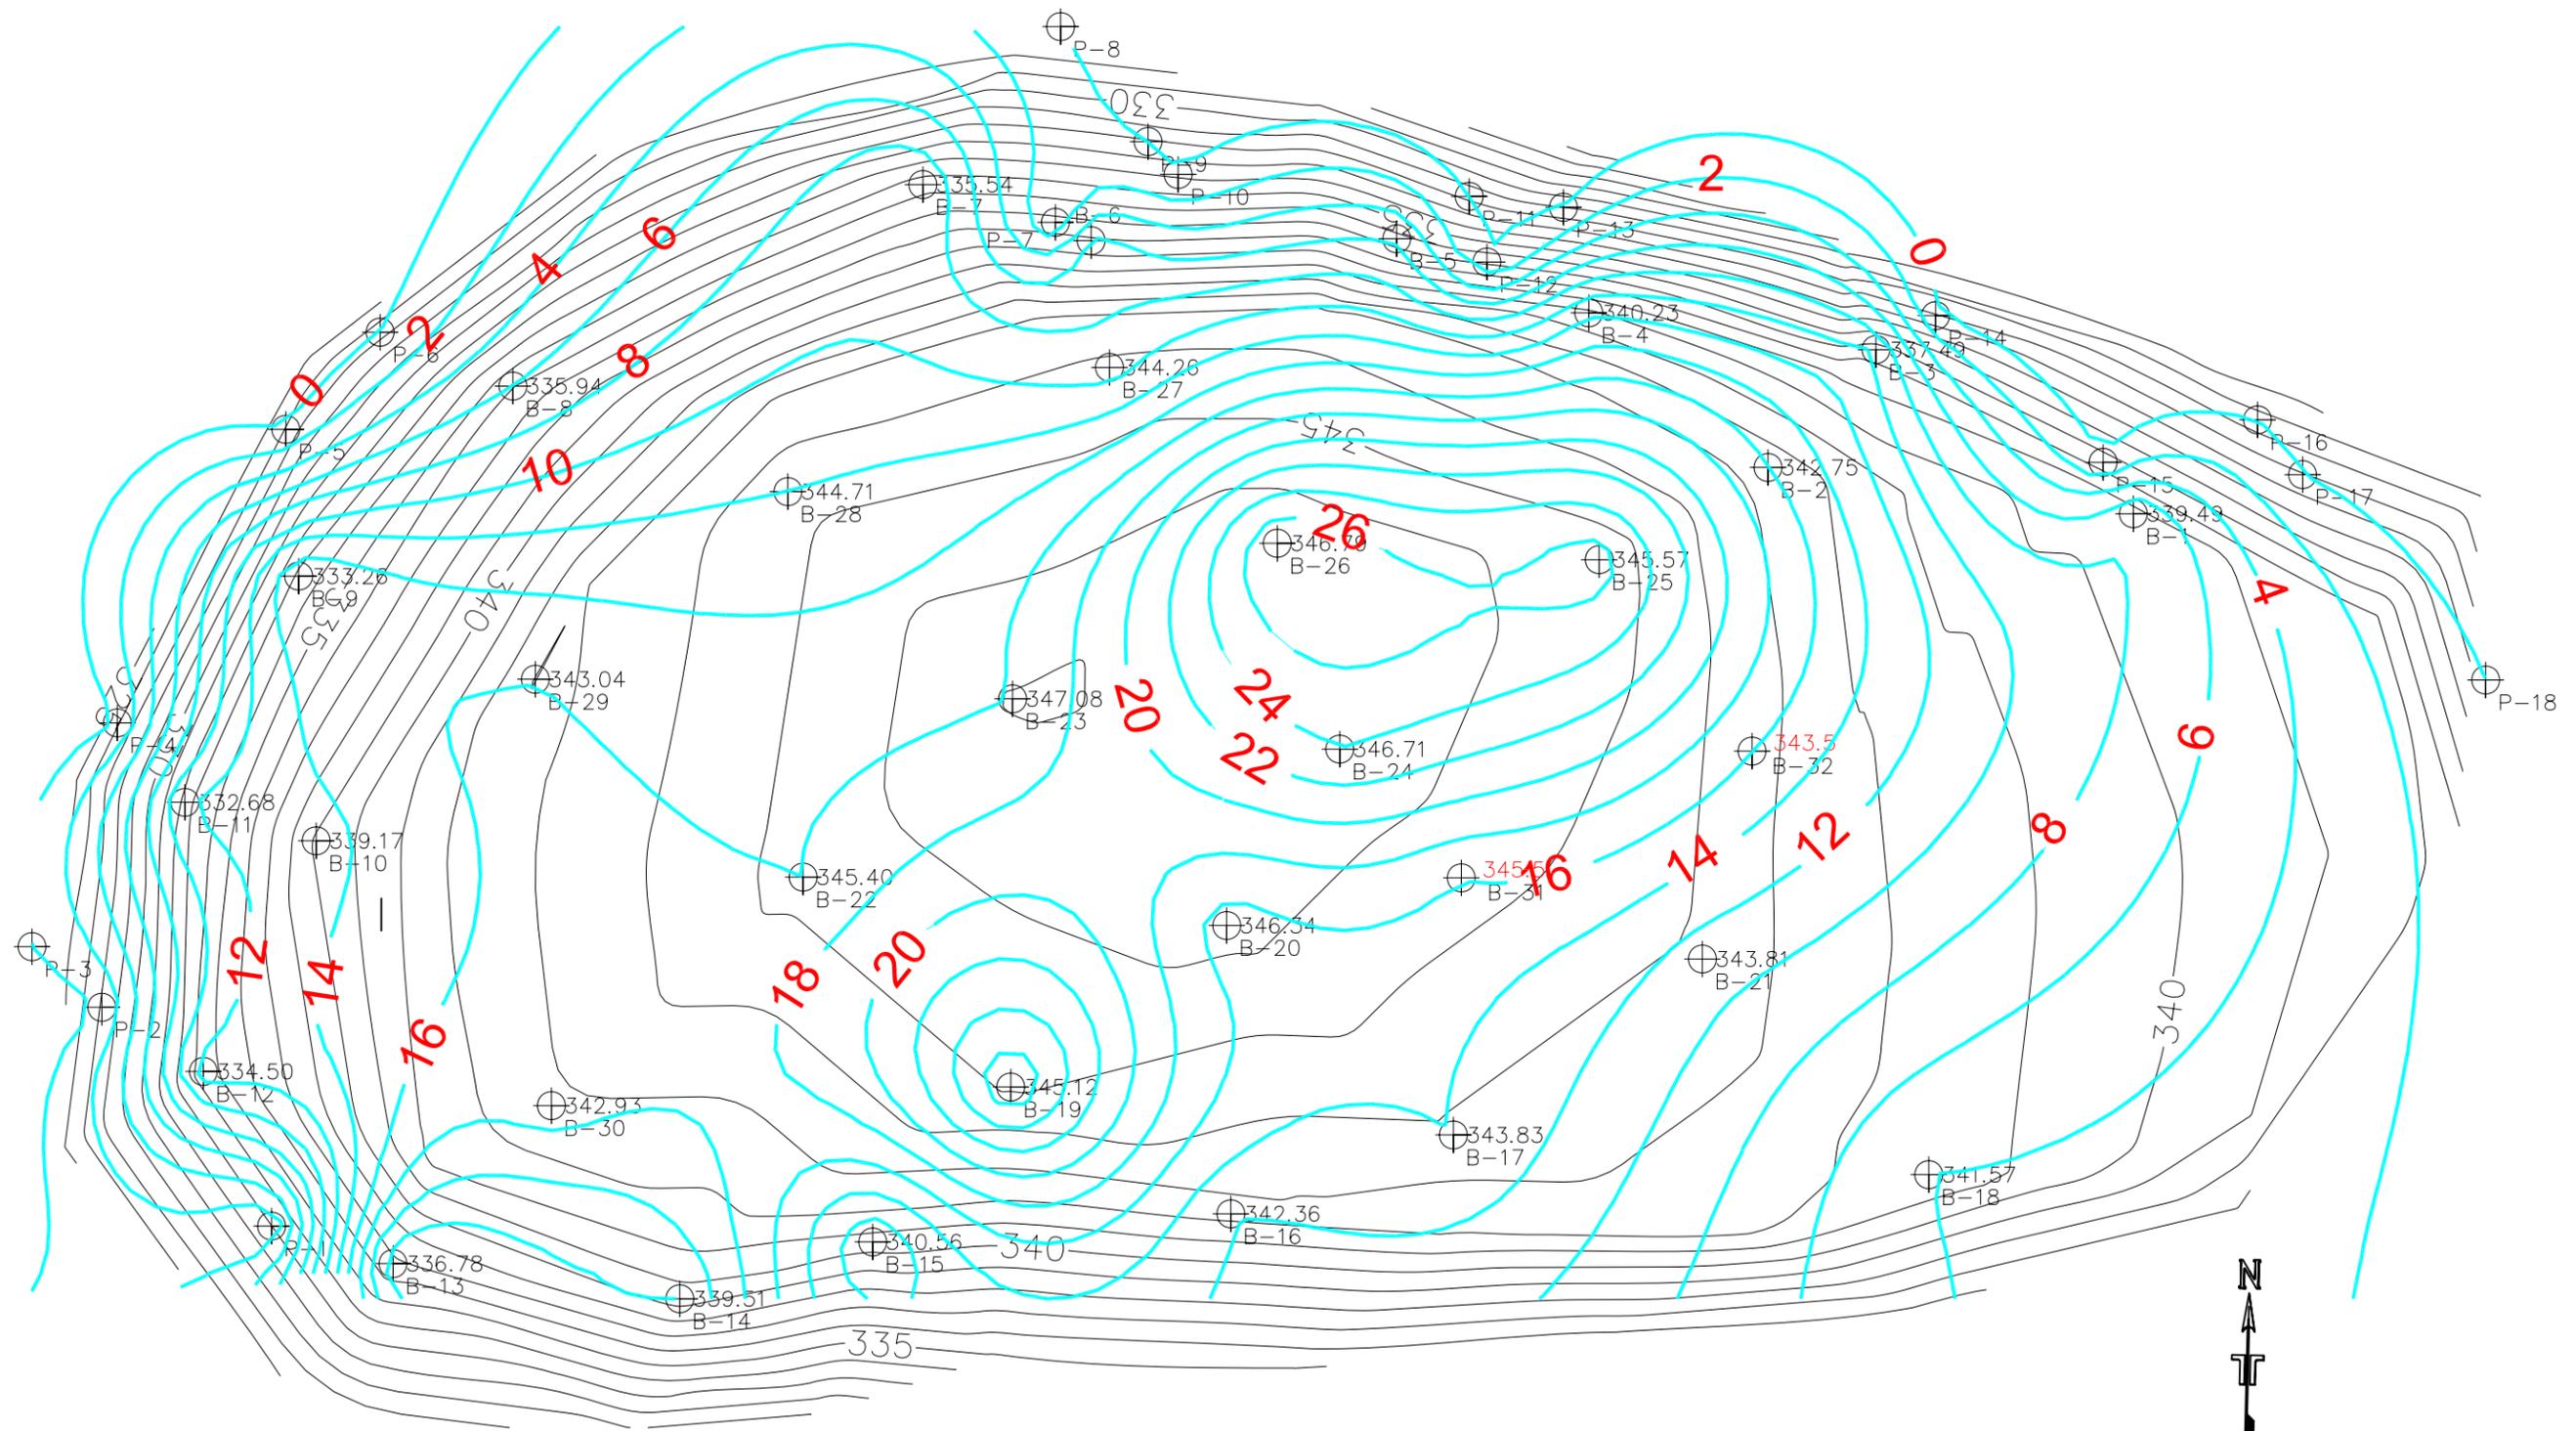
FIGURE #2	
DESIGNED BY:	RLD
DRAWN BY:	DJS
APPVD. BY:	RLD
SCALE:	1:30
DATE:	05/29/09
JOB NO.:	70095022
ACAD NO.:	001
SHEET NO.:	2 OF 2

The cover thickness contour diagram (Figure 2 in the appendix) can be used to determine the locations where additional soil cover will be required and to estimate the volume of soil needed.

LEGEND
 6 - SOIL COVER THICKNESS IN INCHES.

FIGURE 2: COVER THICKNESS CONTOUR DIAGRAM
DURHAM COUNTY LCID
 DURHAM, NORTH CAROLINA
