FACILITY COMPLIANCE INSPECTION REPORT
Division of Waste Management
Solid Waste Section

Date of Site Inspection: July 27, 2015

Fogleman and Fogleman Landfill and Recycling Facility – LCID Landfill and Processing Facility
 4005 Intermere Road
 Durham, NC 27704

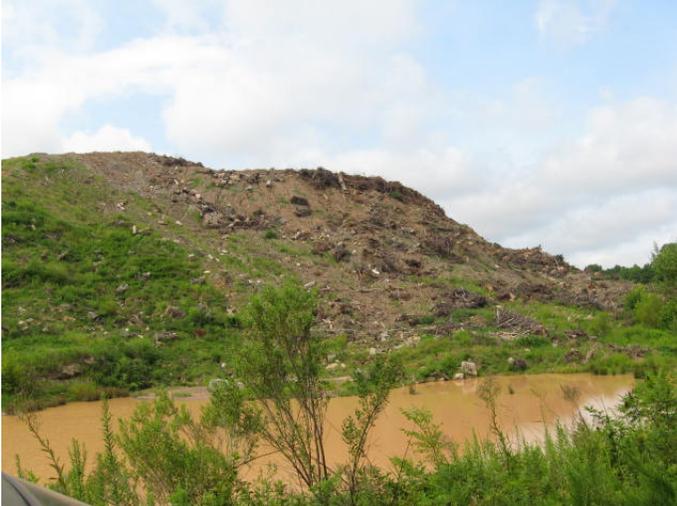
21. The northeast side slope has been graded and soil applied, although additional soil cover is needed.
22. The north and west side slopes contain exposed material. Material that has been placed in the LCID landfill received over a month ago shall be covered with soil; to include material along the side slopes and accumulated material at the bottom of the side slopes. Mr. Ferrell stated that it is likely that the side slopes will have to be reconstructed and graded accordingly. Per discussion with Mr. Ferrell, the aforementioned shall be completed by October 30, 2015.

Northeast side slope requiring additional soil cover (view 1) North side slope requiring soil cover (view 1)

By October 30, 2015, the facility shall adequately cover with soil solid waste that has been placed in the LCID landfill received over a month ago. The SWS may conduct intermittent inspections to ensure completion.

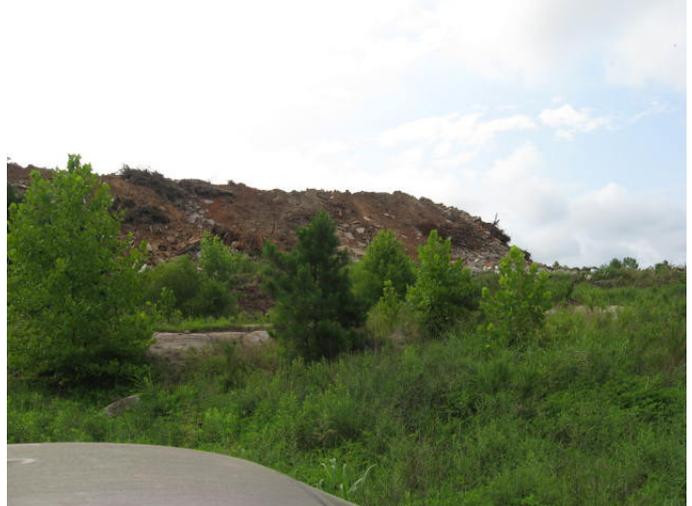
On July 27, 2015, SWS conducted an inspection of the Fogleman and Fogleman Landfill and Recycling Facility – LCID Landfill and Processing Facility. Solid waste along the north and west side slopes was not adequately covered with soil. Solid waste along the northeast side slope requires additional soil cover. Material that has been placed in the LCID landfill received over a month ago shall be covered with soil; to include material along the side slopes, accumulated material at the bottom of the side slopes, and material uncovered due to soil erosion.

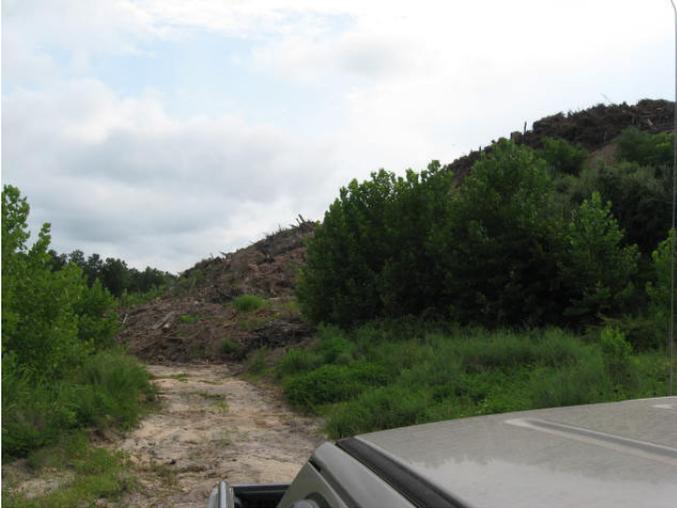
North side slope requiring soil cover(view 2)

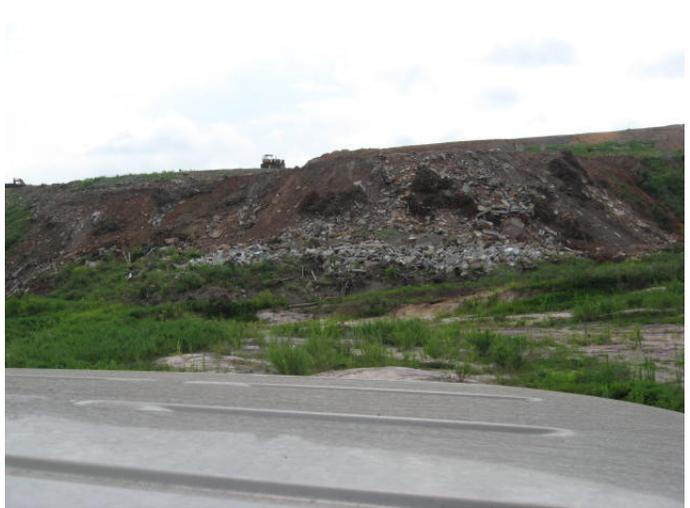
West side slope requiring soil cover

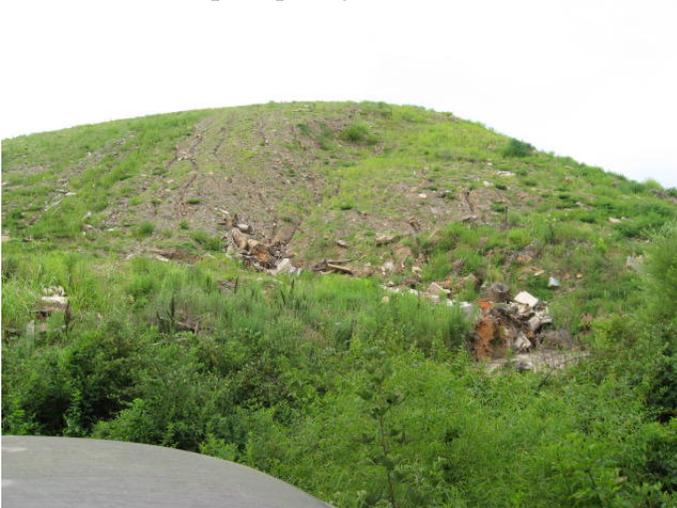
Northeast side slope requiring additional soil cover (view 2) LCD grinding area atop landfill and adjacent overs pile

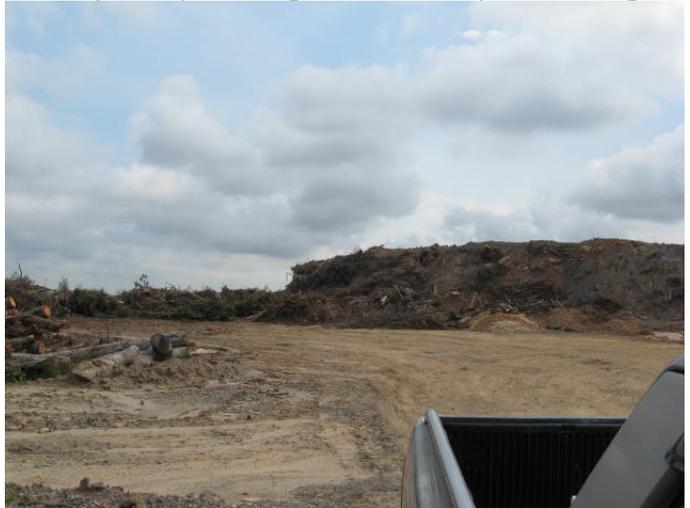
6. Land clearing debris (LCD) is sorted atop the landfill cap to be chipped. Mulch is deposited directly into transfer trailers. The material is sold for boiler fuel.
