FACILITY COMPLIANCE INSPECTION REPORT
Division of Waste Management
Solid Waste Section

Date of Site Inspection: 01/08/15

Cramerton Road MSW (Closed)
 413 Cramerton Road
 Cramerton, NC

Comprehensive Inspection

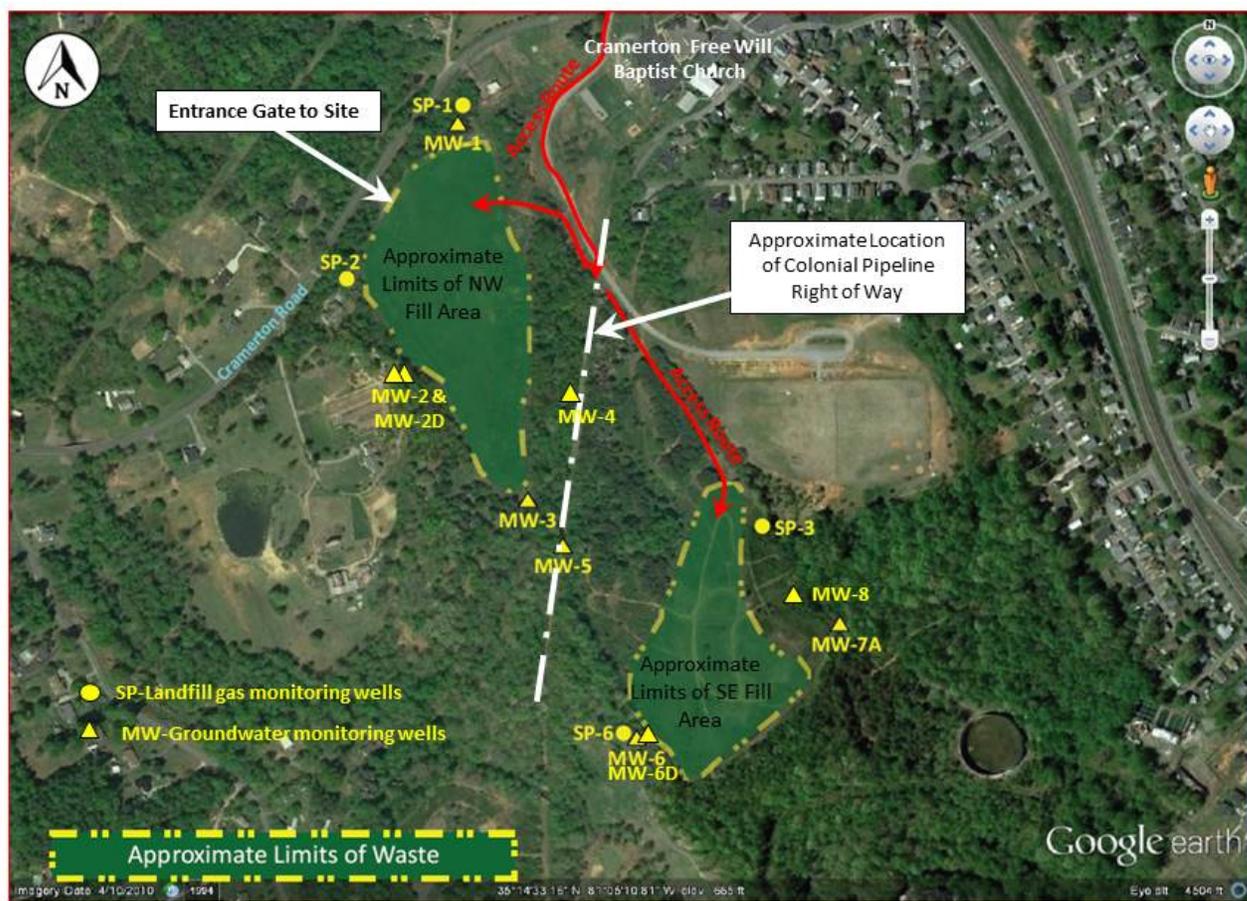
Figure 1: Cramerton Closed MSW 36-01 Monitoring Well Locations

2. Historic entrance to the site is a locked gate on Cramerton Road.
3. The best access to the site is from Cramerton Road, through the *Cramerton Free Will Baptist Church* property and via the *Colonial Pipeline Right-of-Way*. (Figure 1)
4. Water quality monitoring of ten groundwater monitoring wells (MW-1,2,2D,3,4,5,6,6D,7A, MW-8) and two surface water locations (“upstream” and “downstream”) is conducted semi-annually.
5. Results of the most recent analysis of water quality samples that were collected on May 13, 2014 were reviewed.
6. The vegetative cover on both of the landfill areas is well established and free of trees and woody vegetation. (Photos #2 - #4)

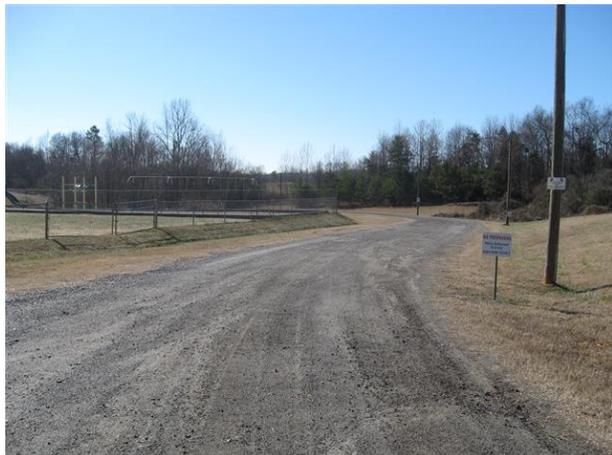
7. Uncontrolled access to the site can be made via the adjacent Cramerton Freewill Baptist Church property (NE of the landfill) and onto the Colonial Pipeline right-of-way.

1. Looking SW along the access road on the *Cramerton Free Will Baptist Church* property towards the closed landfill.

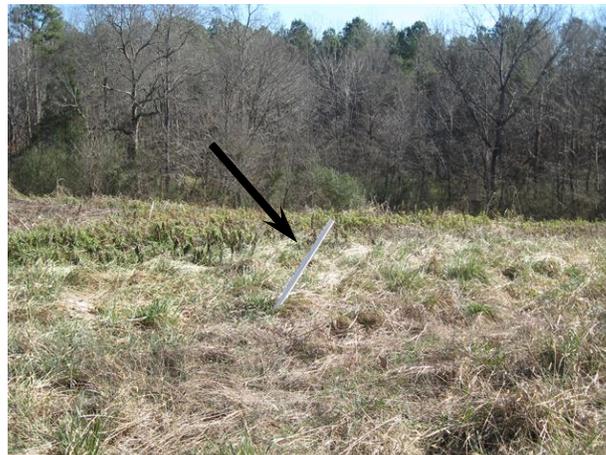
2. PVC edge-of-waste marker (typical) on the NW fill area.

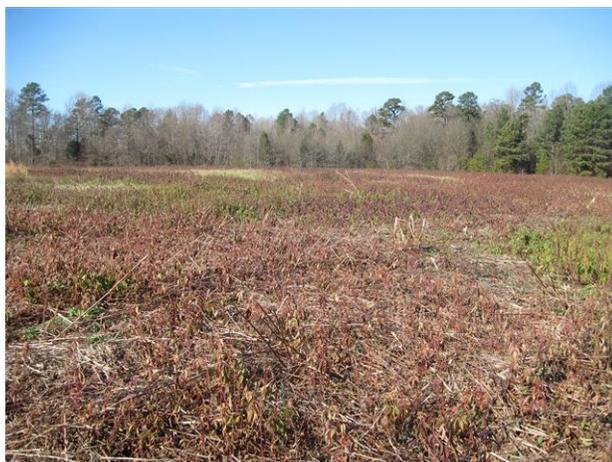
3. Looking S across the NW fill area.

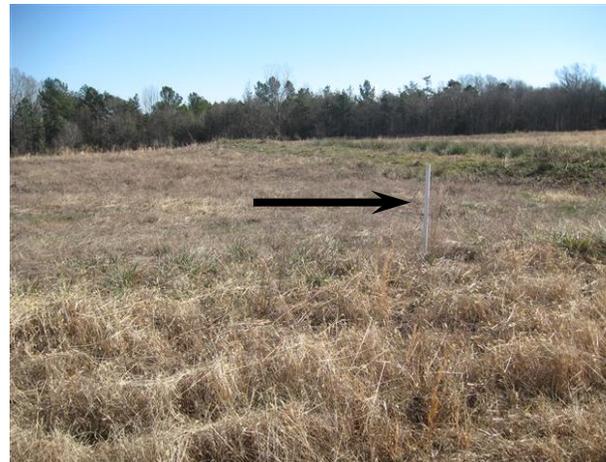
4. PVC edge-of-waste marker (typical) on the SE fill area.

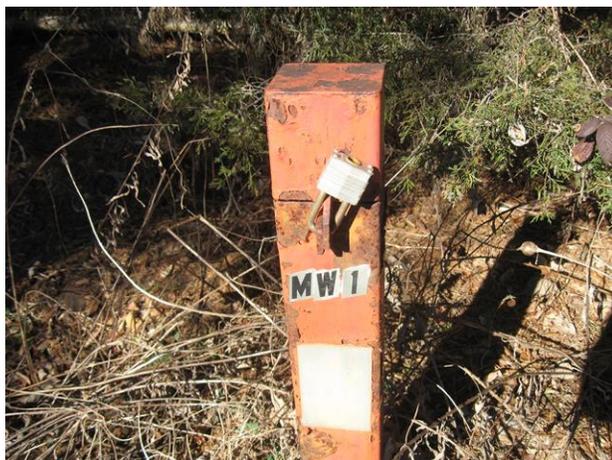
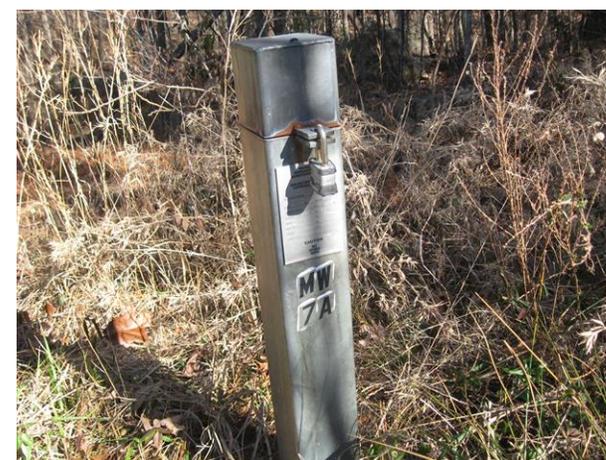
5. Ground water monitoring well – properly identified and secured.

6. Ground water monitoring well – properly identified and secured.

8. A random inspection of ground water and landfill gas monitoring wells conducted. (Photos #5 and #6) All inspected wells were properly marked with IDs and with properly secured with padlocks.
