Subject: Design Hydrogeologic Investigation and Report Revisions
Permit Application for A-1 Sandrock CDLF Phase 2A
Greensboro, North Carolina (Guilford County)
Facility Permit No. 4117-CDLF-2008

Documentation of Report Revisions based on regulatory review comments

A-1 Sandrock, Inc., owns and operates a Construction and Demolition debris landfill (CDLF), located at 2091 Bishop Road, near Greensboro, North Carolina, in southeastern Guilford County. The Owner is seeking a Permit to Construct (PTC) and Permit to Operate (PTO) for Phase 2A. This document presents a Design Hydrogeologic Study prepared in accordance with Solid Waste Rules 15A NCAC 13B .0538, with updates to the facility monitoring plan in accordance with Rule 15A NCAC 13B .0544. This work supports a permit amendment application submitted in March 2015, which details the facility plan, engineering plan and operations plan. The PTO was renewed in early 2014, but the new phase was not ready at that time. This report is presented in two sections: **Section 1** excerpts Site Suitability hydrogeology criteria from 2002, specific to Phase 2; **Section 2** presents the Design Hydrogeologic report based on the March 2015 study.

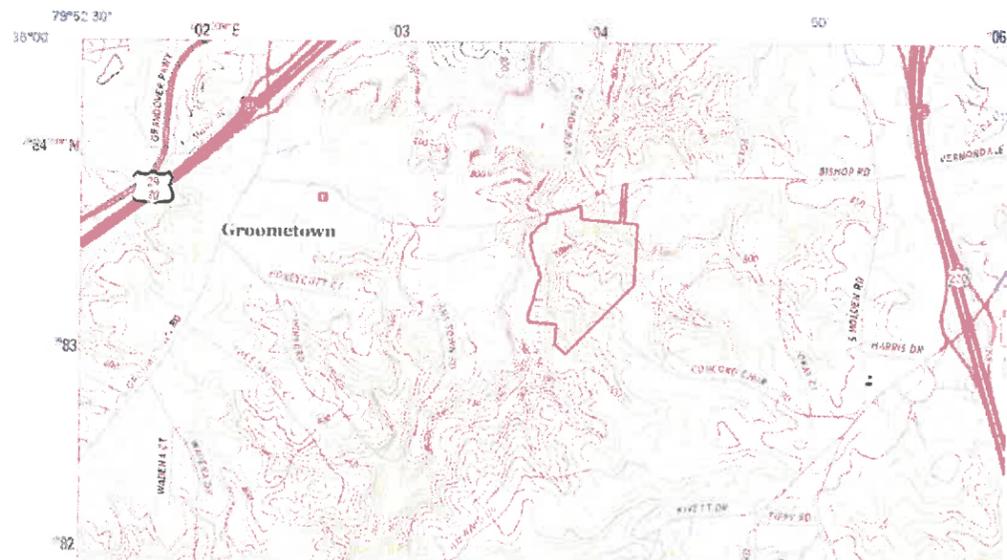
Figure 2 – USGS Pleasant Garden 7.5 minute series topographic quadrangle³

Surface topography serves as a guide to the direction of groundwater flow and influences hydraulic gradients. The variable topography observed at the site and throughout the region (Figure 2) is largely a manifestation of differential weathering of the bedrock,

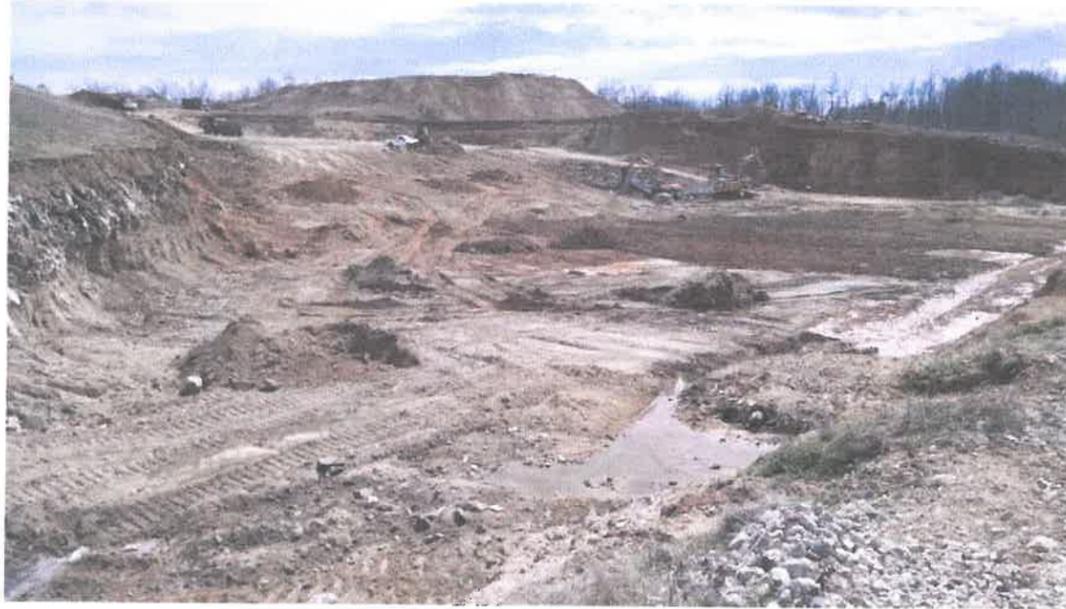
Photo 1 – looking southeast across Phase 2A on May 18, 2015; test pits visible in foreground; dark soils exposed in the south wall (above the excavator) mark the diabase; C&D waste is exposed in the north wall on the left; Phase 2A extends to the base of the large stockpile; the sump is in the right foreground

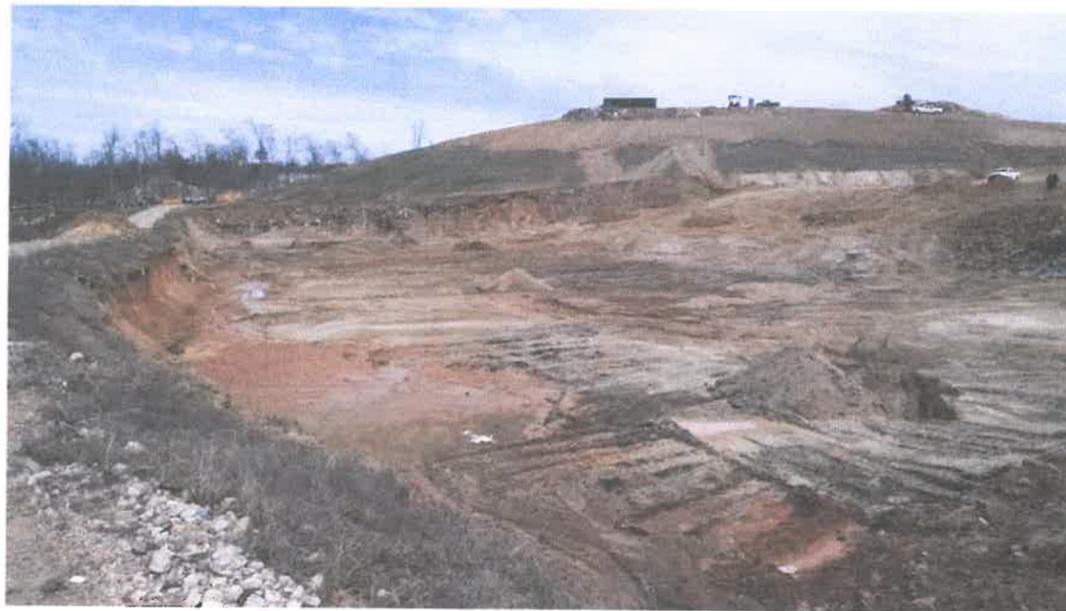
Photo 2 – looking north across Phase 2A on May 18, 2015; test pits are visible across the bottom; a sliver of Phase 1 waste is exposed to the left on the far wall; lower area was subject to ponding of surface water during the recent winter months; sump is visible along the toe of the perimeter berm on the left side; this berm is residual soil (not structural embankment fill); rocky material to the right is the diabase dike

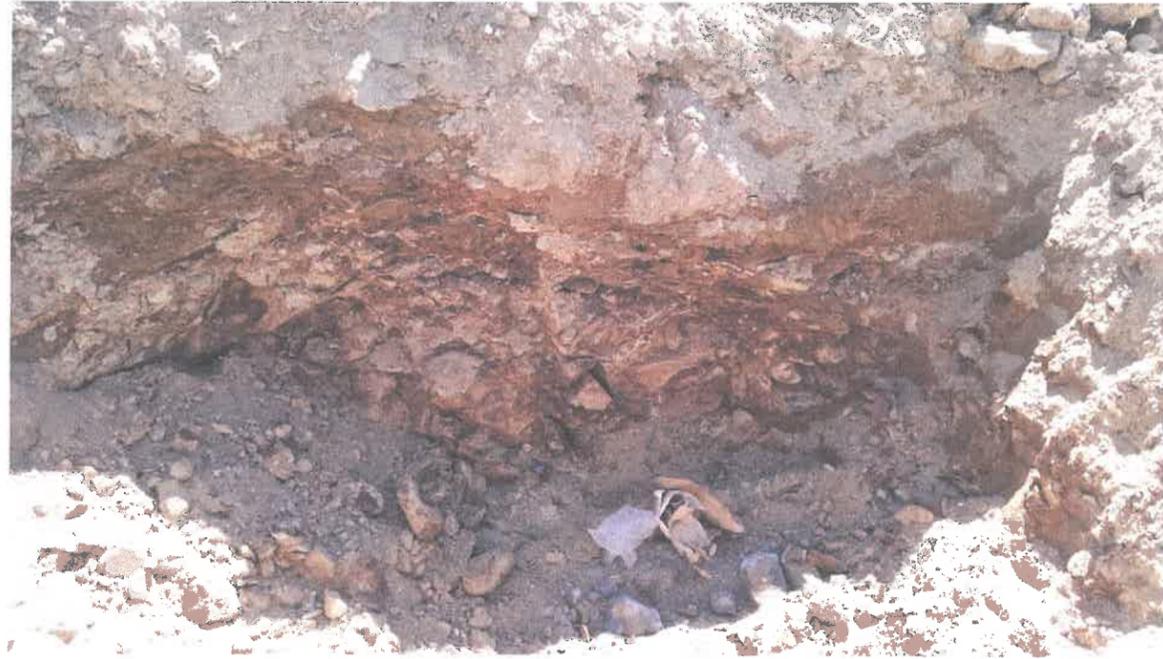
Test Pit 12

Encountered TAN-RED CLAYEY SILT, DIABASE NODULES, ML

Depth of excavation is 4 feet

Dry at 4' after 24 hours

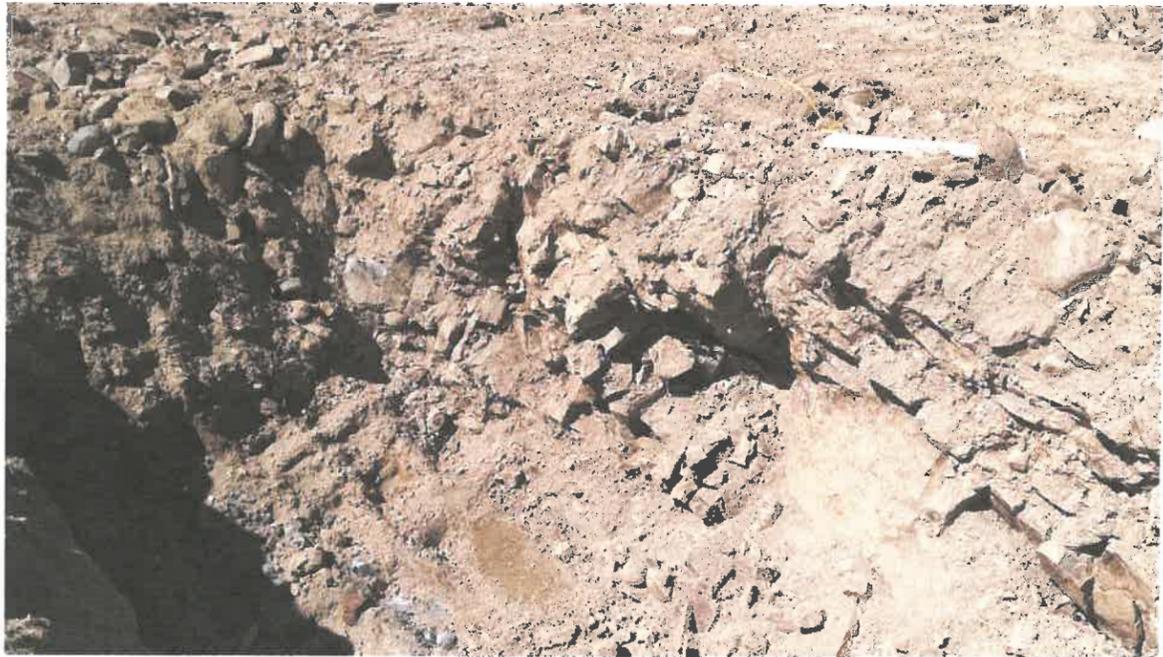
Test Pit 13

Encountered TAN-BROWN VERY SILTY SAND, SM-ML, LAYERED ROCK FRAGMENTS

Depth of excavation is 5 feet

Dry at 5' after 24 hours

- 7 Addition of Test Pit Logs (four pages)
Page 12 substitution of correct photo for TP-13
- 8 Revision of Drawing M1 (small map) for Ground Water Monitoring Plan
- 9 Revision of Drawing M1 (small map) for Landfill Gas Monitoring Plan

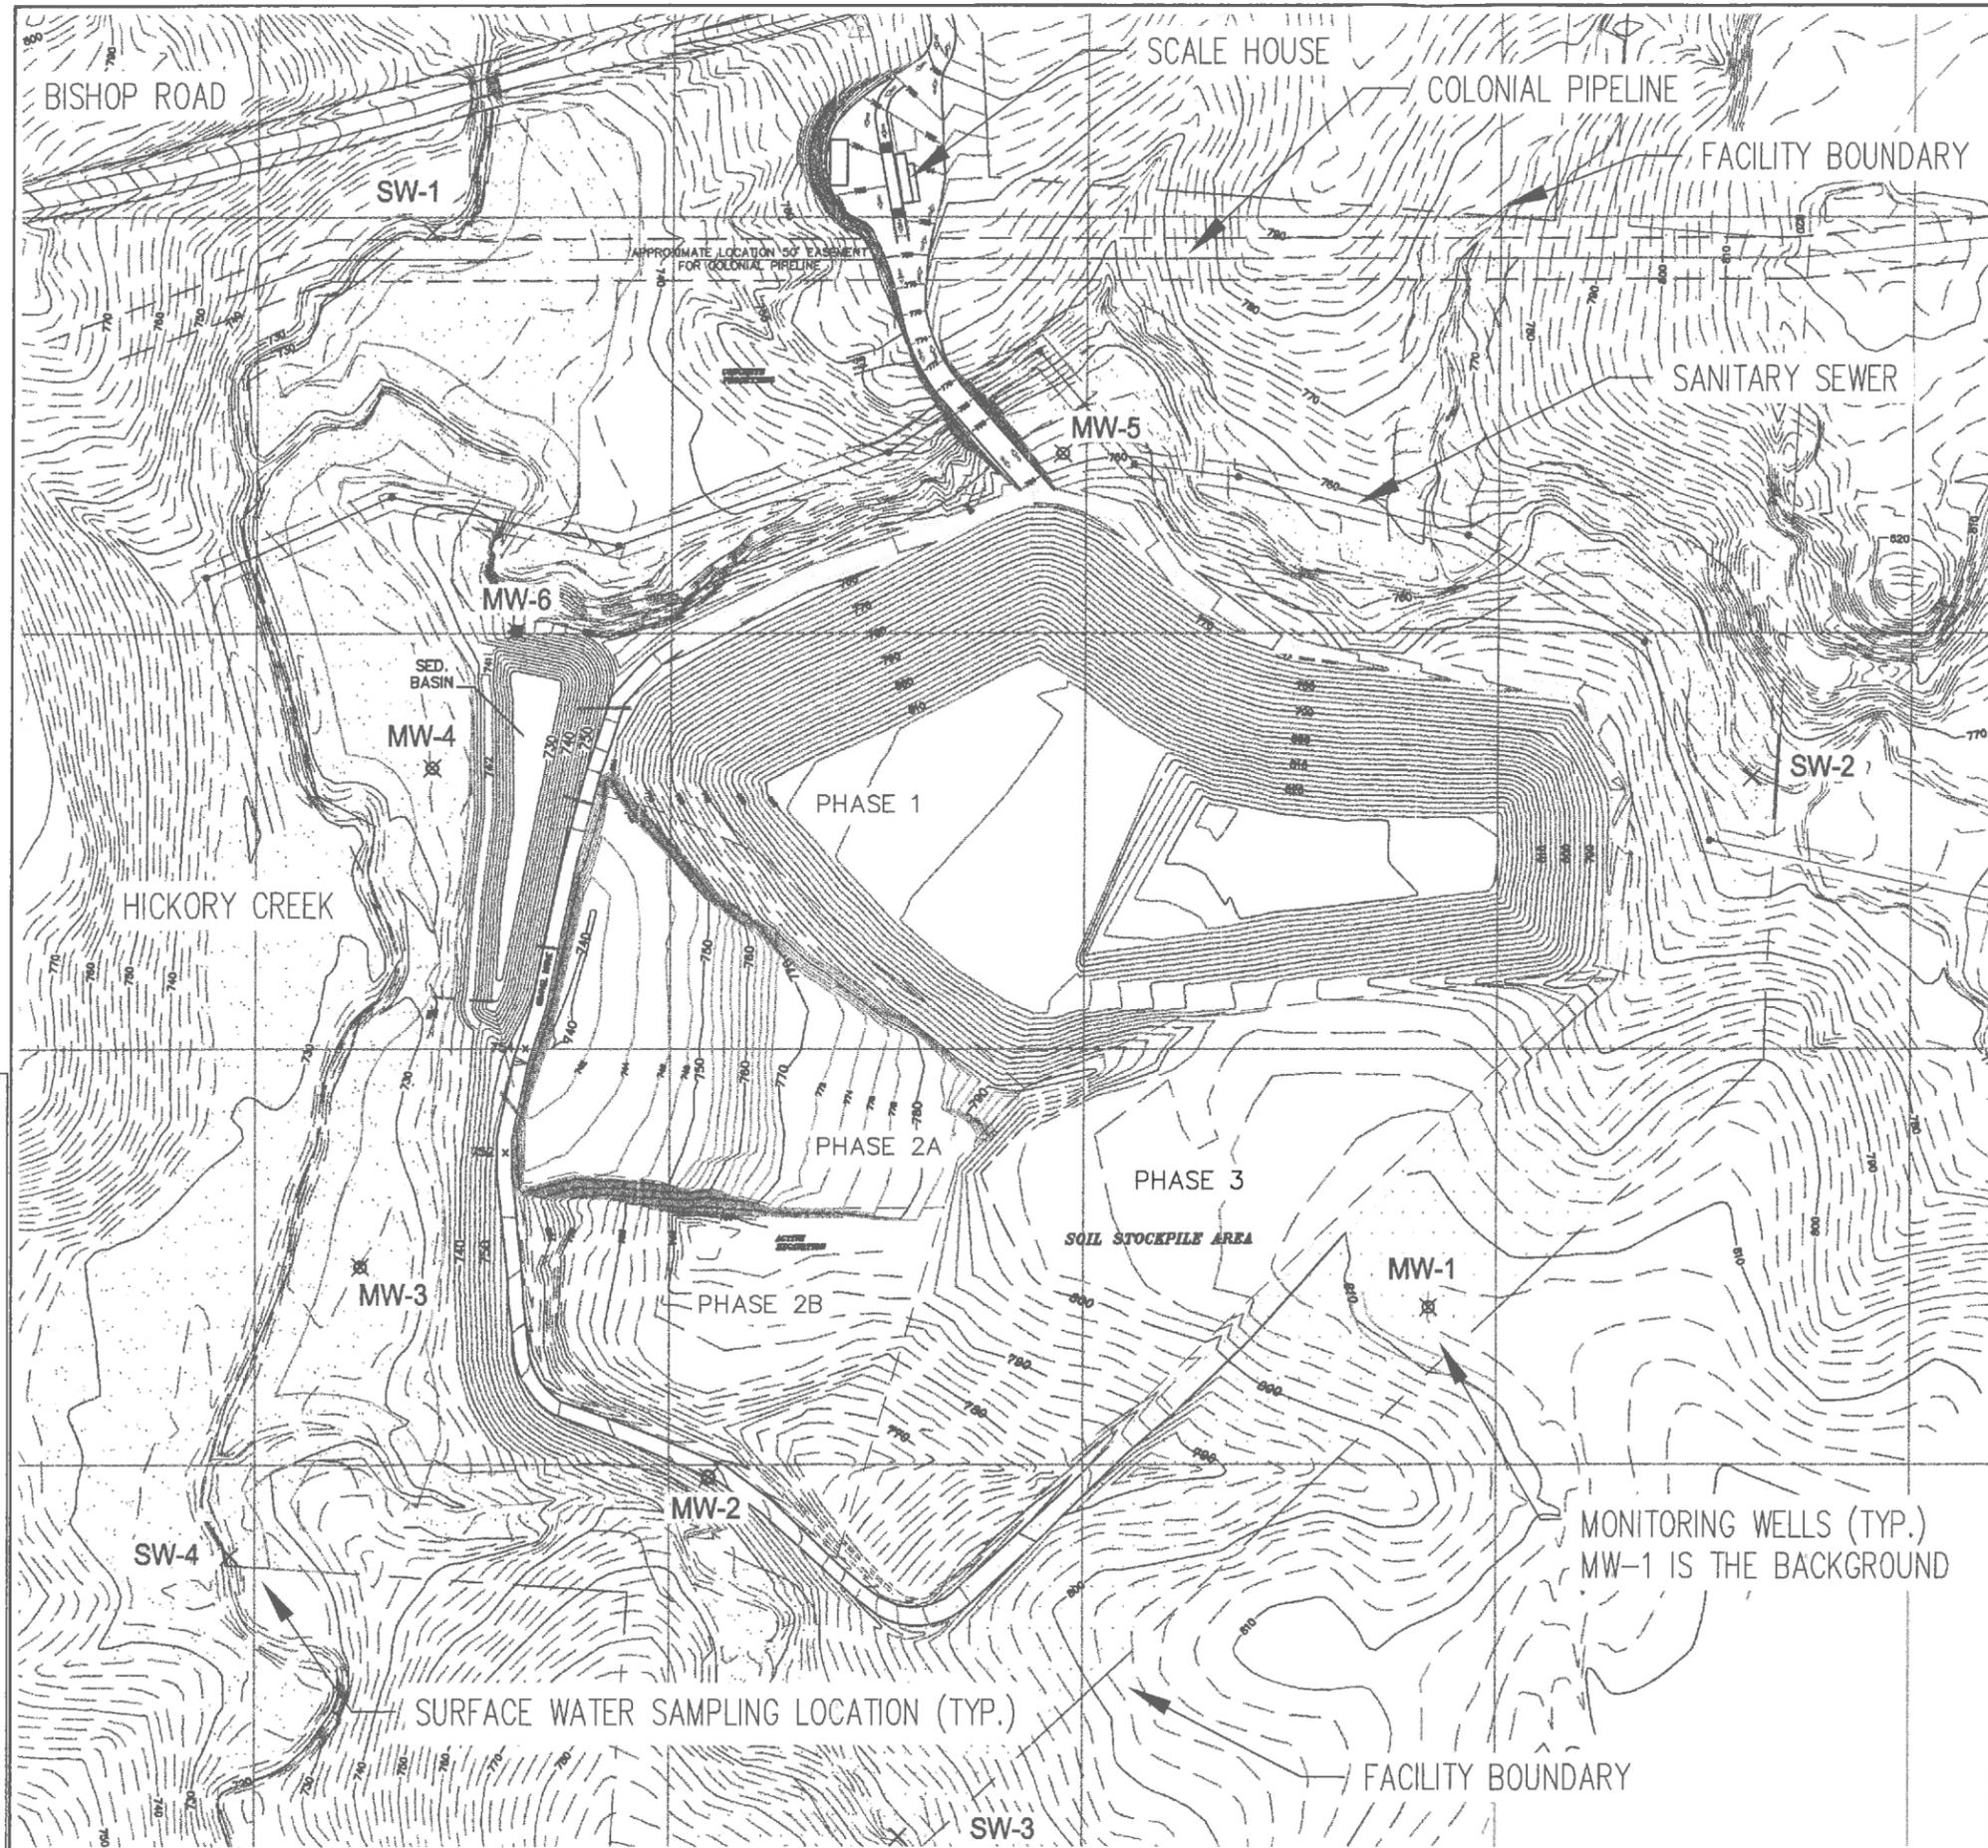
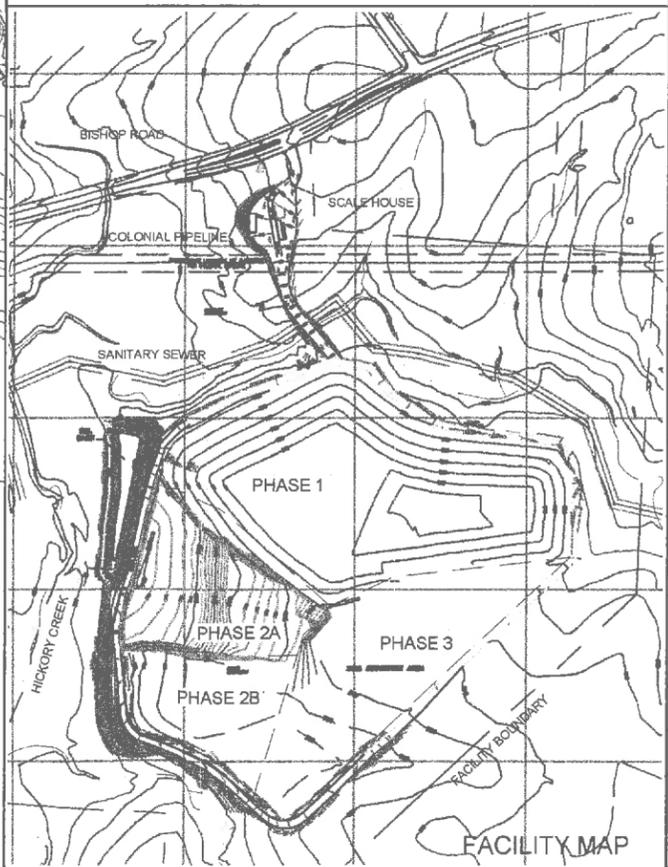
DRAWING NO. GW - M1

BASE GRADE CONTOURS FOR PHASE 2 ARE AS SURVEYED IN APRIL 2015

SHEET TITLE
WATER AND GAS MONITORING LOCATIONS

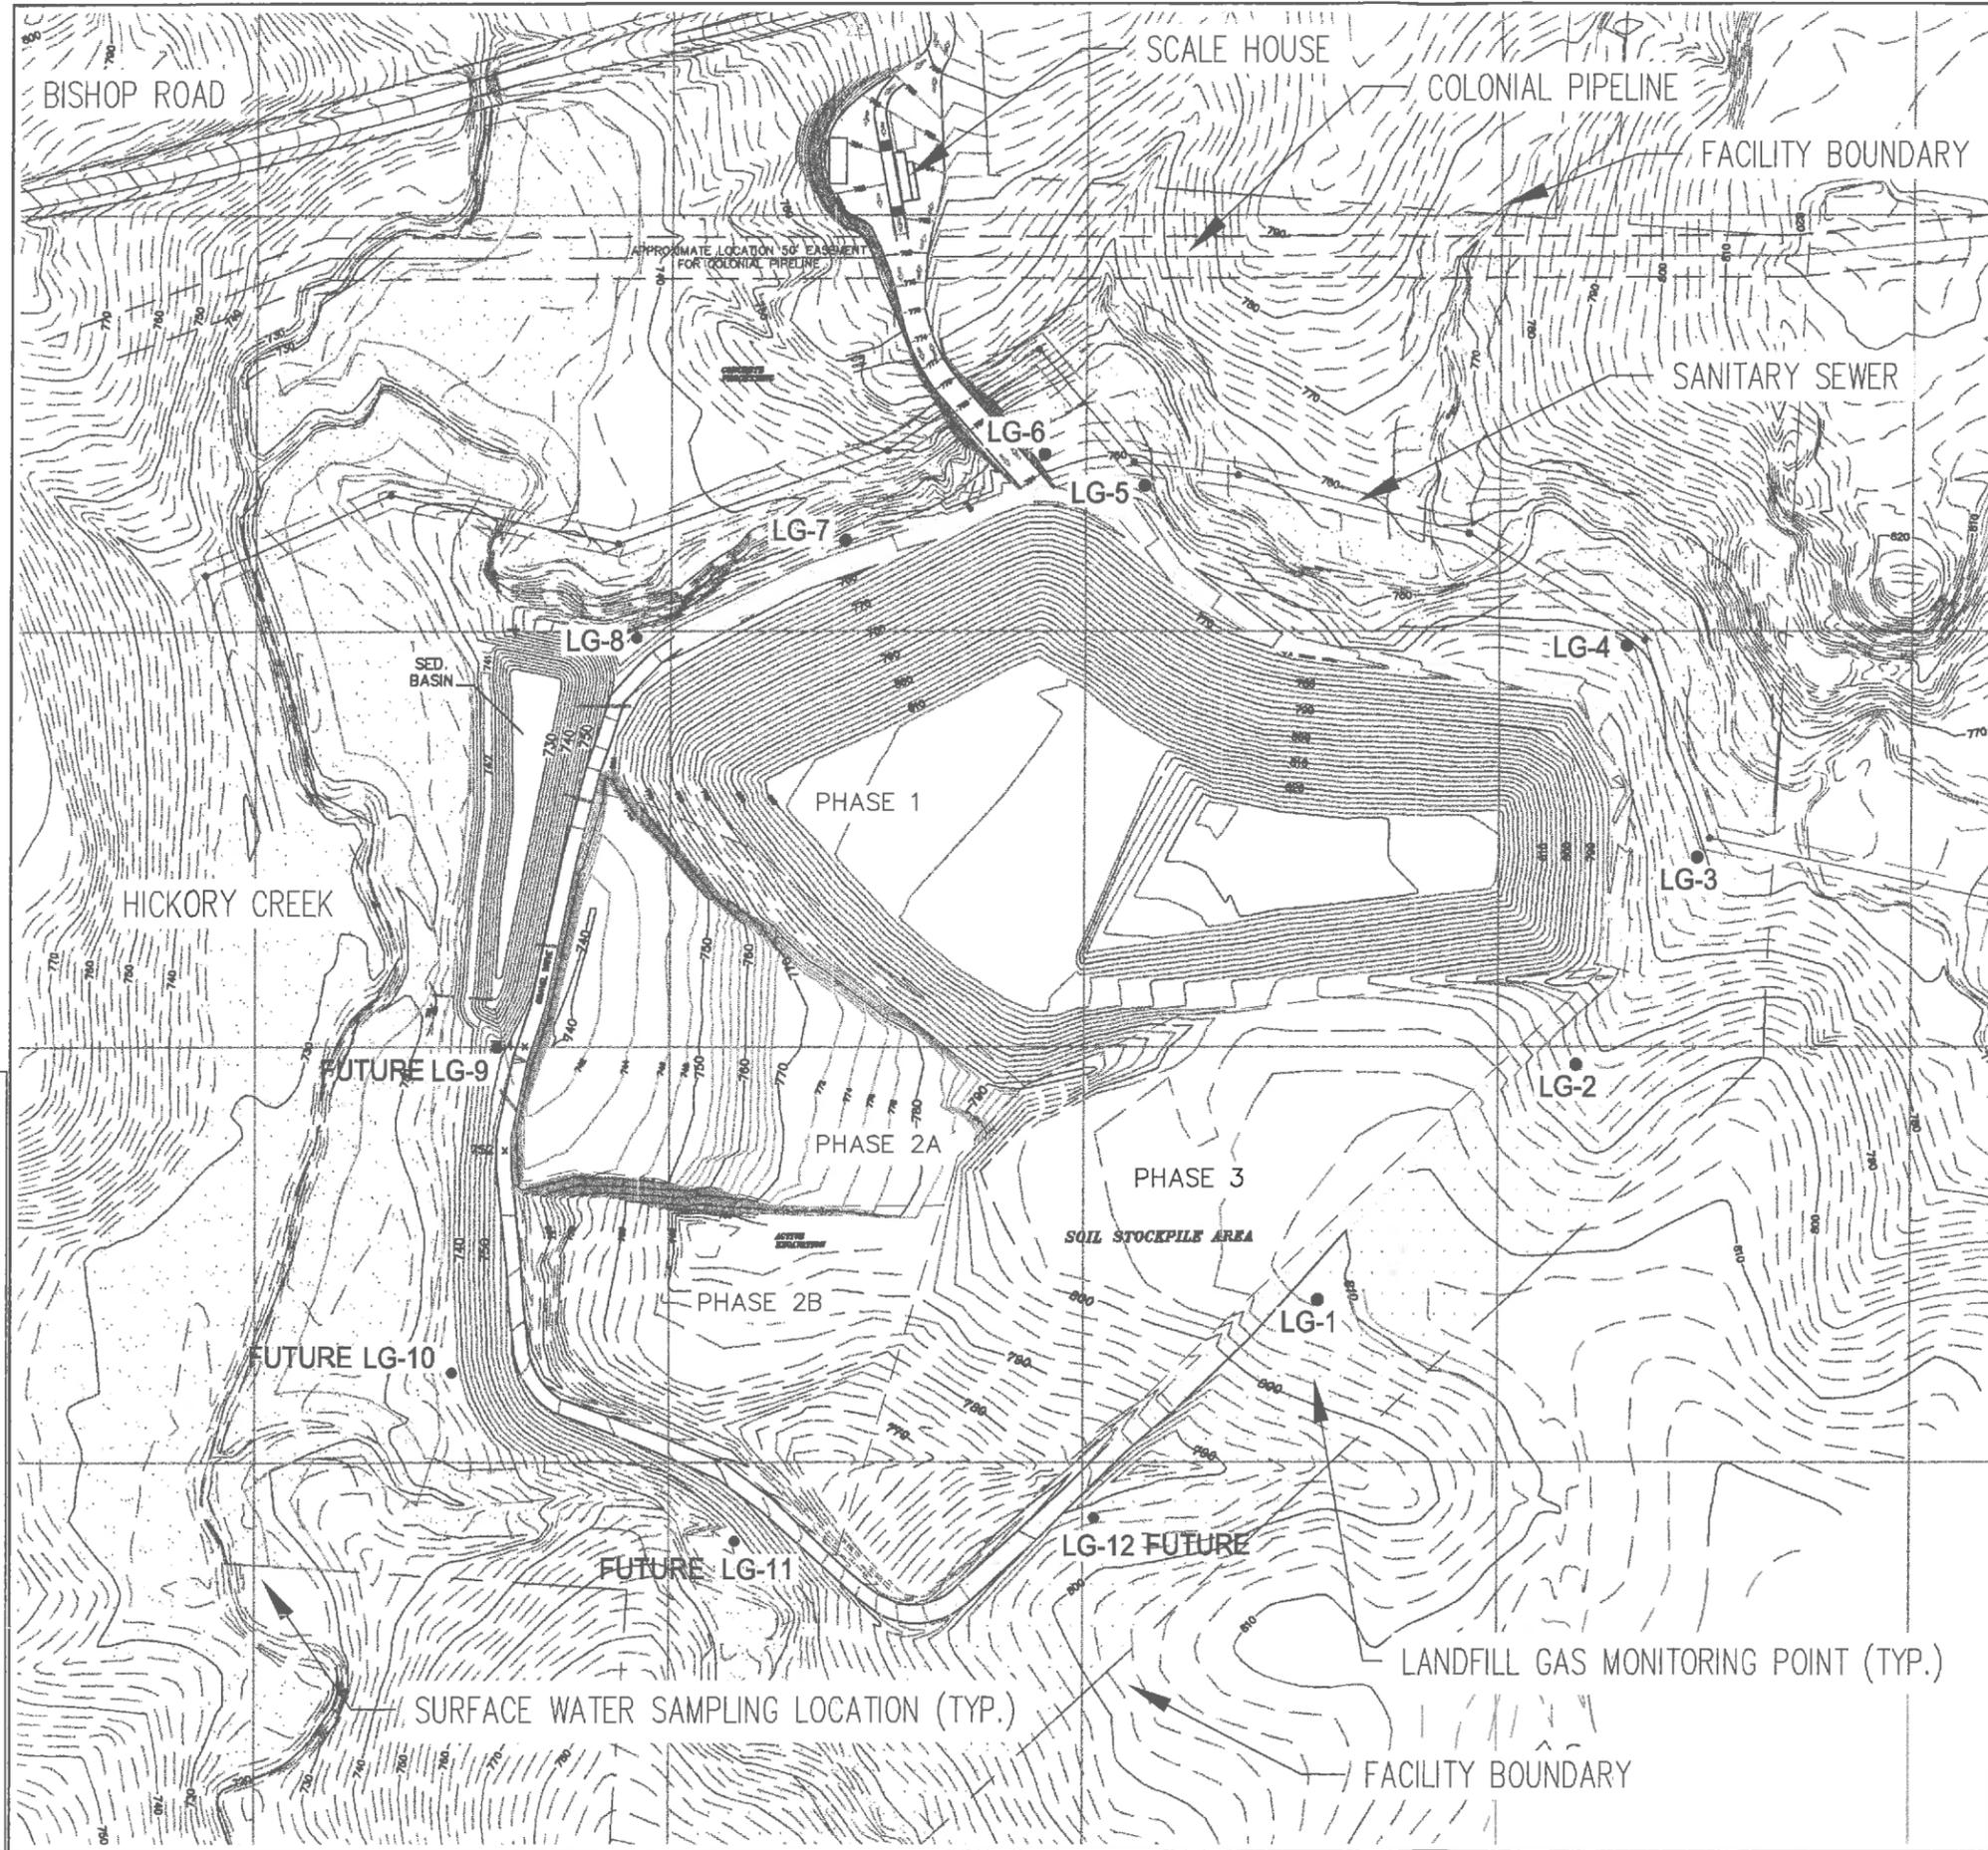
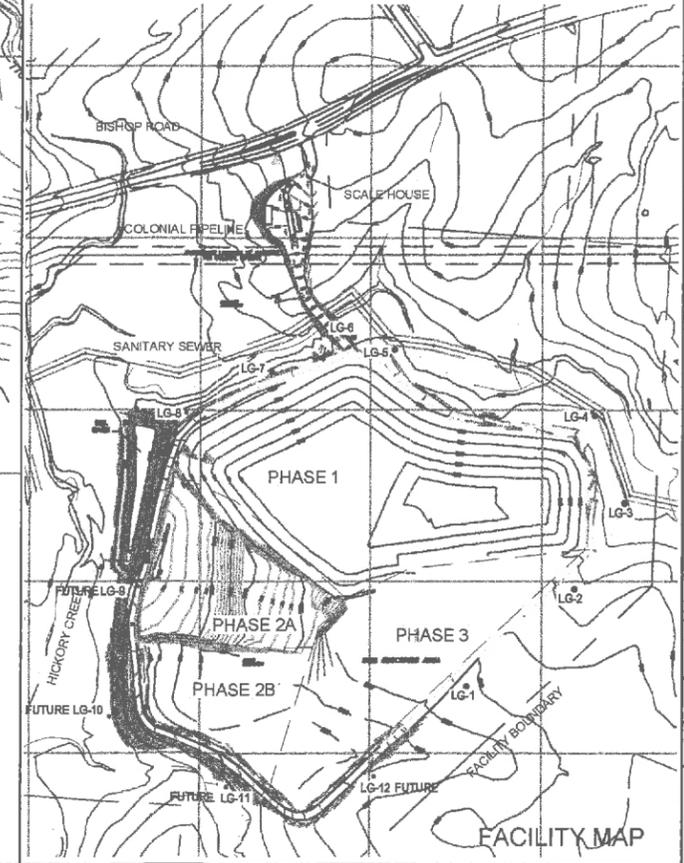
SCS ENGINEERS, PC
2520 WHITEHALL PARK DRIVE, SUITE 450
CHARLOTTE, NORTH CAROLINA 28273
PHONE: (704) 504-3107 FAX: (704) 504-3174
PROJ. NO. 02212704.0073
DATE: 4/30/2015
SCALE: AS SHOWN
DRAWING NO. LFG - M1

BASE GRADE CONTOURS FOR PHASE 2 ARE AS SURVEYED IN APRIL 2015

SHEET TITLE	WATER AND GAS MONITORING LOCATIONS
PROJECT TITLE	PERMIT RENEWAL APPLICATION PHASE 2 PERMIT TO CONSTRUCT
