**FACILITY COMPLIANCE INSPECTION REPORT**  
**Department of Environmental Quality**  
**Division of Waste Management - Solid Waste Section**

**Date of Site Inspection:** September 22, 2015

Doggett Construction Company, Inc. LCID Landfill  
 2075 Bishop Road  
 Greensboro, NC 27406

Comprehensive Inspection

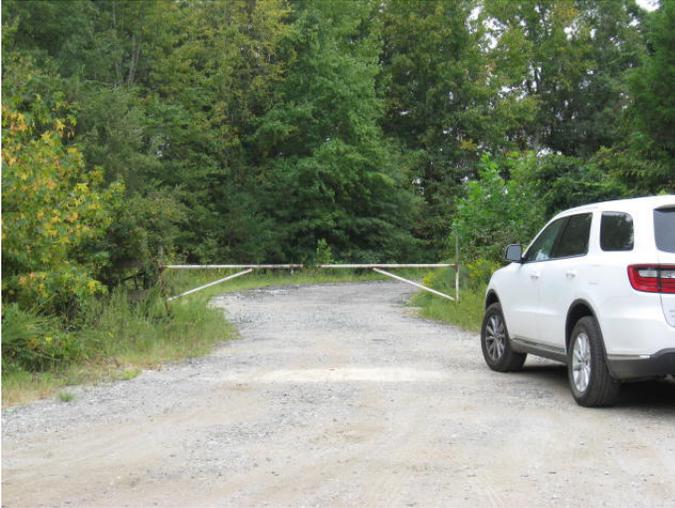
Facility entrance

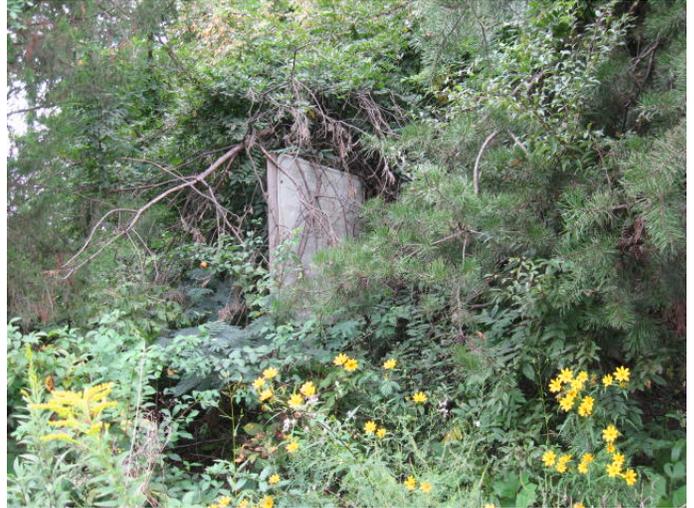
Facility sign (vegetation to be removed and sign cleaned)

16. There was no indication of erosion or runoff.
17. Access roads are of all-weather construction.
18. The facility is secured by a locked gate.
19. The facility has a sign. Remove vegetation to ensure it is easily seen. Clean the sign. Update applicable information.

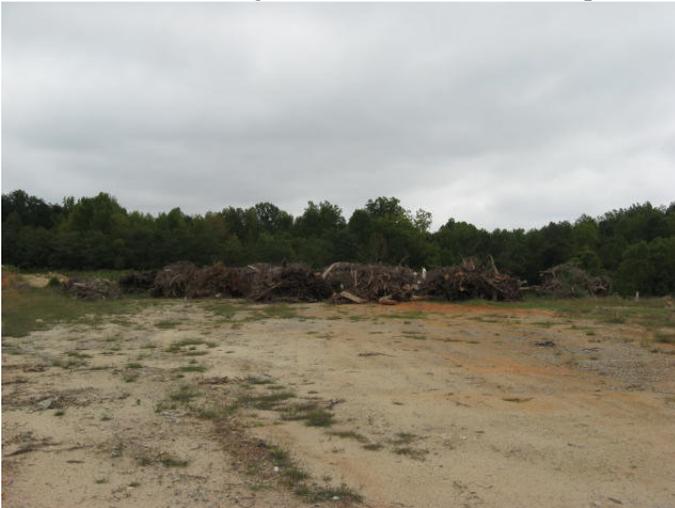
8. The facility operates a long narrow working face, to include side slopes.
9. It is recommended that the working face be maintained small and compact and that the adjacent area/working face is covered with soil accordingly.

LCID landfill working face, also includes side slopes

6. Per 15A NCAC 13B .0566(3), "Solid waste shall be restricted to the smallest area feasible and compacted as densely as practical into cells."
7. Per 15A NCAC 13B .0566(4), "Adequate soil cover shall be applied monthly, or when the active area reaches one acre in size, whichever occurs first."

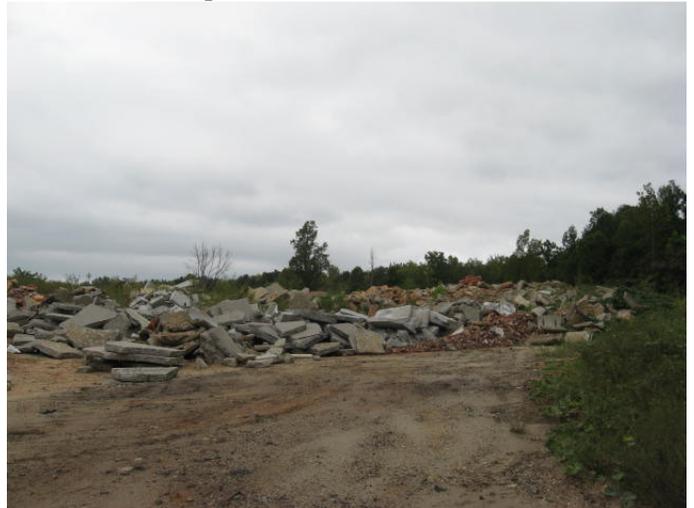
12. The facility stockpiles concrete on the property. Stored concrete should be piled, not spread out.
13. The facility stockpiles used asphalt to use for road bedding material, etc.

Concrete stockpile area
