FACILITY COMPLIANCE INSPECTION REPORT
Division of Waste Management
Solid Waste Section

Date of Site Inspection: January 15, 2014

Weldon Transfer Facility
 2211 Highway 301 North
 Weldon, NC 27839

Partial Audit

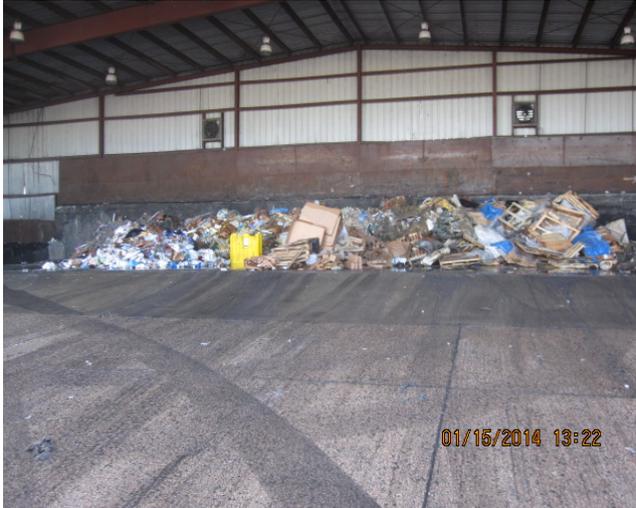
Tipping floor

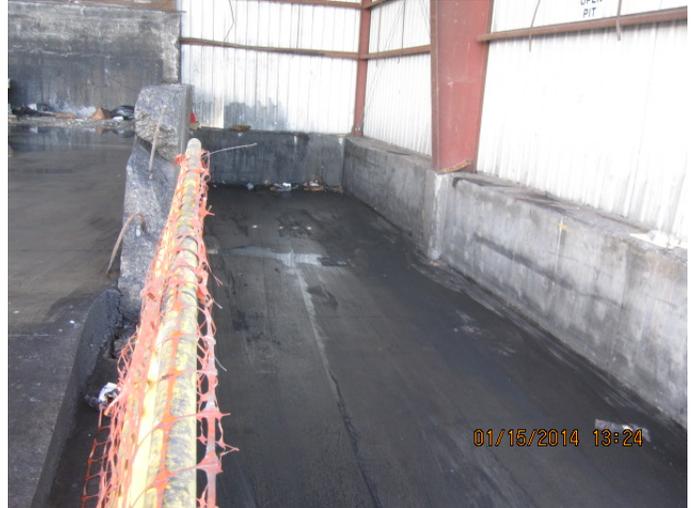
1. All leachate collection areas appear to be open and free flowing. Very good.
2. The areas above the push walls look much better. There are a few areas where the concrete barriers are broken. These must be kept clean or be repaired to facilitate ease of cleaning.

Recycles bay to right of tipping floor. Leachate drains working.

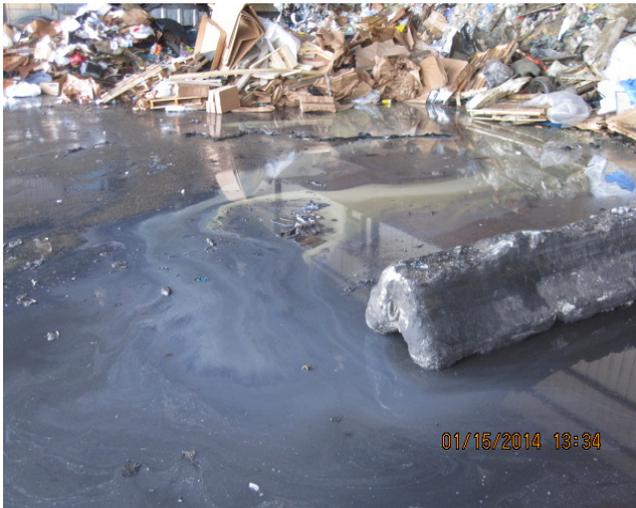
Leachate from Reesers vegetables on tipping floor

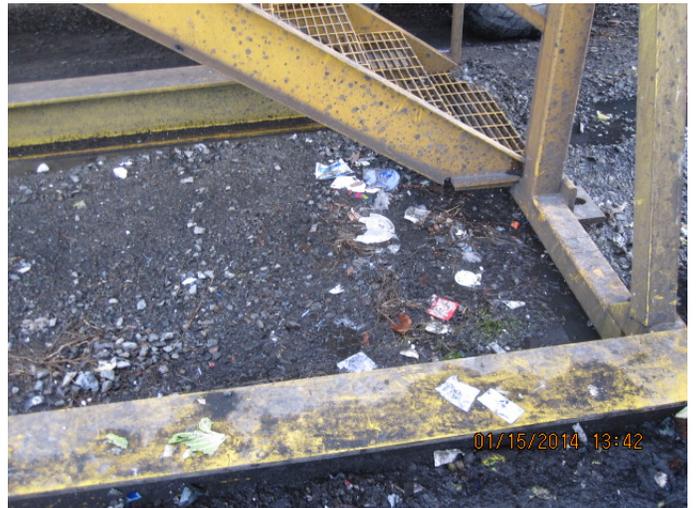
3. The windblown is not excessive, but it does need to be picked up every day. The area outside of the trailer loading bay (towards the back of the lot) had a buildup of debris. This area must be cleaned daily.

Area outside back loading dock- needs to be kept clean
