**FACILITY COMPLIANCE INSPECTION REPORT**  
**Department of Environmental Quality**  
**Division of Waste Management - Solid Waste Section**

**Date of Site Inspection:** September 2, 2015      **Date of Last Inspection:** October 31, 2013

**FACILITY NAME AND ADDRESS:**  
 Harnett County Anderson Creek C&D Landfill  
 1086 Poplar Drive  
 Spring Lake, NC 28390

**PURPOSE OF SITE VISIT:**  
 Comprehensive Inspection

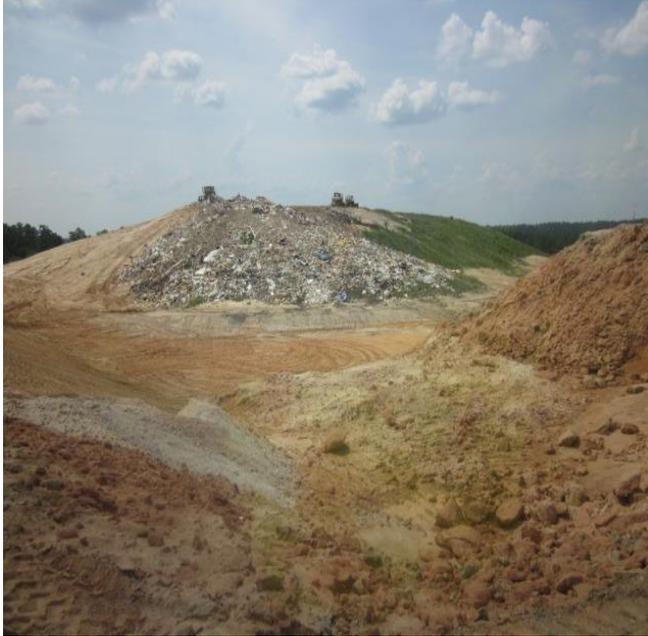
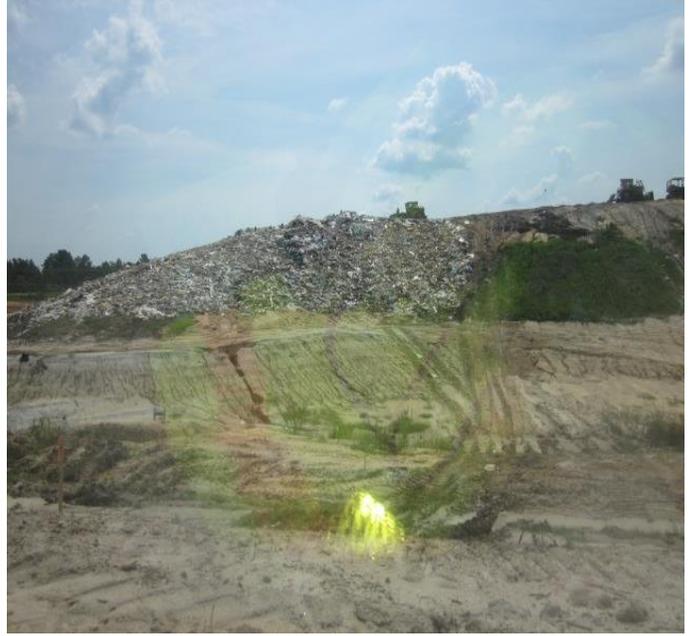
8. The working face was around the ½ acre size. Six inches of earthen material should be properly applied once weekly or when the working face reaches ½ acre. Additional areas of waste outside the working face were exposed and needed additional cover. Areas that become uncovered from other activities or erosion need to be covered as they are noticed.

Working face of landfill

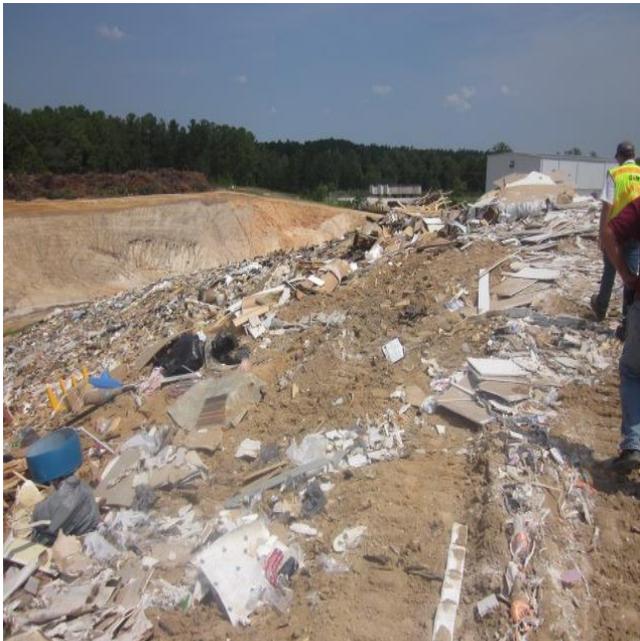
Top of landfill with waste uncovered.

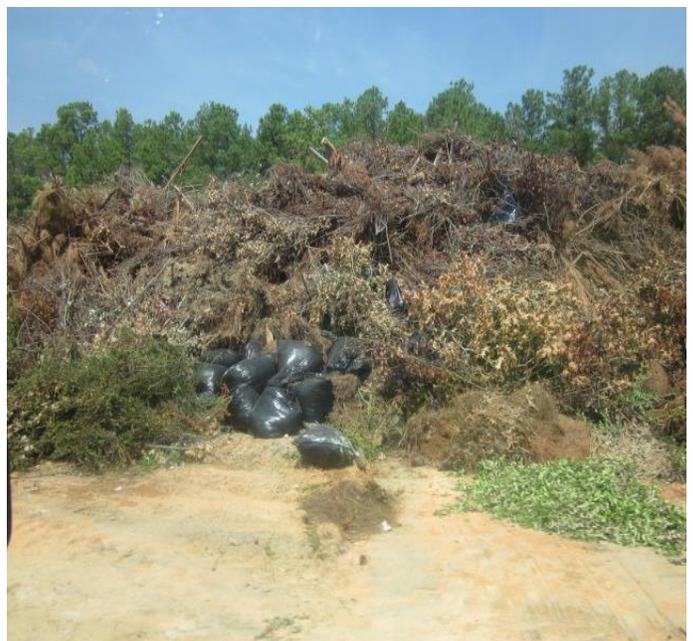
Yardwaste area. Remove plastic bags.

15. The edge of waste markers were reviewed. Missing markers need to be reinstalled if they are damaged or removed.
  16. Yard waste area being properly managed. Non-compostable bags should be removed from yard waste area. Yard waste to be ground by Shavender.
