# Construction Quality Assurance Report

## Harnett County Anderson Creek C&D Landfill - Phase IIIA-1 Spring Lake, North Carolina

**RE: Harnett County Anderson Creek C&DLF - Phase IIIA-1 (Permit No. 43-03)  
Construction Quality Assurance (CQA) Report**

**S+G Project No. HARNETT-AC-15-2**

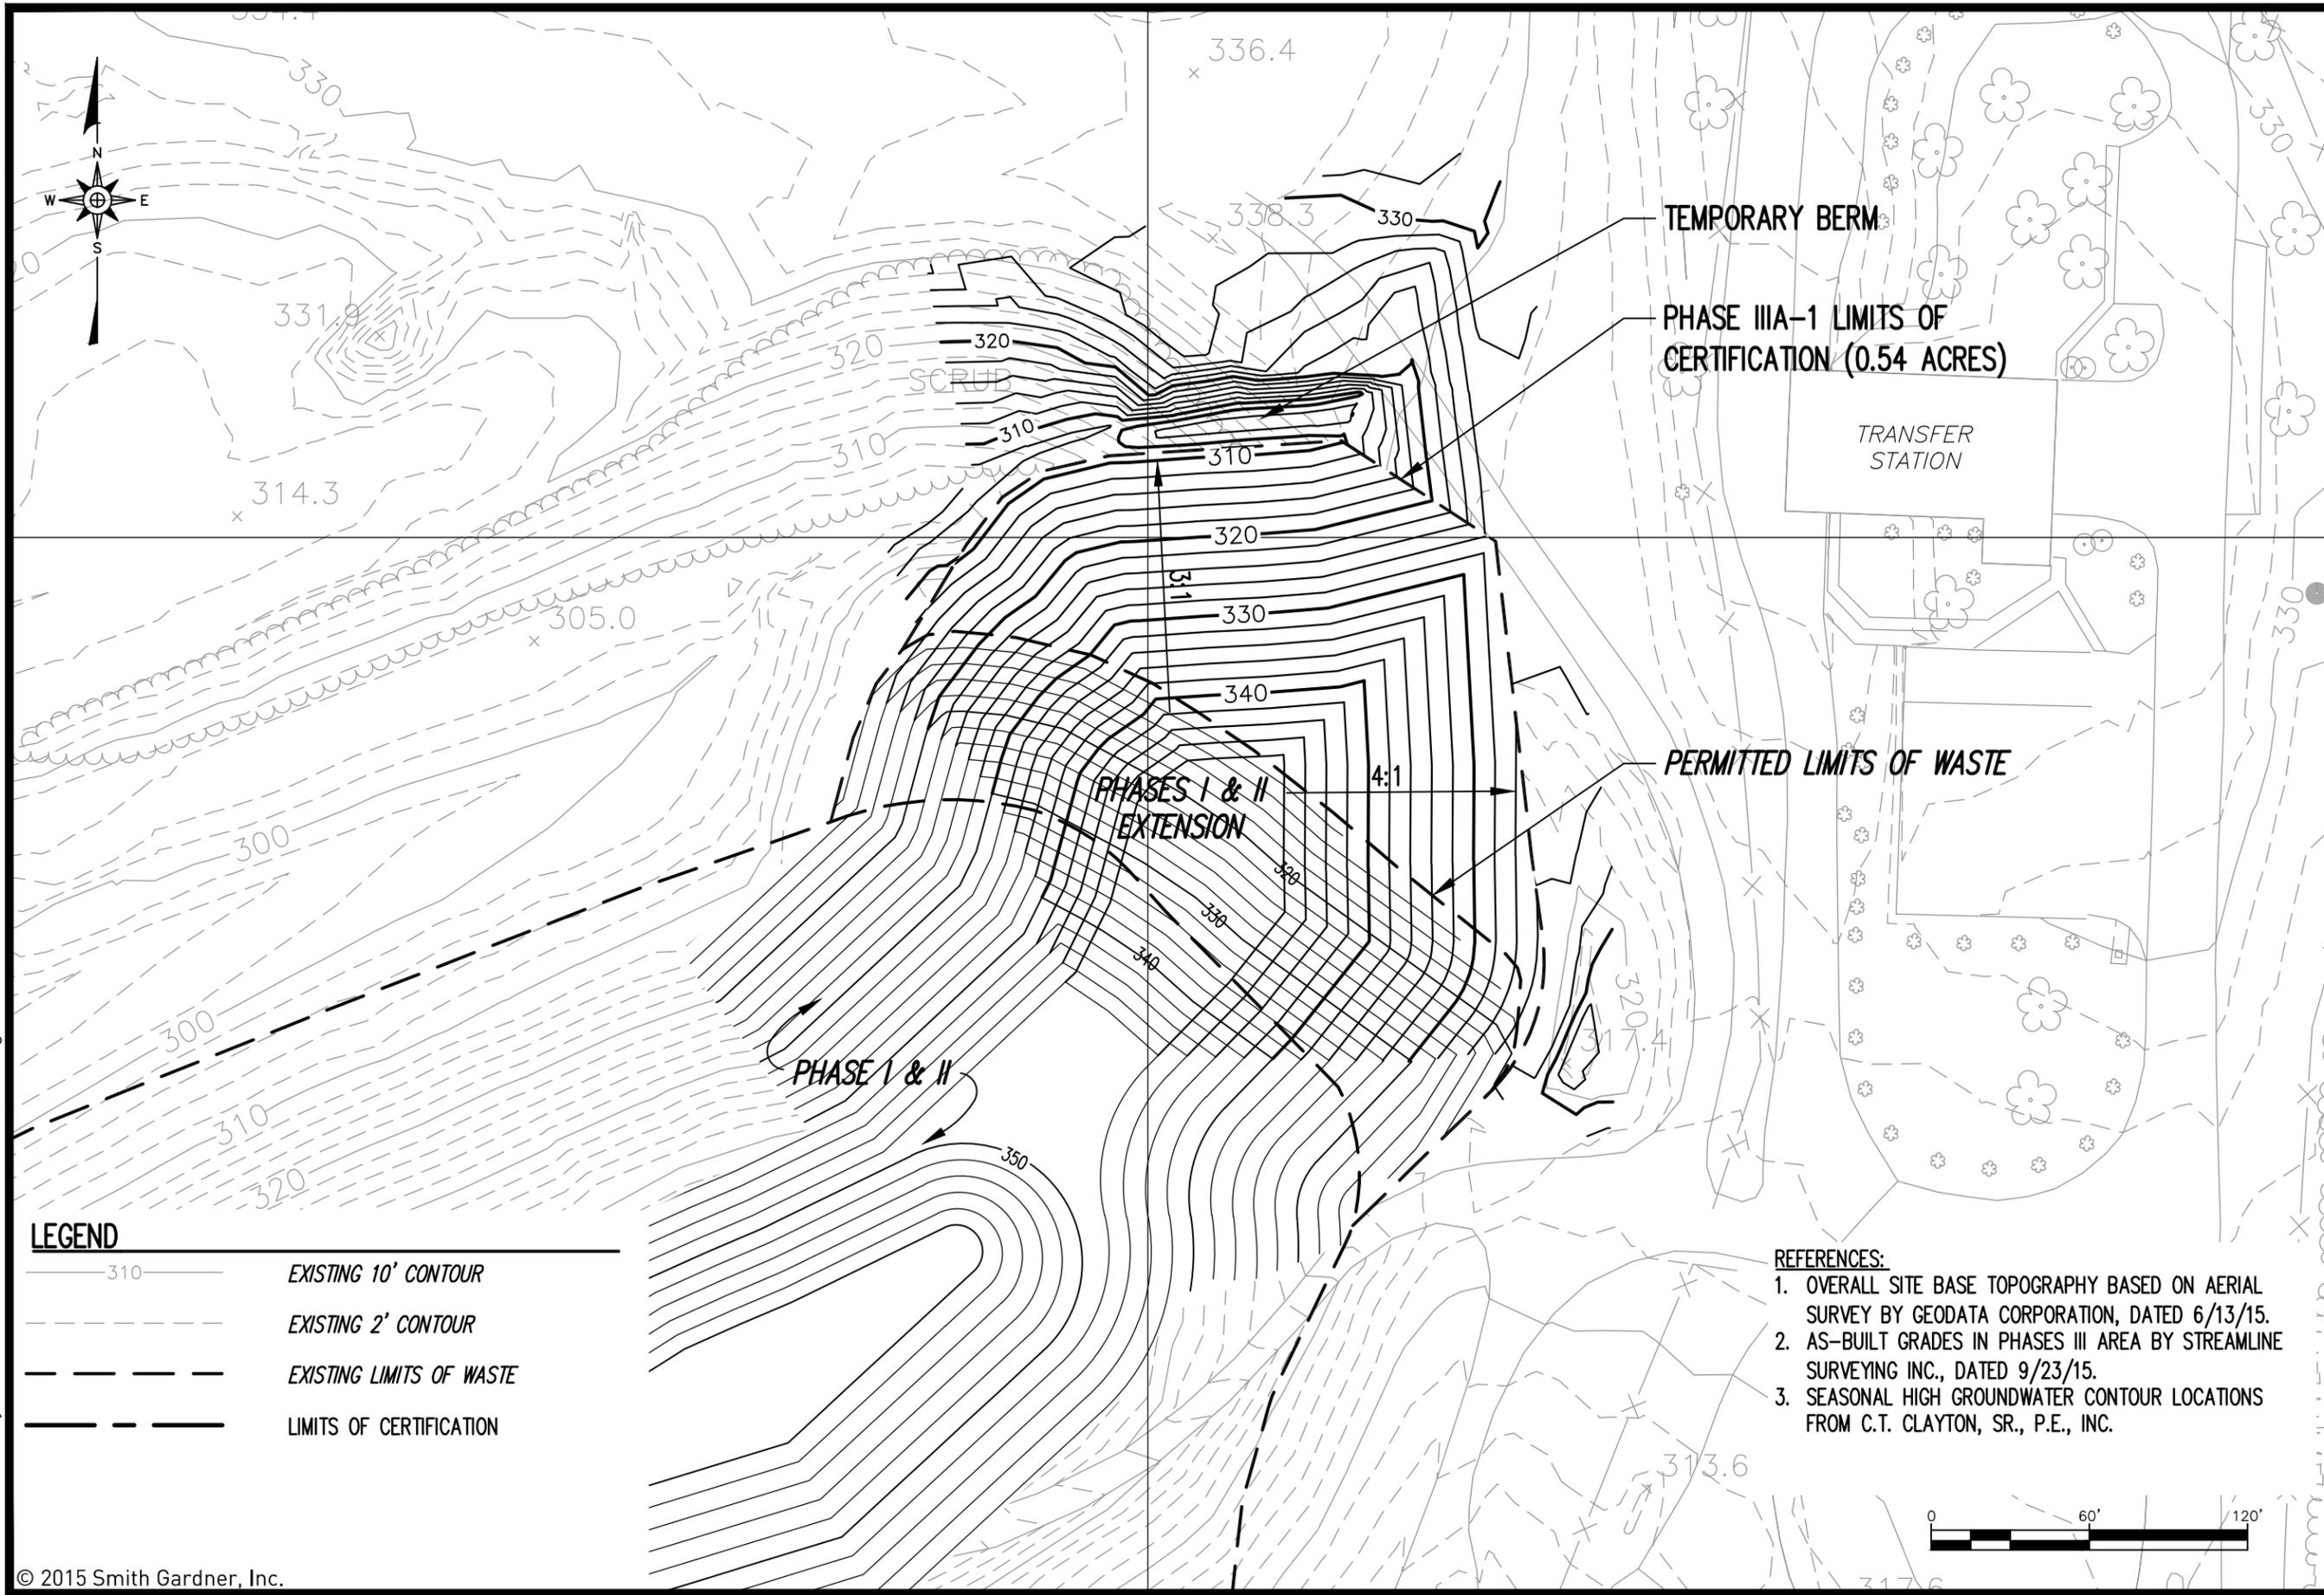
PREPARED BY: \_\_\_\_\_ NC LIC. NO. C-0828 (ENGINEERING)  
 FIGURE NO. 1  
 SCALE: AS SHOWN  
 APPROVED: P.K.S.  
 DRAWN: C.T.J.  
 DATE: Sep 2015  
 PROJECT NO.: HARNETT-AC 15-2  
 FILENAME: HARNETT-B0083

**ANDERSON CREEK GOLF  
 PHASE IIIA-1 CAPACITY**

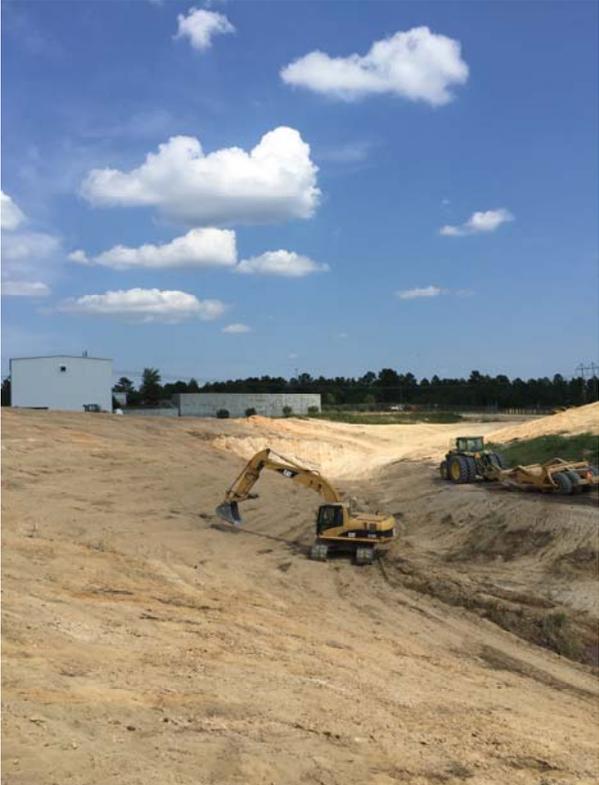
<b>Client Name:</b> Harnett County, North Carolina		<b>Site Location:</b> Anderson Creek C&DLF – Phase IIIA-1		<b>Project No.</b> HARNETT-AC-15-2	
<b>Photo No.</b> 1	<b>Date</b> 7/28/15

<b>Direction Photo Taken:</b> East					
<b>Description:</b> Initial Excavation Activities

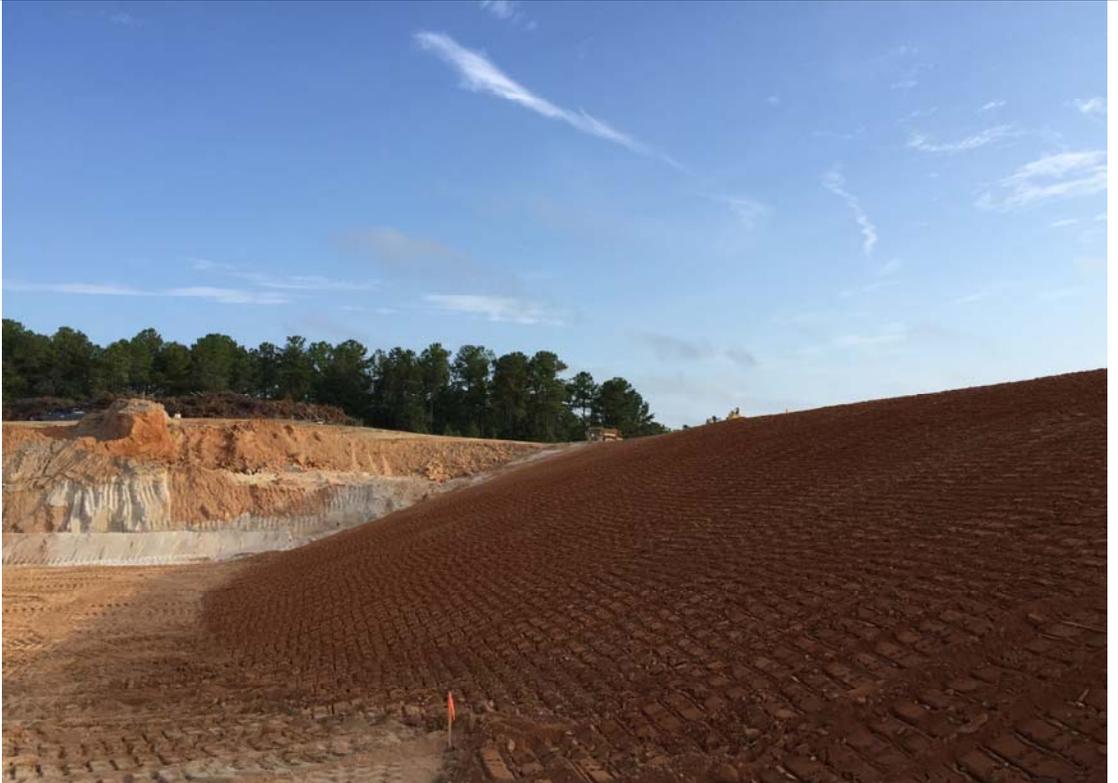
<b>Photo No.</b> 2	<b>Date</b> 9/22/15

<b>Direction Photo Taken:</b> North					
<b>Description:</b> Completed East Slope

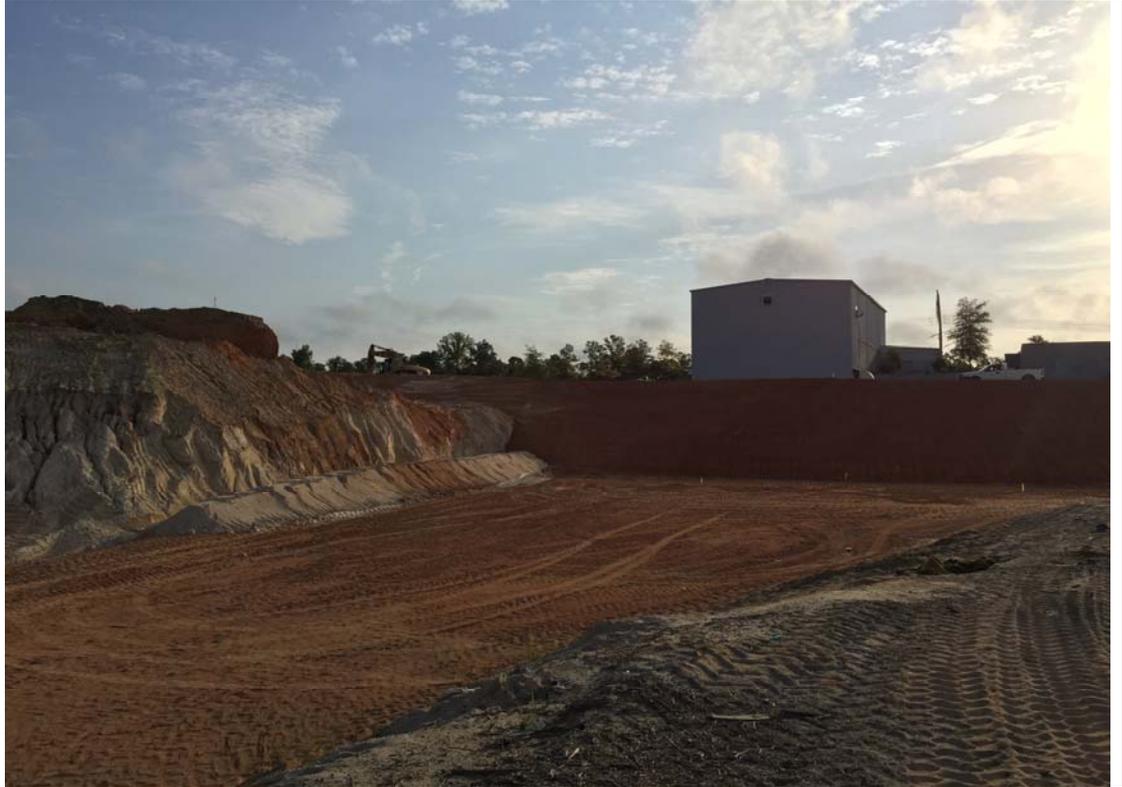
**Photo No.**  
**3**

**Description:**  
View from Phases I & II  
Berm

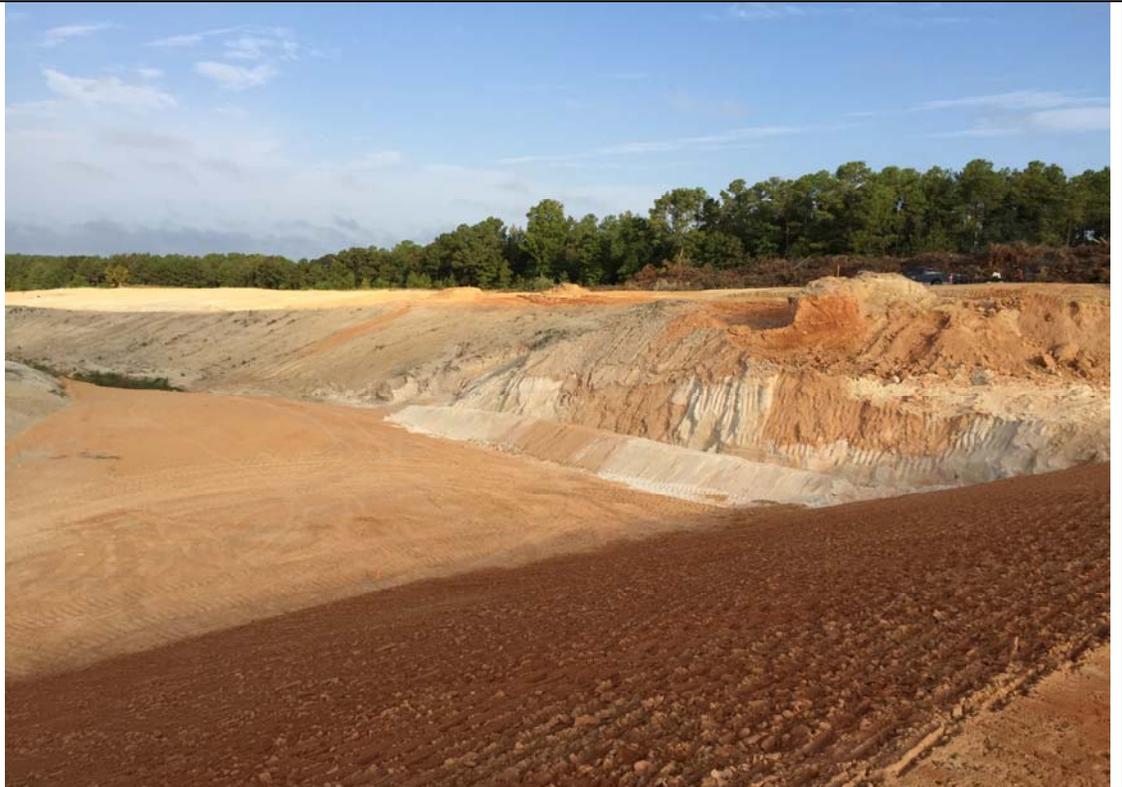
**Photo No.**  
**4**

**Description:**  
View from Top of East  
Slope

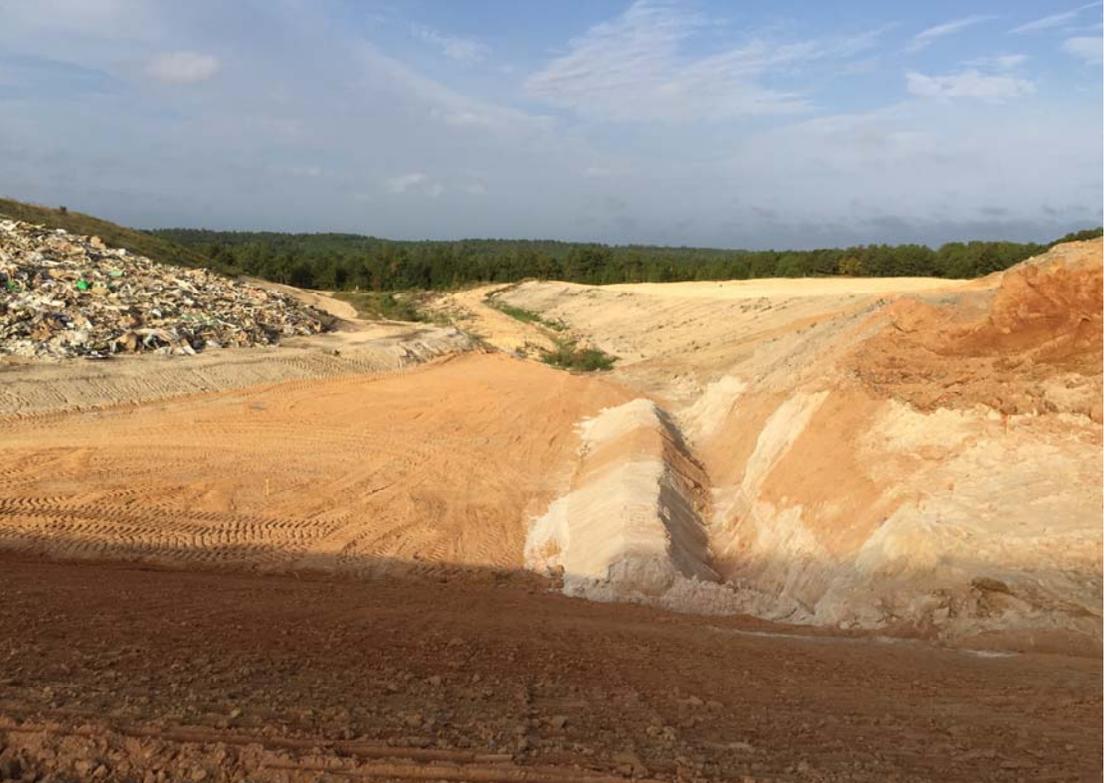
<b>Client Name:</b> Harnett County, North Carolina		<b>Site Location:</b> Anderson Creek C&DLF – Phase IIIA-1	<b>Project No.</b> HARNETT-AC-15-2
<b>Photo No.</b> <b>5</b>	<b>Date:</b> 9/22/15

<b>Direction Photo Taken:</b> West			
<b>Description:</b> Temporary Berm

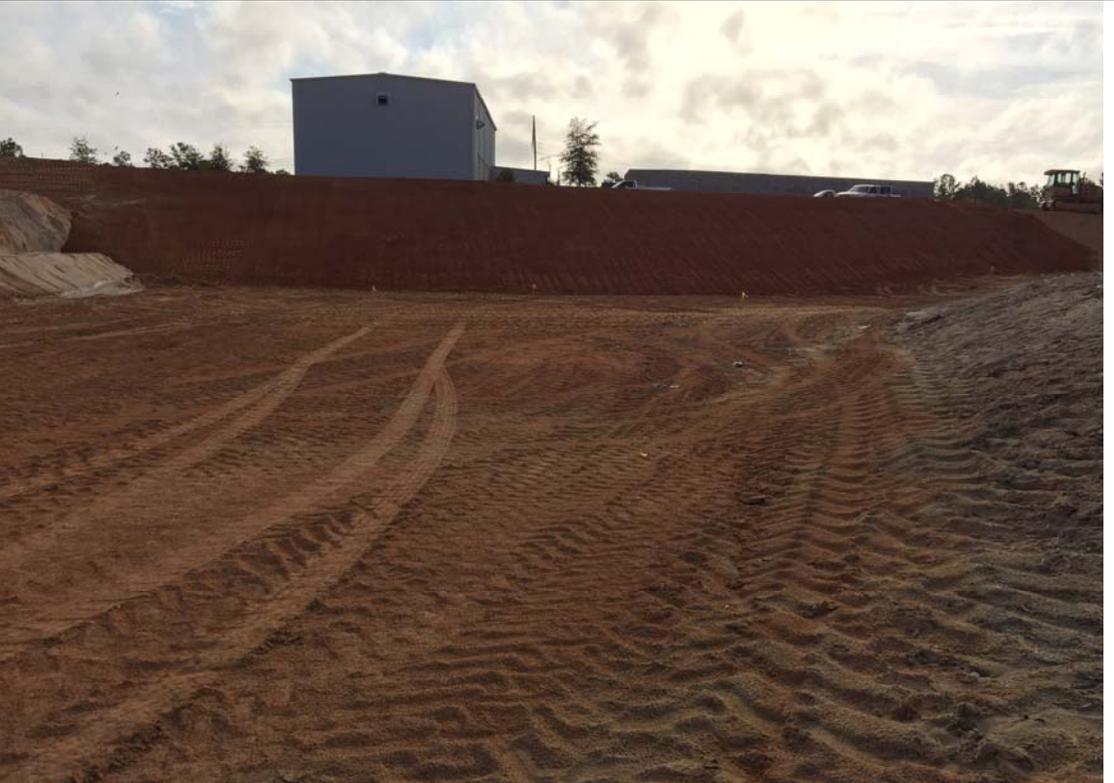
<b>Photo No.</b> <b>6</b>	<b>Date:</b> 9/22/15

<b>Direction Photo Taken:</b> East			
<b>Description:</b> View from West End of Phase IIIA-1

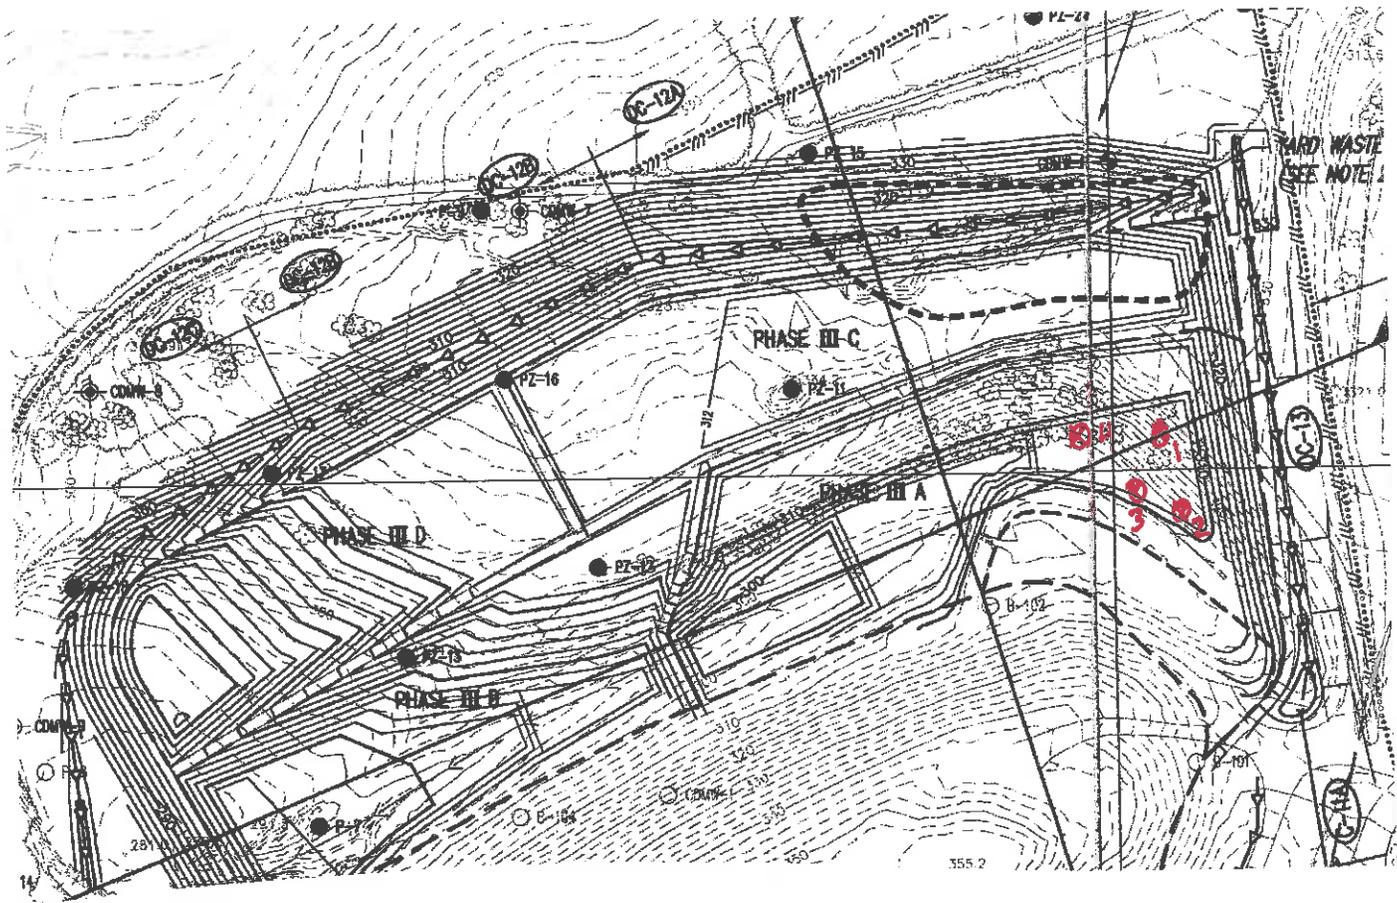
<p>Site Plan Anderson Creek C&amp;D Landfill Spring Lake, North Carolina</p>	<p>Legend Test Locations</p>	<p>Project No. 1-15-0502-CA Scale: = NTS Figure: 1</p>
--	----------------------------------	--

GeoTechnologies representative was onsite to perform in-place density testing on the area marked on the attached site plan. The technician observed one lift of material being placed and compacted. The technician took a density test, which did not meet specifications. The technician recommended rolling the material more and once this was done, another test was taken. This test did not meet compaction requirement either, so the contractor elected to bring in a water truck to wet the entire lift and roll it again. After this was complete, the technician took a retest, which met the compaction requirement. Another test was obtained on a lower area. This test also met compaction requirement and the contractor was informed of the results. After all tests were complete, the technician departed the site.

#	Type of Test	Compaction	Wc +/- Opt.	Pass/Fail	Elevation	Stone Depth (in.)
1	Drive Tube	92.7	-5.8	F	SG	
2	Drive Tube	92.5	-5.2	F	SG	
3	Drive Tube	95.6	-4.9	P	SG	
4	Drive Tube	96.8	-2.0	P	-1'

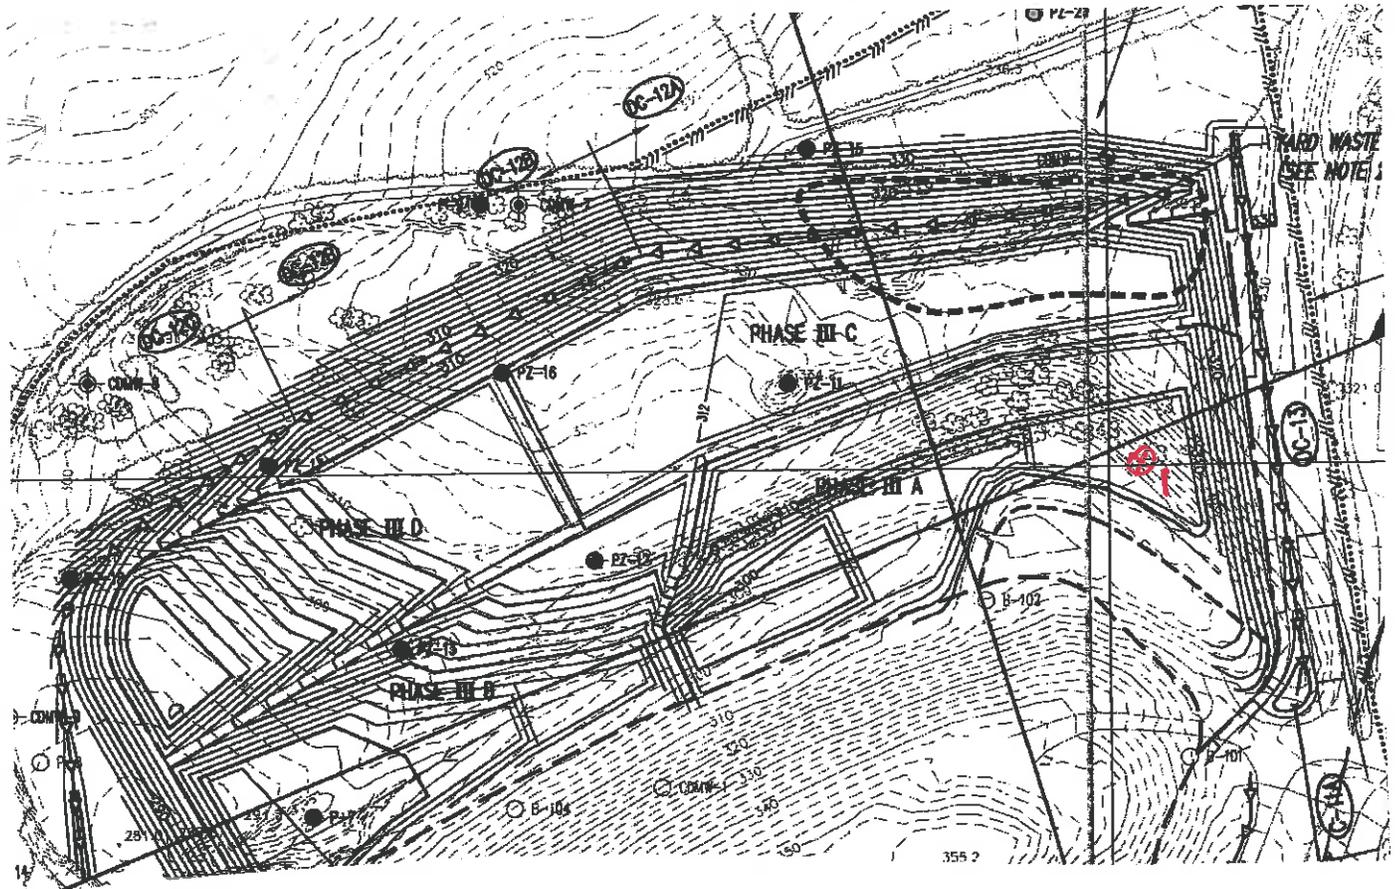
Site Plan  
Anderson Creek C&D Landfill  
Spring Lake, North Carolina

GeoTechnologies representative was onsite to perform in-place density testing on the small fill area marked on the attached site plan. The technician observed as the contractor placed, wet, and compacted. The area was probed and one test was taken by the technician. This test met specifications for compaction and the contractor was informed of the results.

#	Type of Test	Compaction	Wc +/- Opt.	Pass/Fail	Elevation	Stone Depth (in.)
1	Drive Tube	98.5	-3.4	P	SG

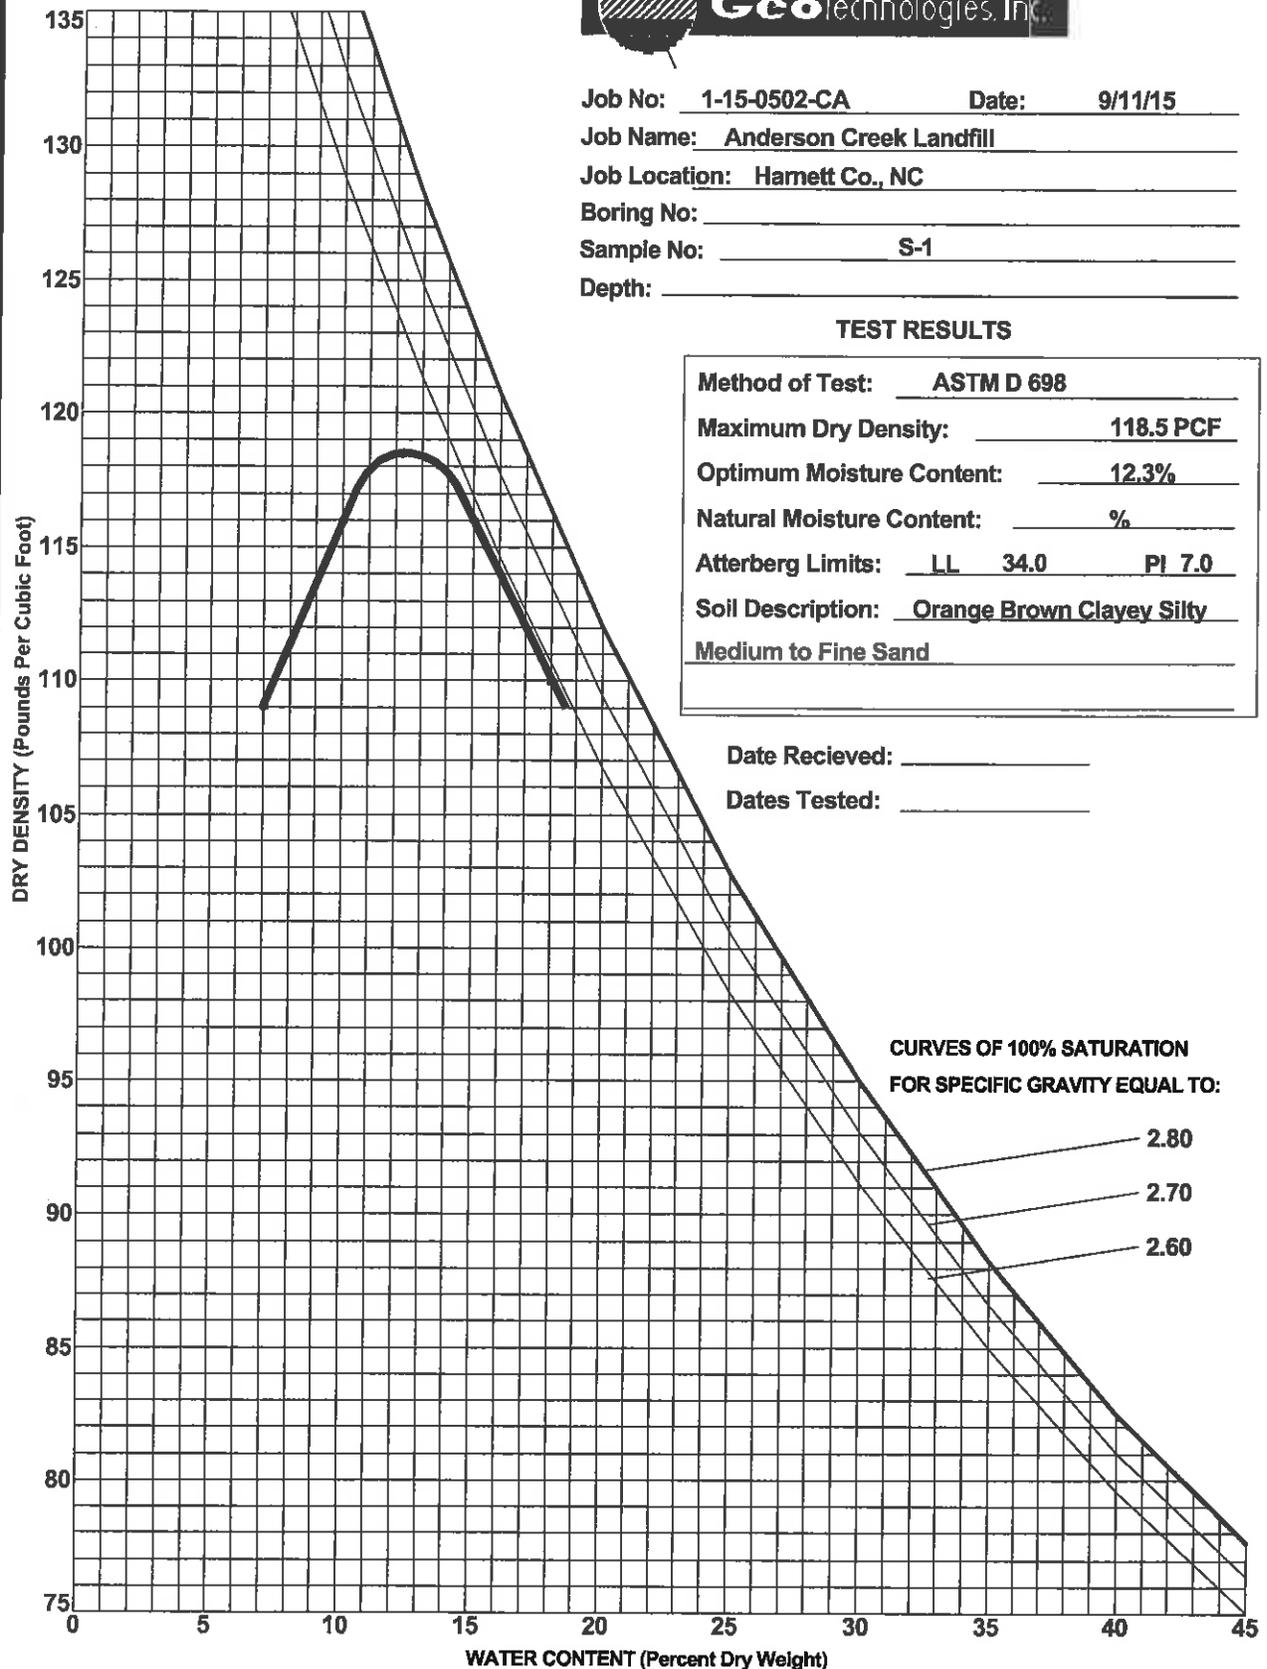
**MOISTURE-DENSITY RELATIONSHIP**

Method of Test:	<u>ASTM D 698</u>
Maximum Dry Density:	<u>118.5 PCF</u>
Optimum Moisture Content:	<u>12.3%</u>
Natural Moisture Content:	<u>%</u>
Atterberg Limits:	<u>LL 34.0 PI 7.0</u>
Soil Description:	<u>Orange Brown Clayey Silty</u>
	<u>Medium to Fine Sand</u>

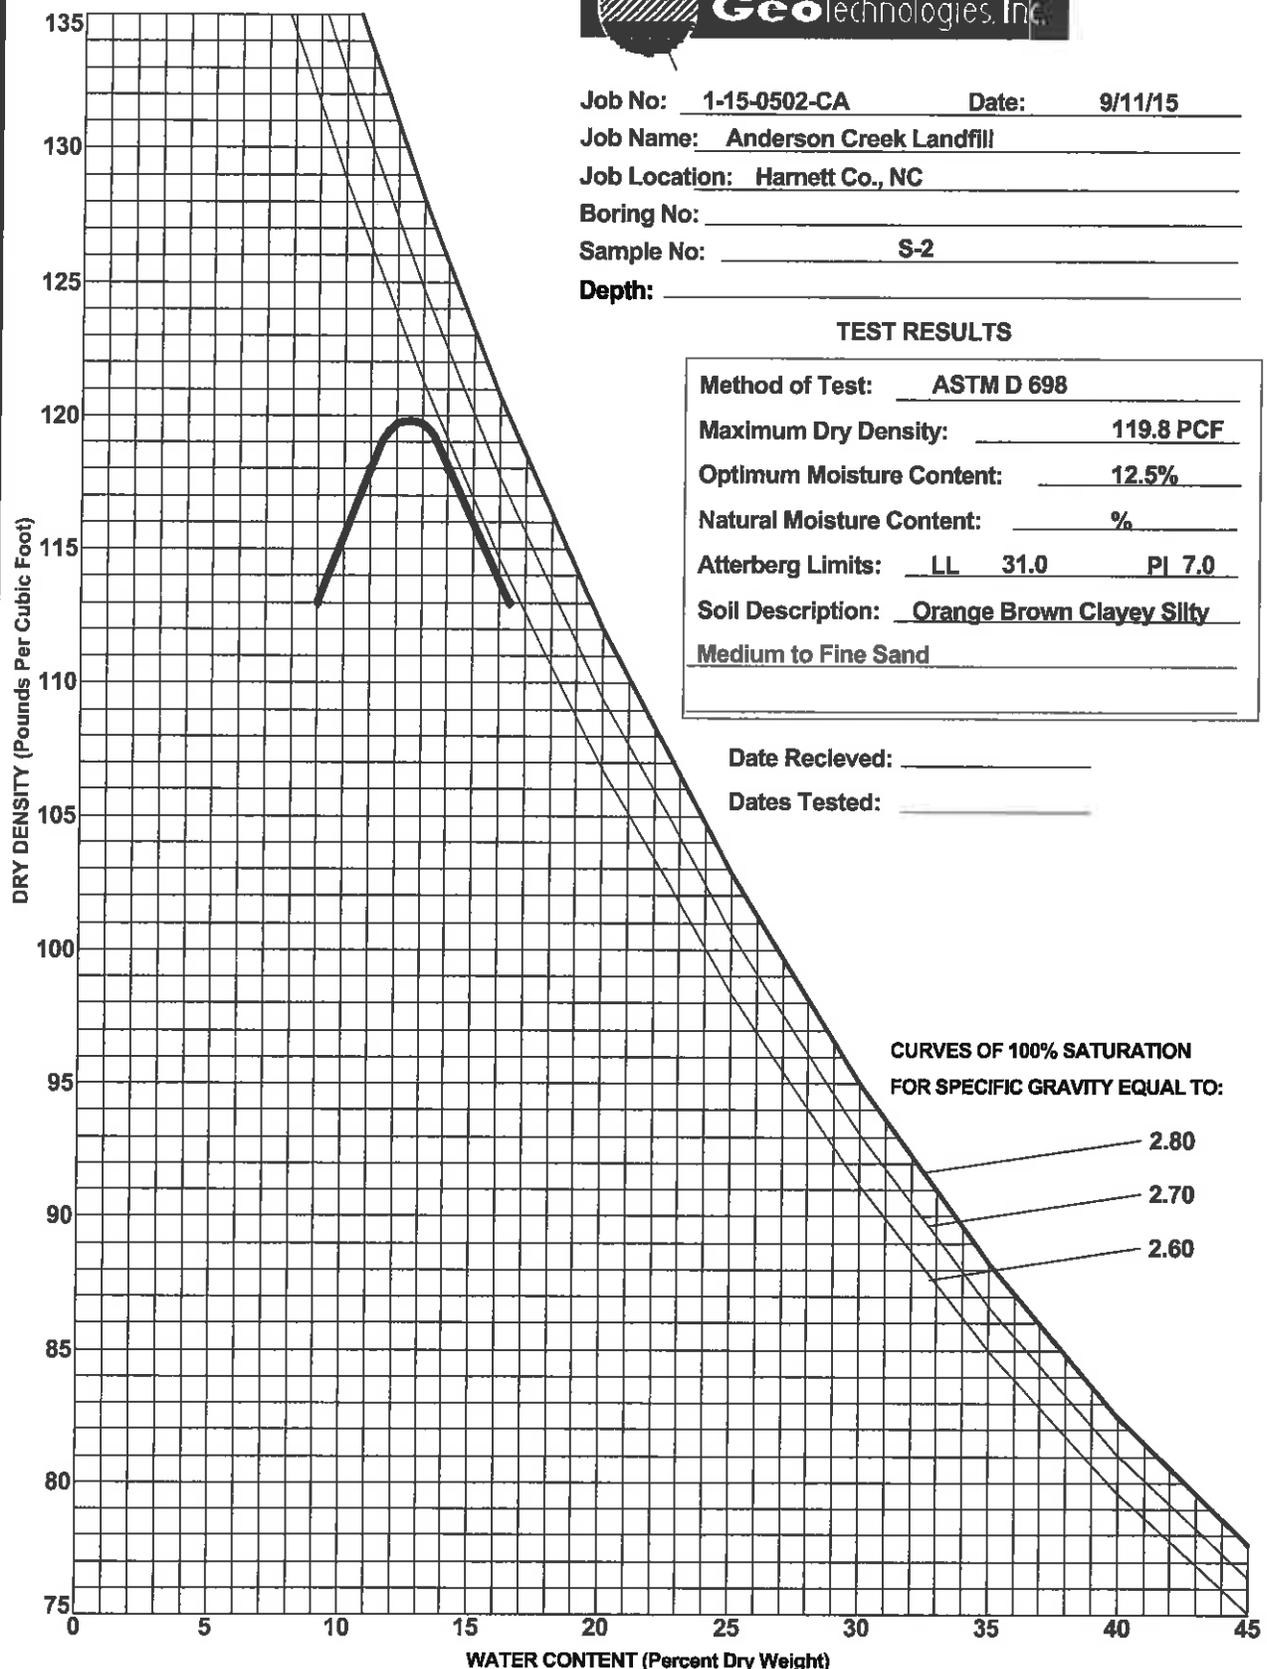
**MOISTURE-DENSITY RELATIONSHIP**

Method of Test:	<u>ASTM D 698</u>
Maximum Dry Density:	<u>119.8 PCF</u>
Optimum Moisture Content:	<u>12.5%</u>
Natural Moisture Content:	<u>%</u>
Atterberg Limits:	<u>LL 31.0 PI 7.0</u>
Soil Description:	<u>Orange Brown Clayey Silty</u>
	<u>Medium to Fine Sand</u>

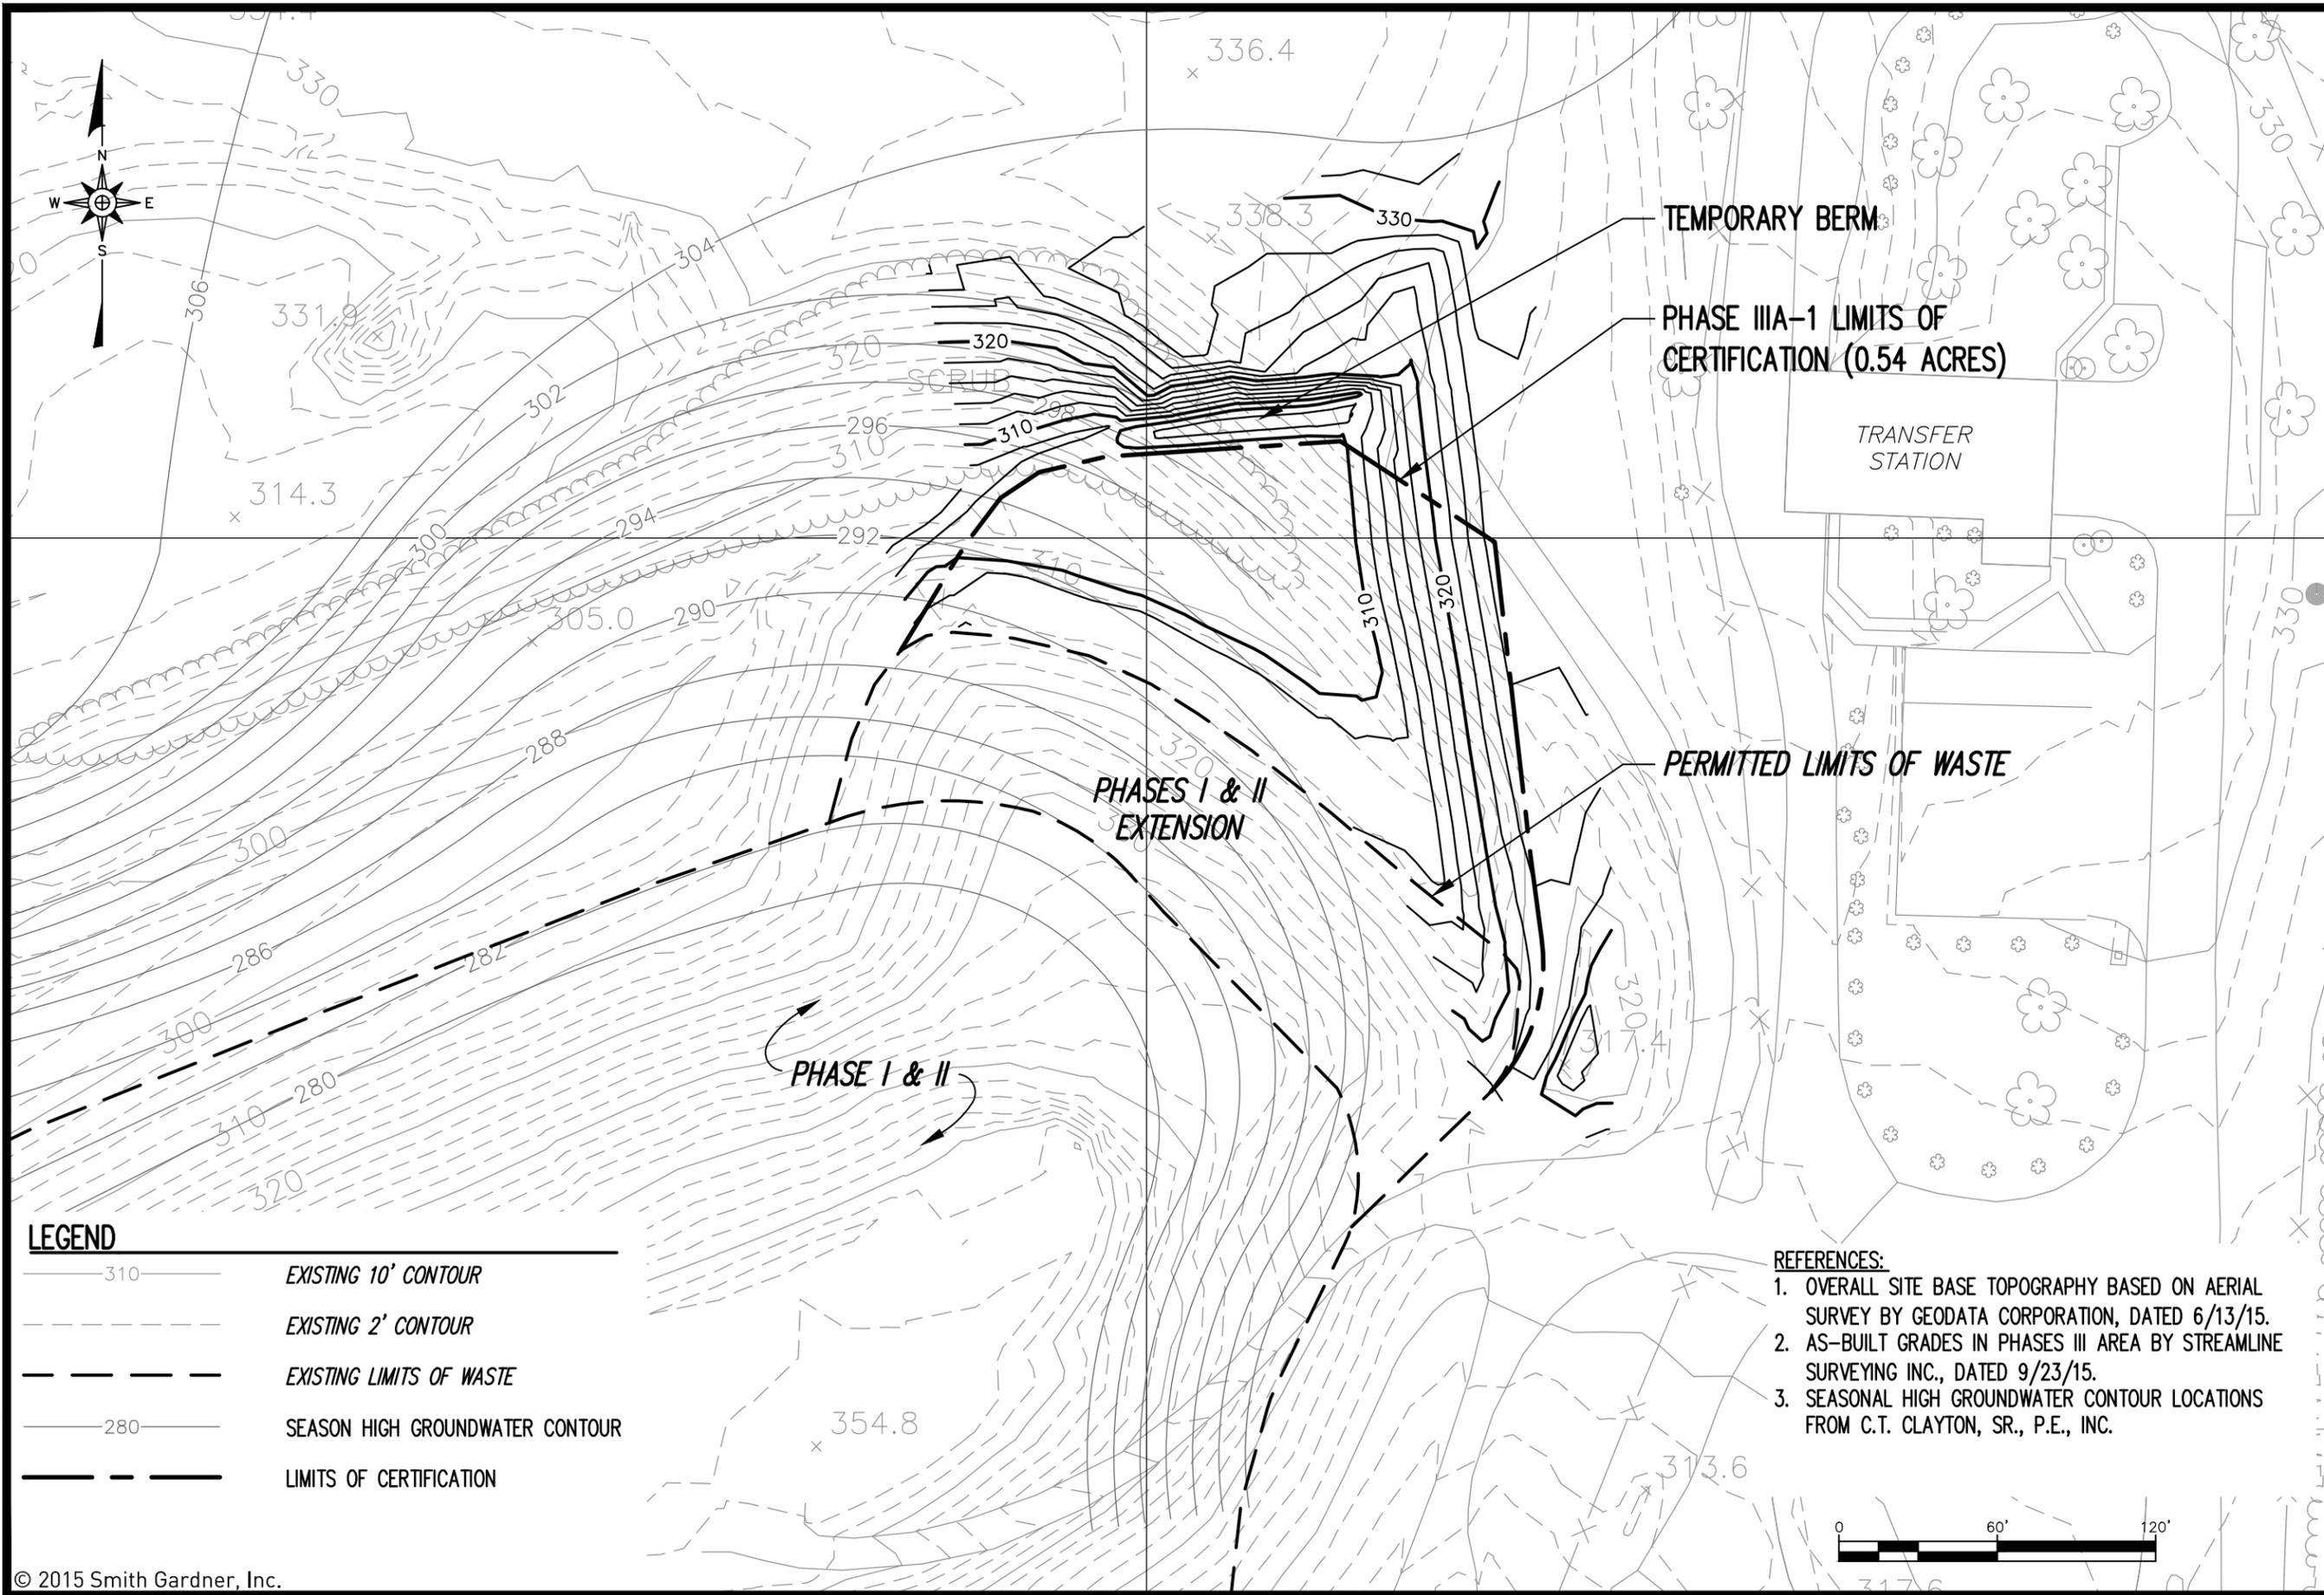
An as-built drawing showing completed subgrade elevations is provided in **Appendix D**.

- Subgrade (prepared by S+G using surveyed elevations by Streamline Land Surveying, Robert Godwin, PLS).
