FACILITY COMPLIANCE INSPECTION REPORT
Division of Waste Management
Solid Waste Section

UNIT TYPE:										
Lined MSWLF		NLCID		YWN		Transfer		Compost	SLAS	COUNTY: HAYWOOD PERMIT NO.: 4403-MSWLF-1982 FILE TYPE: COMPLIANCE
Closed MSWLF	X	HHW		White goods		Incineration		T&P	FIRM	
CDFL		Tire T&P / Collection		Tire Monofill		Closed Industrial Landfill		DEMO	SDTF

Haywood County Francis Farm Landfill
Francis Farm Road
Waynesville, NC

PURPOSE OF SITE VISIT: Comprehensive site inspection

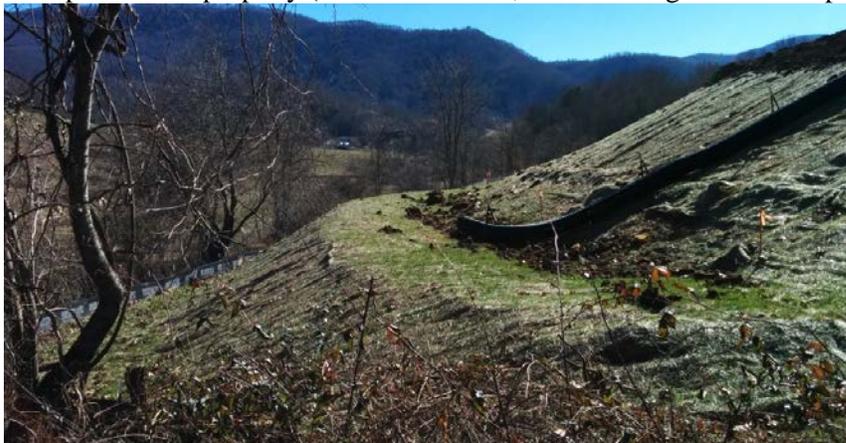
1/16/15

1. On site to conduct comprehensive facility inspection of the closed Francis Farm MSW landfill with Mr. Stephen King and Mr. Randy Siske. The facility is currently actively remediating for both groundwater and landfill gas issues. The proposed expansion of the compliance boundary (acorage) and future cap upgrade was underway at the time of the inspection. Soil from regional NCDOT road construction was being stockpiled at the property (NHM contractor, DOT oversight – with respect to erosion control measures).

Soil staging area

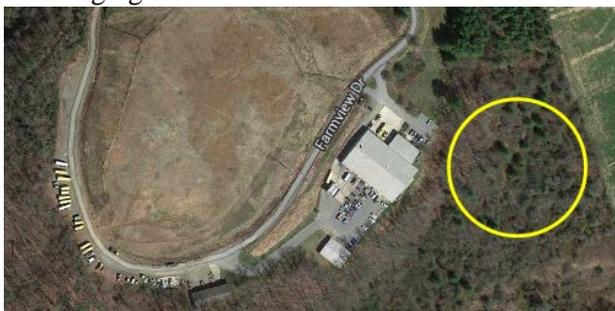
GoogleMaps

General location of the soil staging area with respect to the landfill and school maintenance building

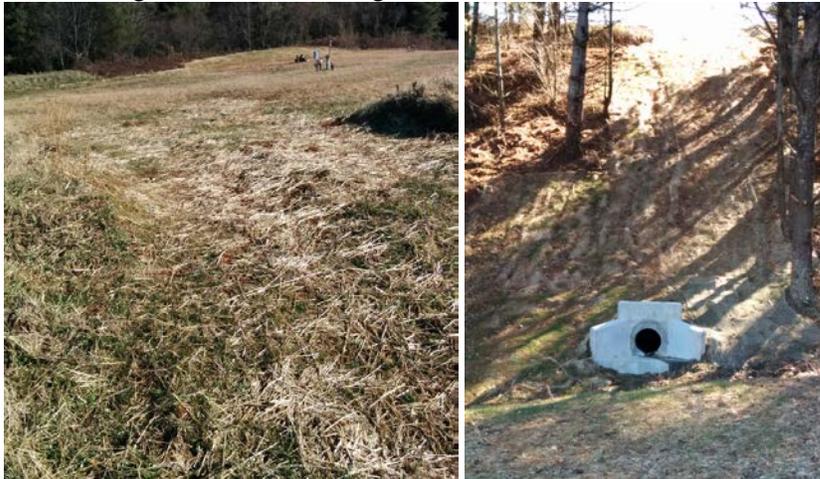
1/16/15

- The landfill cap was in good vegetative condition. Ongoing repairs to establish vegetation and manage settlement were visible. Erosion and sedimentation controls appeared maintained and in good condition. Significant work had been conducted to direct surface water off the cap of the closed landfill cell including a new drainage channel (below right).
