FACILITY COMPLIANCE INSPECTION REPORT
Division of Waste Management
Solid Waste Section

Date of Site Inspection: 1/16/2015

Town of Canton LCID Landfill
 Dutch Cove Road/SR 1854
 Canton, NC 28716

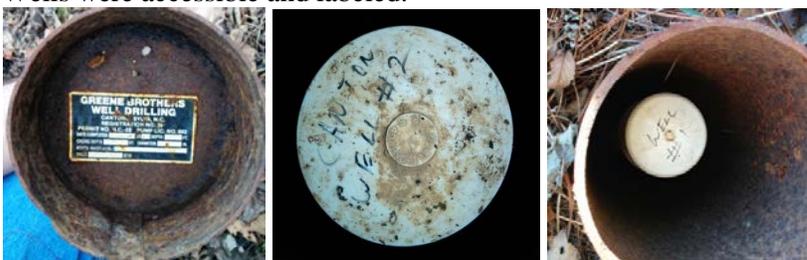
1/16/15

1. On site to conduct comprehensive site inspection with Mr. Gibson, Town of Canton Public Works, in conjunction with the N0136 site inspection. Site access was controlled and roads were in good condition.
2. Review of the facility parcel and records was conducted at the Town of Canton manager's office with Mr. Seth Hendler-Voss and Mr. Johnny Gibson prior to the site inspection. While current GIS (Haywood County GIS, PIN 8666-38-4094) indicates the landfill on one parcel, the associated monitoring well #2 is located on an adjacent tract (same deeded parcel, PIN 8666-48-2111).
3. Groundwater records were available at the courthouse and are reviewed by the Section hydrogeologist, Ervin Lane. Two monitoring wells are part of the approved groundwater monitoring network (MW-1 and MW-2). Wells were accessible and labeled.

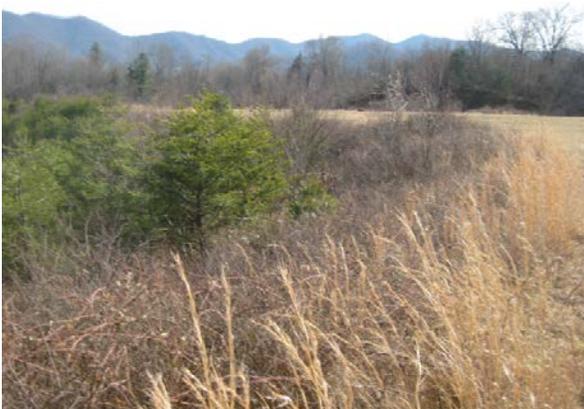
4. The previous inspection reports outlined the following:
While the edge of waste was not clearly defined, it appeared as though some small trees had taken root on the cap. This landfill was closed under the .0500 Rules and the Post-Closure General Condition #4 states that: the integrity and effectiveness of the final cover system and any permanent erosion control devices must be maintained. This could include making repairs to the cover as necessary to correct the effects of settlement, subsidence, erosion, or other events.

No clear EOW markers 2/21/13

Records review at the office indicated that the edge of waste extends down the slope shown above. Please work to remove the trees and establish clearly marked/labeled edge-of-waste (EOW) markers in order to meet the Rules and Post-Closure care requirements.

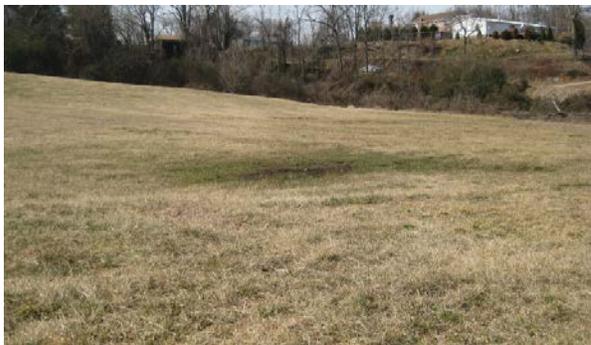
Settlement 2/21/13

The settlement shown above may not actually be over waste, based on the closure map review. However, best management practices for long-term maintenance of closed landfills would be to prevent any water intrusion into the waste cell. The map below is a rough estimate, based on the closure map, of the MSW footprint. The key area requiring EOW markers, settlement repair, and tree removal and cap maintenance is the “MSW unit” shown below. Please refer to your closure maps and site layout to accurately place the EOW markers.
