**FACILITY COMPLIANCE INSPECTION REPORT**  
**Division of Waste Management**  
**Solid Waste Section**

**Date of Site Inspection:** 3/18/2015, 3/25/15

Haywood County Municipal Solid Waste Landfill  
 State Road 1338, White Oak Community  
 Waynesville, N. C. 28786

Comprehensive Site Inspection

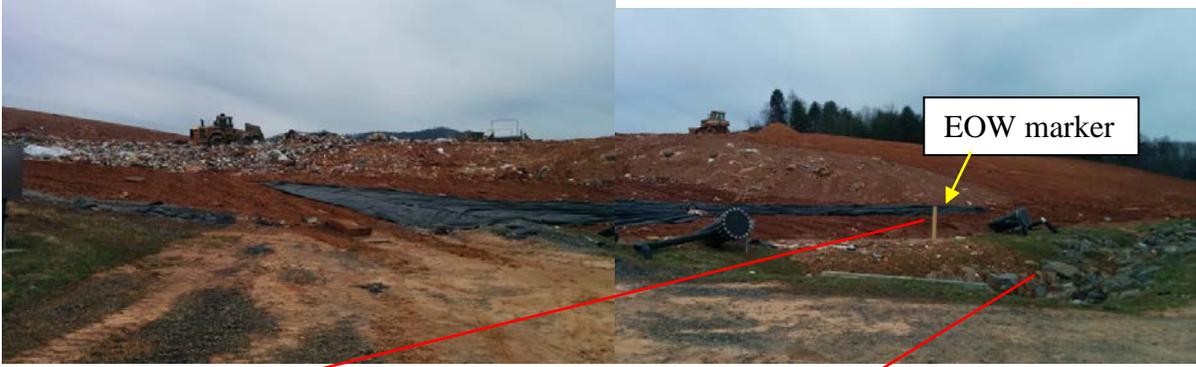
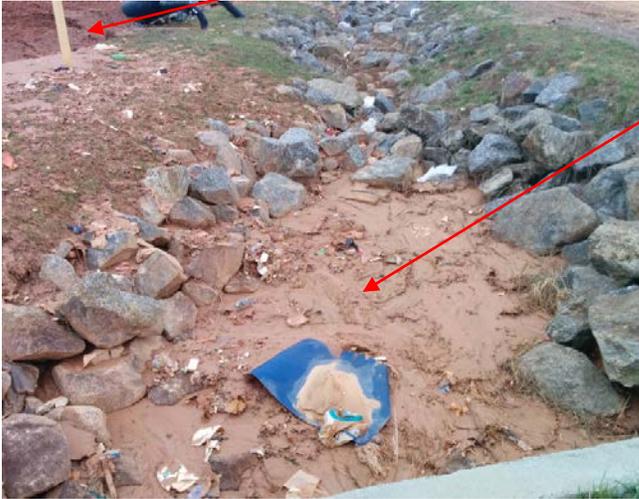
During the March 18, 2015, comprehensive landfill inspection, sediment containing waste had visibly flowed outside the lined limits of the Phase Three waste cell. The apparent leachate and sediment flow was observed in several ditches outside the liner system and waste particles reached the sediment basin below Phase Three.

3. The toe of the working face exhibited significant erosion, sediment movement, and waste movement (leachate flow) outside the lined Phase Three waste cell. This condition was brought to the attention of Mr. Gregg who contacted Mr. Preston for instructions on how to contain and begin repair of the area.

Waste and flow (leachate and sediment) past the EOW marker and in the surface water drainage channel.

**Santek Environmental of North Carolina, LLC and Haywood County are in violation of 15A NCAC 13B .1626 (8)(d) in that leachate was released outside of the lined disposal cell.**

To correct this violation, and come in compliance with 15A NCAC 13B .1626 (8)(d), the permit holders must investigate and determine the extent of the leachate release, as instructed by the Section compliance hydrogeologist. Further action may be required by the Division.

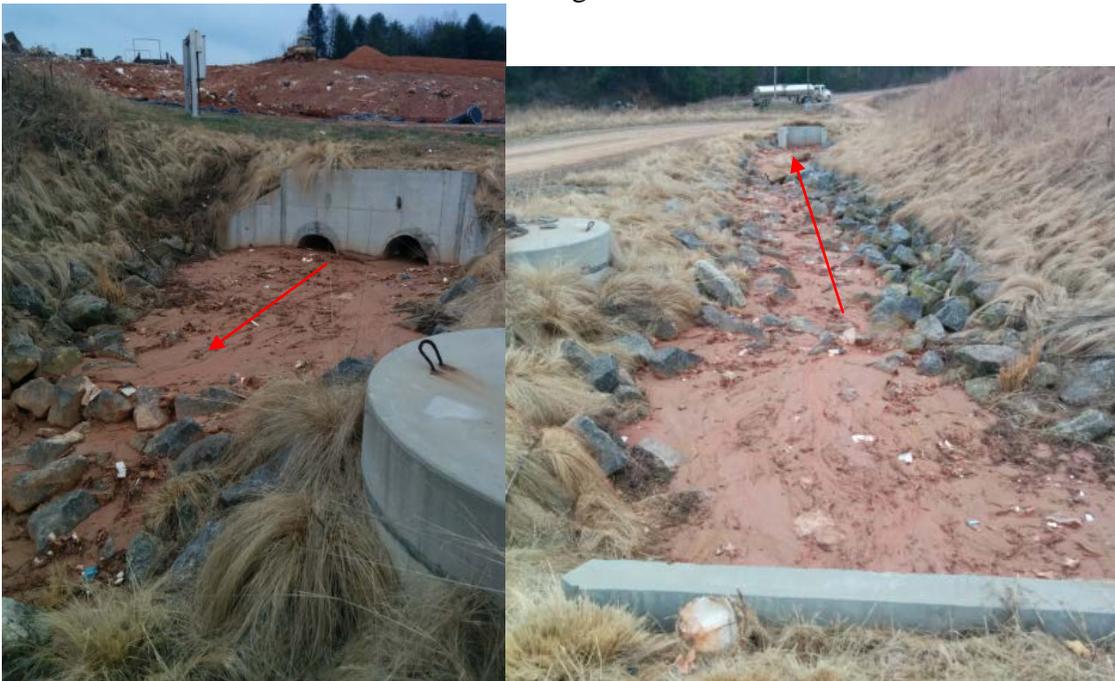
Continuing along channel.

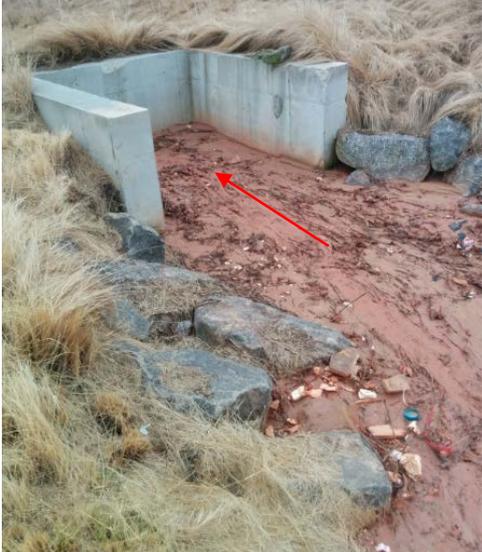
Entering a drainage point that discharges to a lower sediment basin.

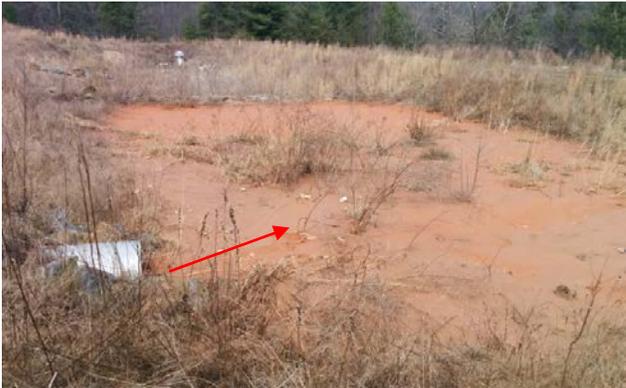
Lower sediment basin.

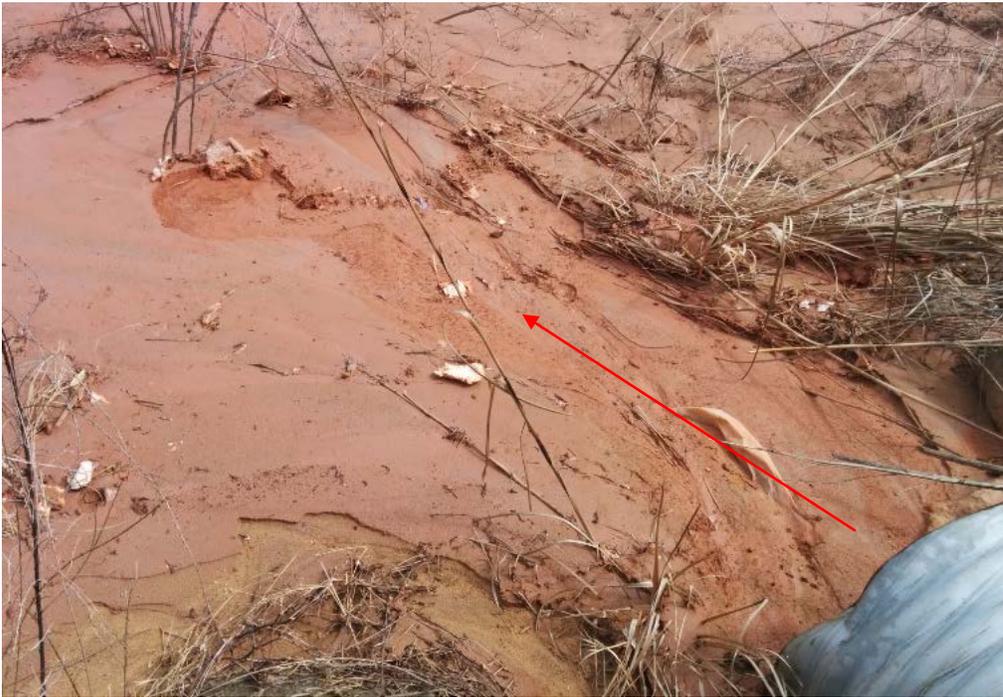
Waste visible.

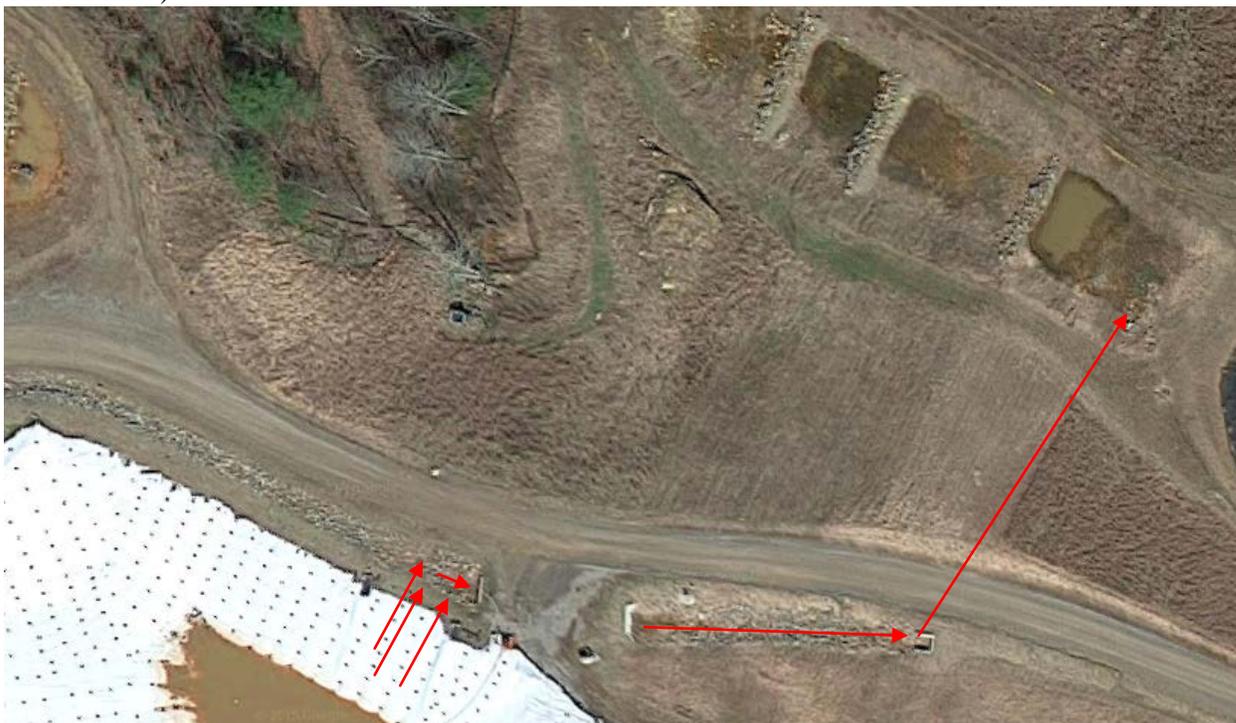
4. The path of the leachate, sediment, and waste flow is indicated below (Googlemap, older Phase Three Photo):

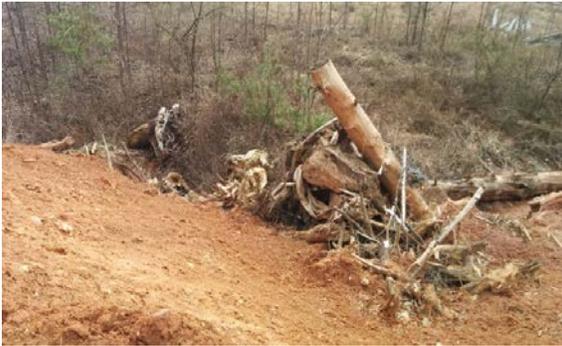
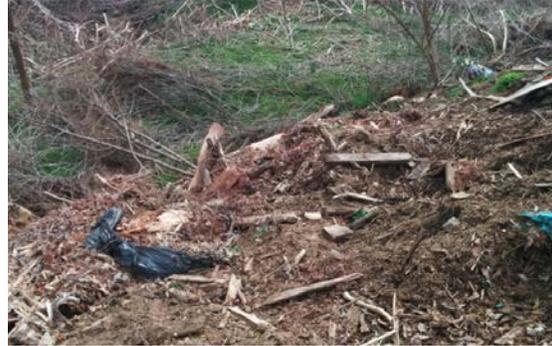
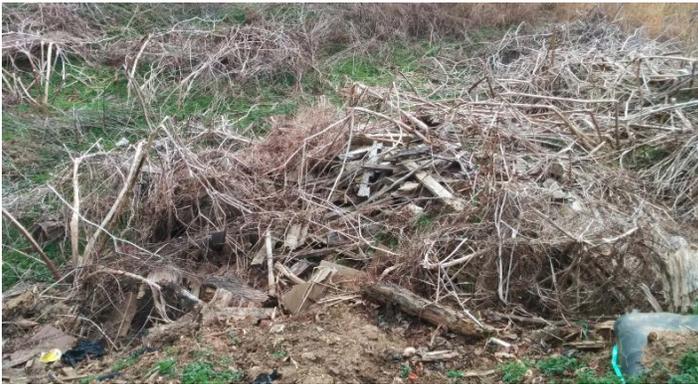
3/18/15 (all)

7. Land clearing materials, brush, etc. are accepted and staged for grinding at the facility. The material had recently been ground. Please note that some wood and vegetative material appeared to have been pushed down the sloped area of this location – this material must be removed and handled properly, including disposal where necessary. Some unacceptable material was noted in this area (painted wood, plastics) – this material must be removed, containerized, and disposed of at the working face.

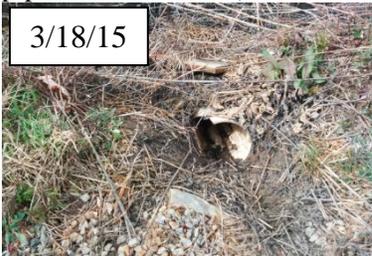
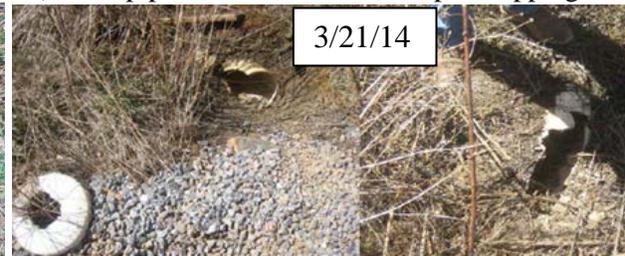
8. The closed C&D Landfill appeared to be maintained, vegetation was established and no significant erosion was noted. EOW markers were in place. During previous inspection in 2014, the damaged leachate cleanout pipe was discussed (with J. Preston). The pipe was still in need of repair/capping.

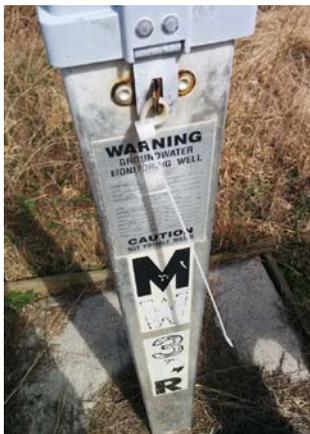
9. As part of the DEMLR inspection, sediment basins and erosion control measures were inspected and the history of the site was discussed in detail. The sediment basin on the western side of the property, north of the CDLF cell, has incurred some erosion damage. Please correct, repair, and maintain these features in accordance with the NCDENR DEMLR recommendations and requirements.
10. No issues were noted at the leachate collection pond. In the course of the inspection, several wells were observed, similar to the photo below, with zip-ties rather than locks. **Please see the “observed violation” section above for well-locking requirements.**

To correct this violation, and come in compliance with 15A NCAC 13B .1631 (b)(2), the permit holders must, within 30 days, ensure that all non-water supply wells, including temporary wells, are secured with locks/locked caps.

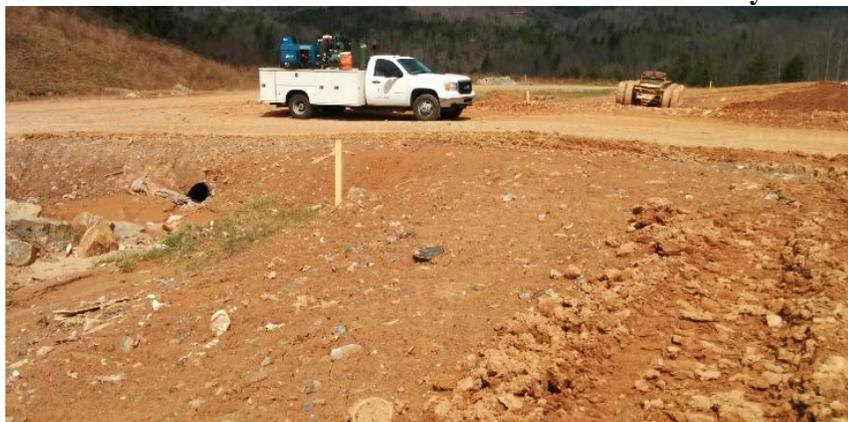
11. Further inspection of the working face and the intermediate slopes on Phase One were conducted with J. Preston present (after 2pm). The following items were discussed in detail:
- a. Due to the fill sequence and placement of soil beyond the EOW markers there were concerns about actual edge-of-waste. The records indicated (Ops Plan) that the liner is 9-feet interior to the EOW posts (yellow wood markers for this phase of the landfill). The photo below shows the access route for commercial vehicles, the EOW liner, and the soil mixed with waste (surface) crossing or potential crossing outside of the liner system. **Please work to correct this. All waste, buried, surficial, or windblown must be contained within the limits of the liner system.**

- b. The area below the working face was discussed. J. Preston stated that by the end of the day, the area would be contained with berms and check dam(s) in place and that they would work top down to the sediment basin. A. Keller noted that this was considered a violation (see “observed violation” section above) and that further instruction on possible remediation and/or sampling requirements would come from Mr. Ervin Lane.
- c. It appeared as though windblown waste issues were potentially becoming an issue for the facility.

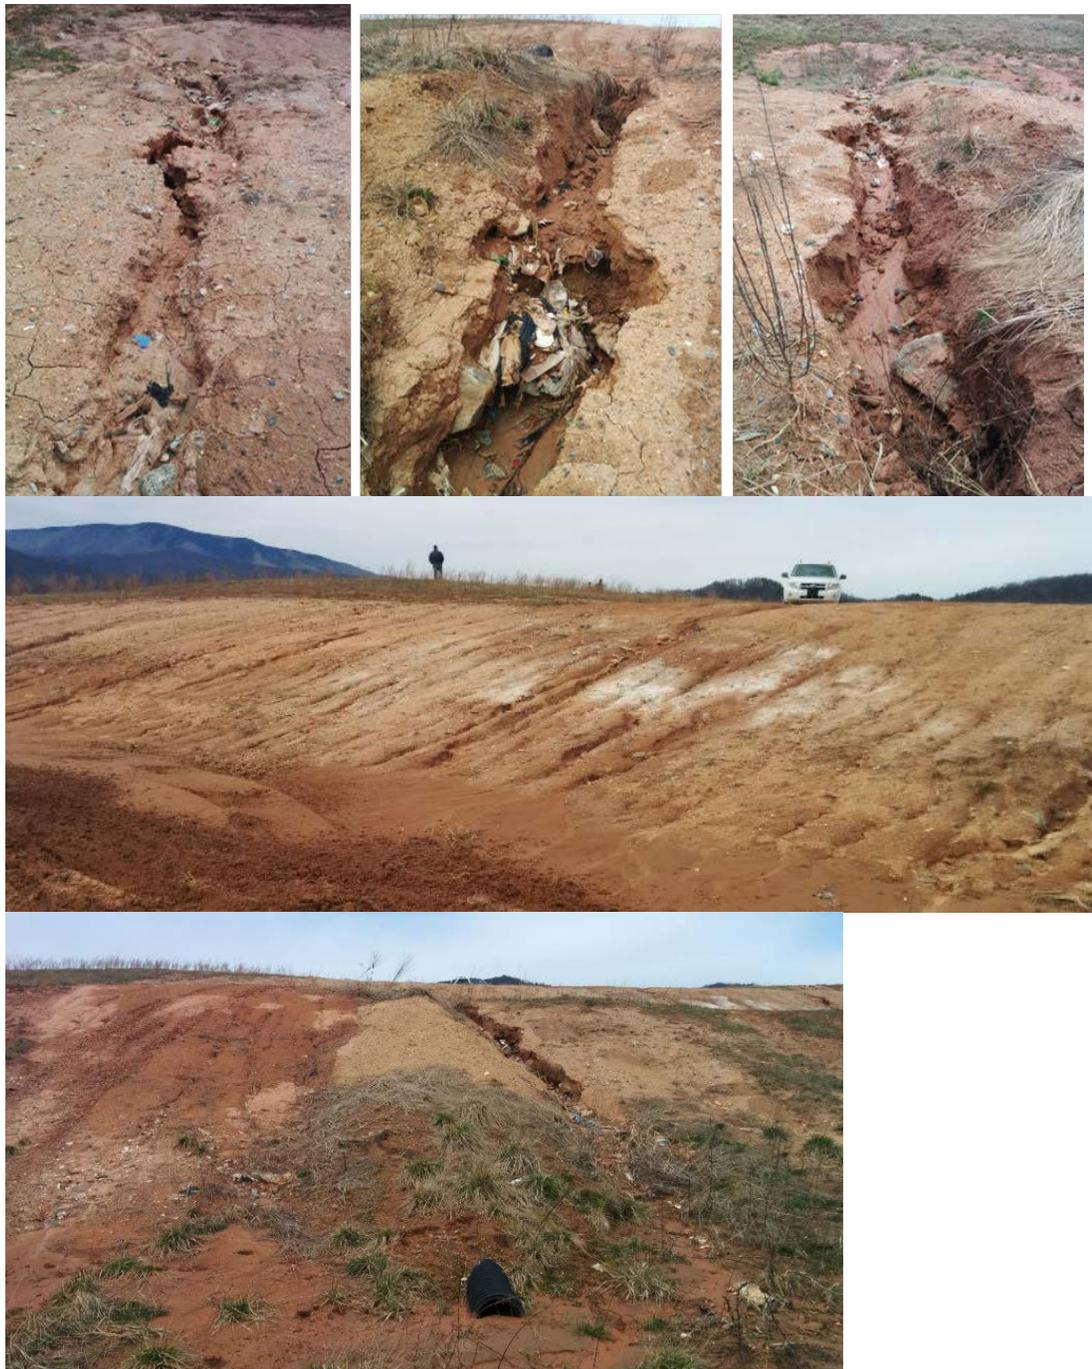
On March 18, 2015, during the comprehensive landfill inspection, areas of erosion and exposed wastes were observed on the Phase One intermediate cap.

**Santek Environmental of North Carolina, LLC and Haywood County are in violation of 15A NCAC 13B .1626(2)(c) for failure to maintain the minimum one foot of intermediate cover.**

- d.** The intermediate slope of the Phase One portion of the MSWLF exhibited significant erosion. In some areas the rills were deep enough to show exposed waste (see “observed violation” section above). Mr. Preston stated that the rills and exposed waste would be covered by the end of day – this area was addressed immediately and some repairs were observed prior to leaving the site. **These areas, along with other areas along the top and sides of Phase One, require significant attention and improved vegetative cover.**

To correct this violation, and come in compliance with 15A NCAC 13B .1631 (2)(c), the permit holders must, within 30 days, repair the Phase One intermediate slopes exhibiting significant cap erosion, and establish vegetation to restrain future erosion of the cap.
