**FACILITY COMPLIANCE INSPECTION REPORT**  
**Division of Waste Management**  
**Solid Waste Section**

**Date of Site Inspection:** 7/2/2014, 8/21/2014

Haywood County Municipal Solid Waste Landfill  
 State Road 1338, White Oak Community  
 Waynesville, N. C. 28786

July 2, 2014: Resolution of Notice of Violation/Partial Site Inspection  
 August 21, 2014: Fire Occurrence/Partial Site Inspection

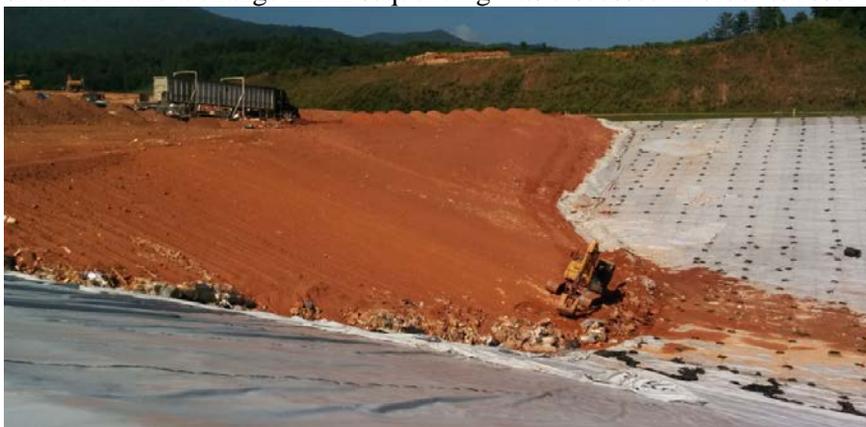
7/2/15

3. Sediment and erosion control features were inspected and no issues were noted. Access roads were functional and minimal windblown was noted.
4. During the inspection the working face/active phase of the landfill was inspected and discussed with J. Preston. The facility was experience erosion and sediment movement into the surface water drainage portion of the cell and a change in fill sequencing was discussed in order to resolve this issue.

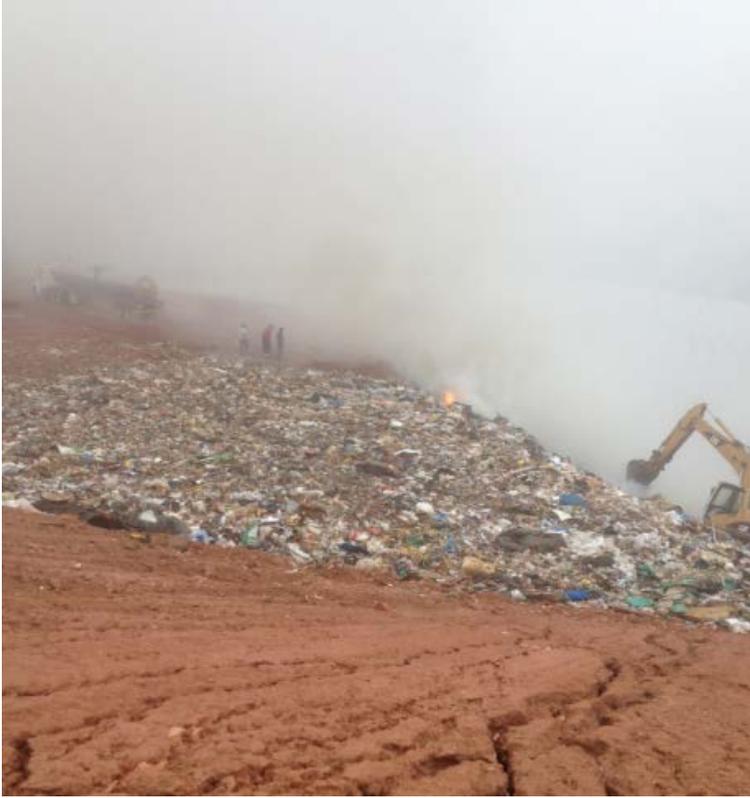
Photo provided by SKing.

5. On August 21, 2014, a partial facility inspection was conducted following the reporting of a landfill fire. The Section was notified by 8:30 a.m. and the fire was contained (per J. Preston) by approximately 9:30 a.m. The region of the working face where the fire had occurred was utilizing tarps (approved ACM) – it appeared to be a surficial fire.

- The Fire Occurrence Notification report was received by the Section on August 27, 2014. No specific cause for the fire was determined. Report is on file with the Section.
