# LANDFILL GAS REMEDIATION PLAN – PHASE 2

Closed Henderson County Municipal Solid Waste  
Landfill, Permit No. 45-01

Henderson County, North Carolina

January 2015

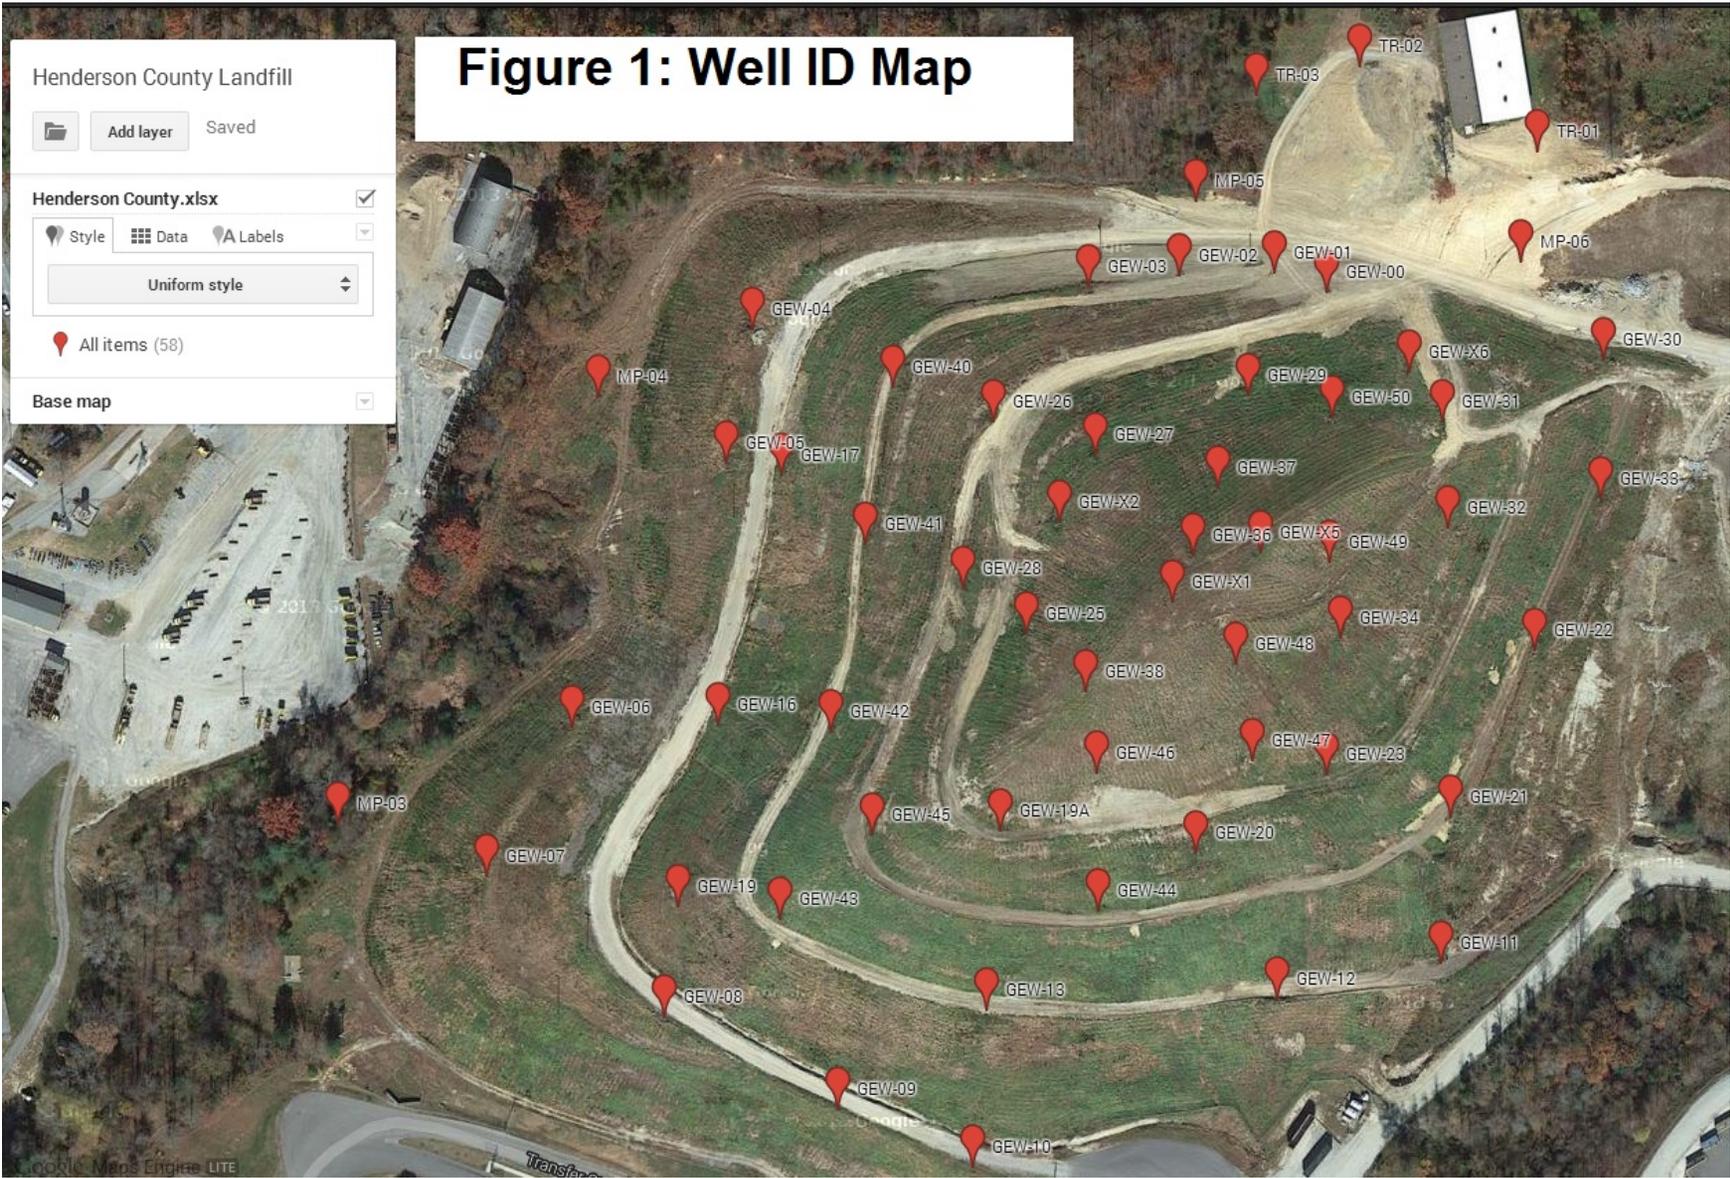
# Figure 1: Well ID Map

The Golder technician monitored the gas quality at each wellhead and methane probe using a Landtec GEM2000 following standard monitoring techniques between September 16<sup>th</sup> and 18<sup>th</sup>, 2013. The technician also recorded latitude and longitude, liquid levels, well construction information, wellhead information, lateral information, notes and observations, and a photo for each well. The tabulated results can be found in Table 1. A map of the wellfield with an overlay of the well identifications can be found on Figure 1. Field photos are included as Appendix A.

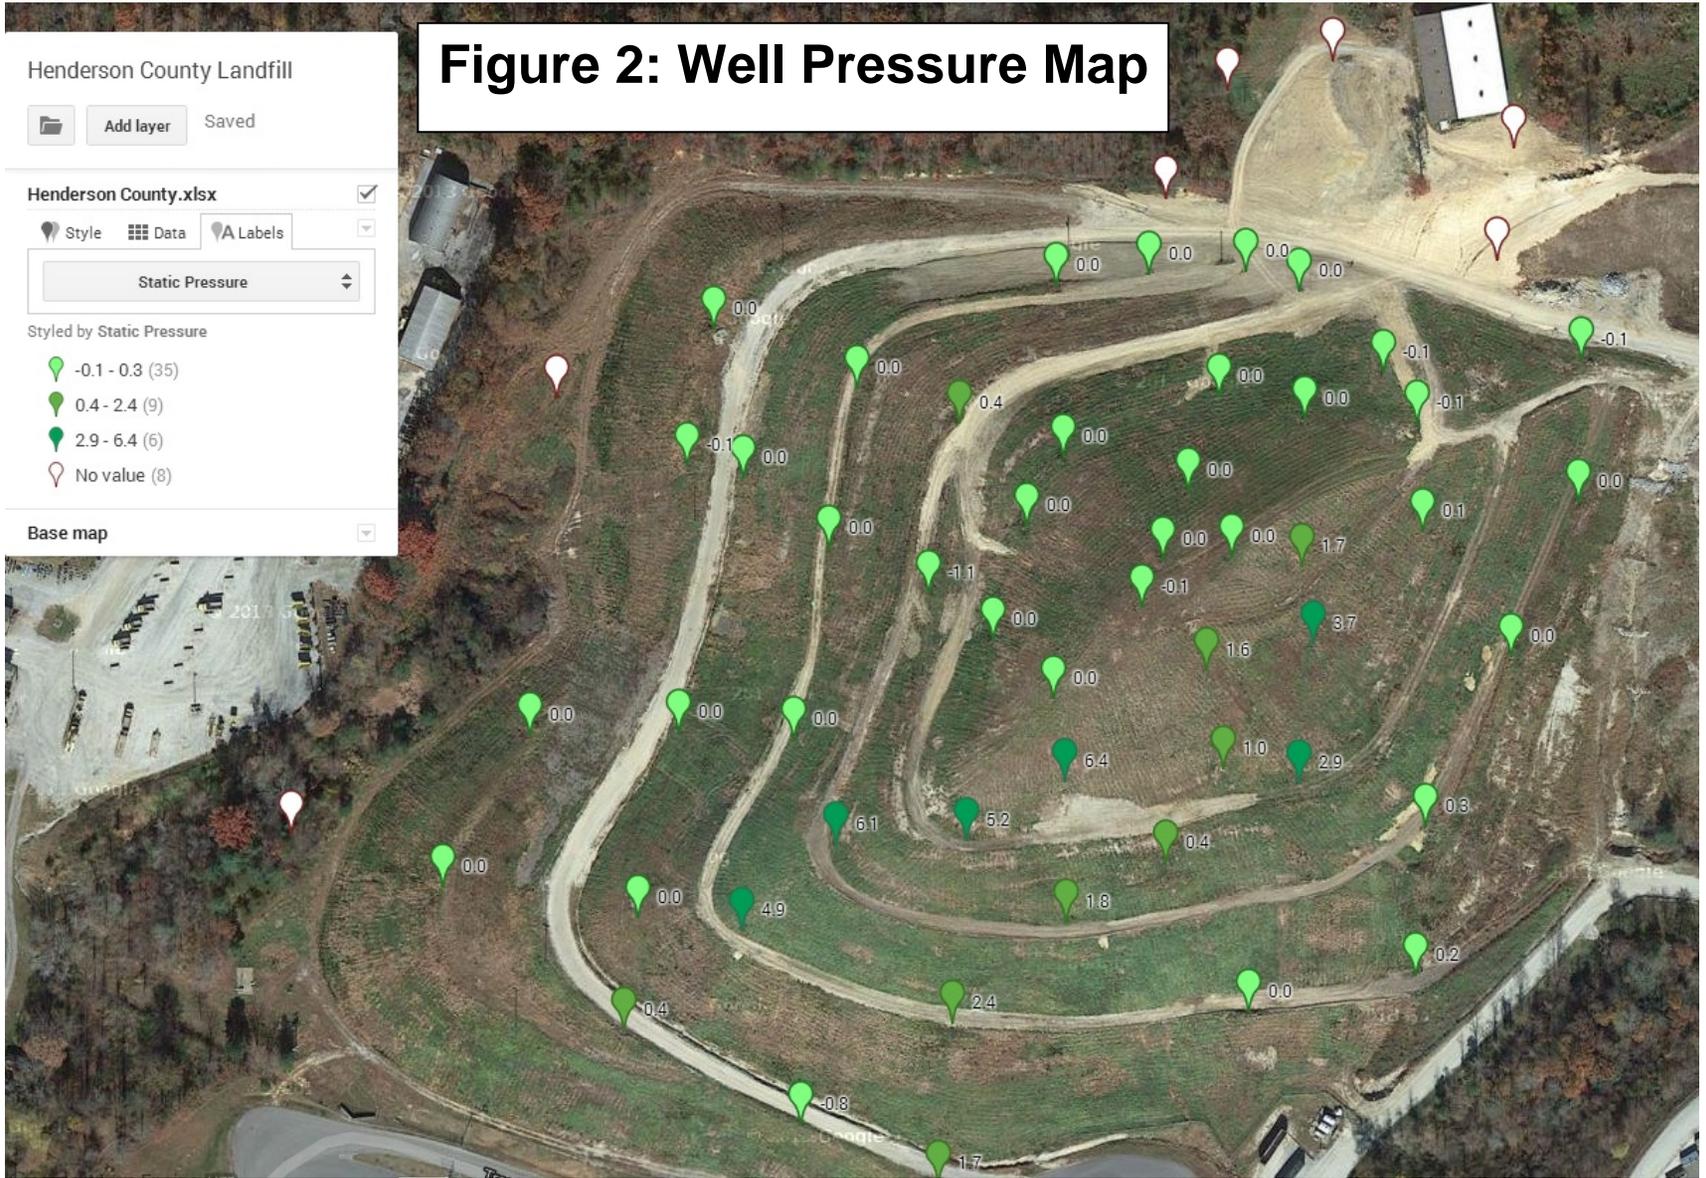
# Figure 2: Well Pressure Map

Wellhead pressures are provided as an overlay of the wellfield map in Figure 2. The majority of the wells (32 out of the 50, or 64%) had either slightly negative (7 wells) or a '0' pressure reading (25 wells). A small number (6) had a wellhead pressure between 0" and 1", while the remaining 12 wells had a positive pressure greater than 1". The wells with these slightly elevated positive pressures are fairly concentrated into groups, mainly around the top and southern slope of the landfill; most likely these are the areas containing the newest waste. The average wellhead pressure across the wellfield was 0.8" with a maximum wellhead pressure of 6.4" at GEW-46 (58.7% methane) and a minimum pressure of -1.1" at GEW-28 (0.4% methane). Considering the amount of time between the removal of the active collection system and these readings (approximately 5 months), these numbers indicate a very low gas production rate. In our experience, in active landfills that are in a more productive phase of their gas generation

curve, it is not unheard of to see wells with very large positive pressures when they have been removed from the collection system for as little as a few hours.

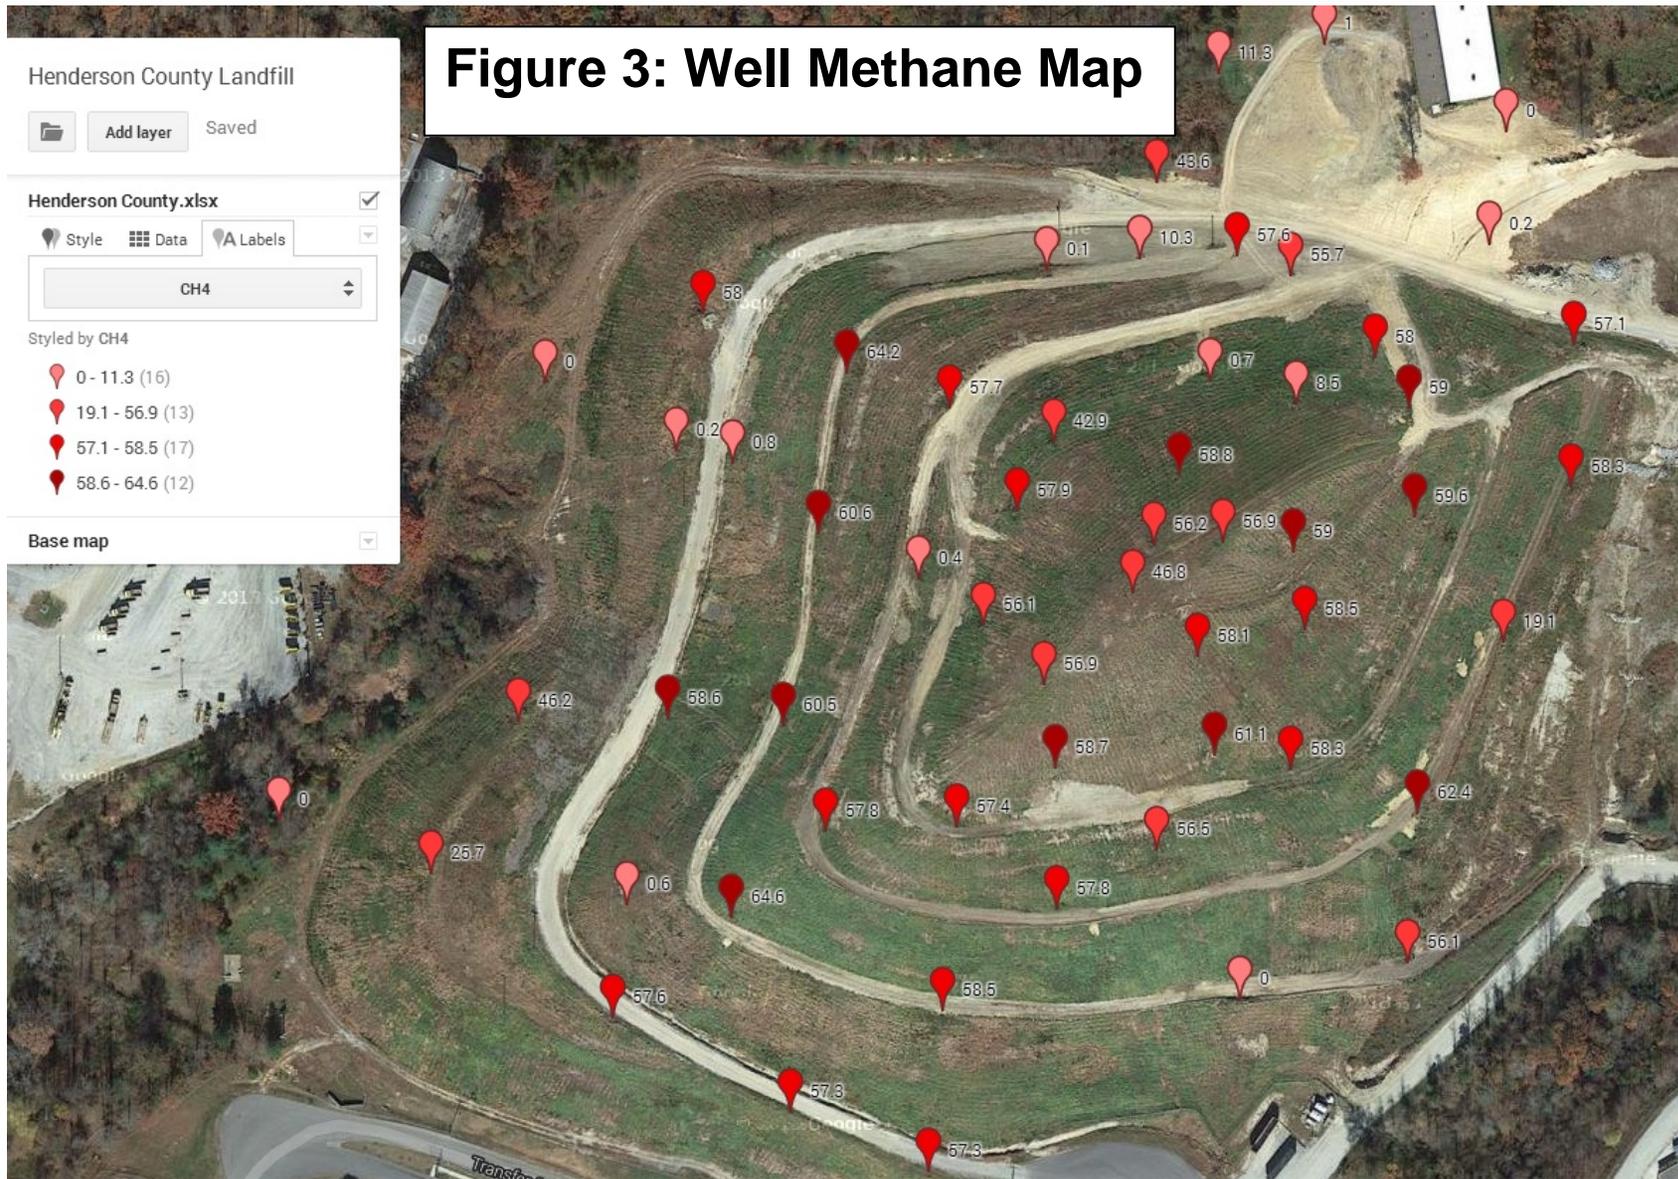
# Figure 3: Well Methane Map

Wellhead methane concentrations are provided as an overlay of the wellfield map in Figure 3. Methane concentrations are fairly uniform and elevated across the wellfield with no obvious patterns or groupings. The average wellhead methane concentration is 46%, with minimum readings of less than 1% at 7 wells and maximum readings above 60% at 6 wells. A total of 36 wells, or 72% of the wellfield, are above 50% methane; although, as noted above, only 12 of these wells have a positive wellhead pressure of 1" or greater. These methane readings are fairly typical for an active gas collection system; however, by themselves do not indicate a need for an active system. When viewed in light of the pressure readings noted above, these methane levels are likely not sustainable and are probably due to stagnant gas accumulating in the well casings.

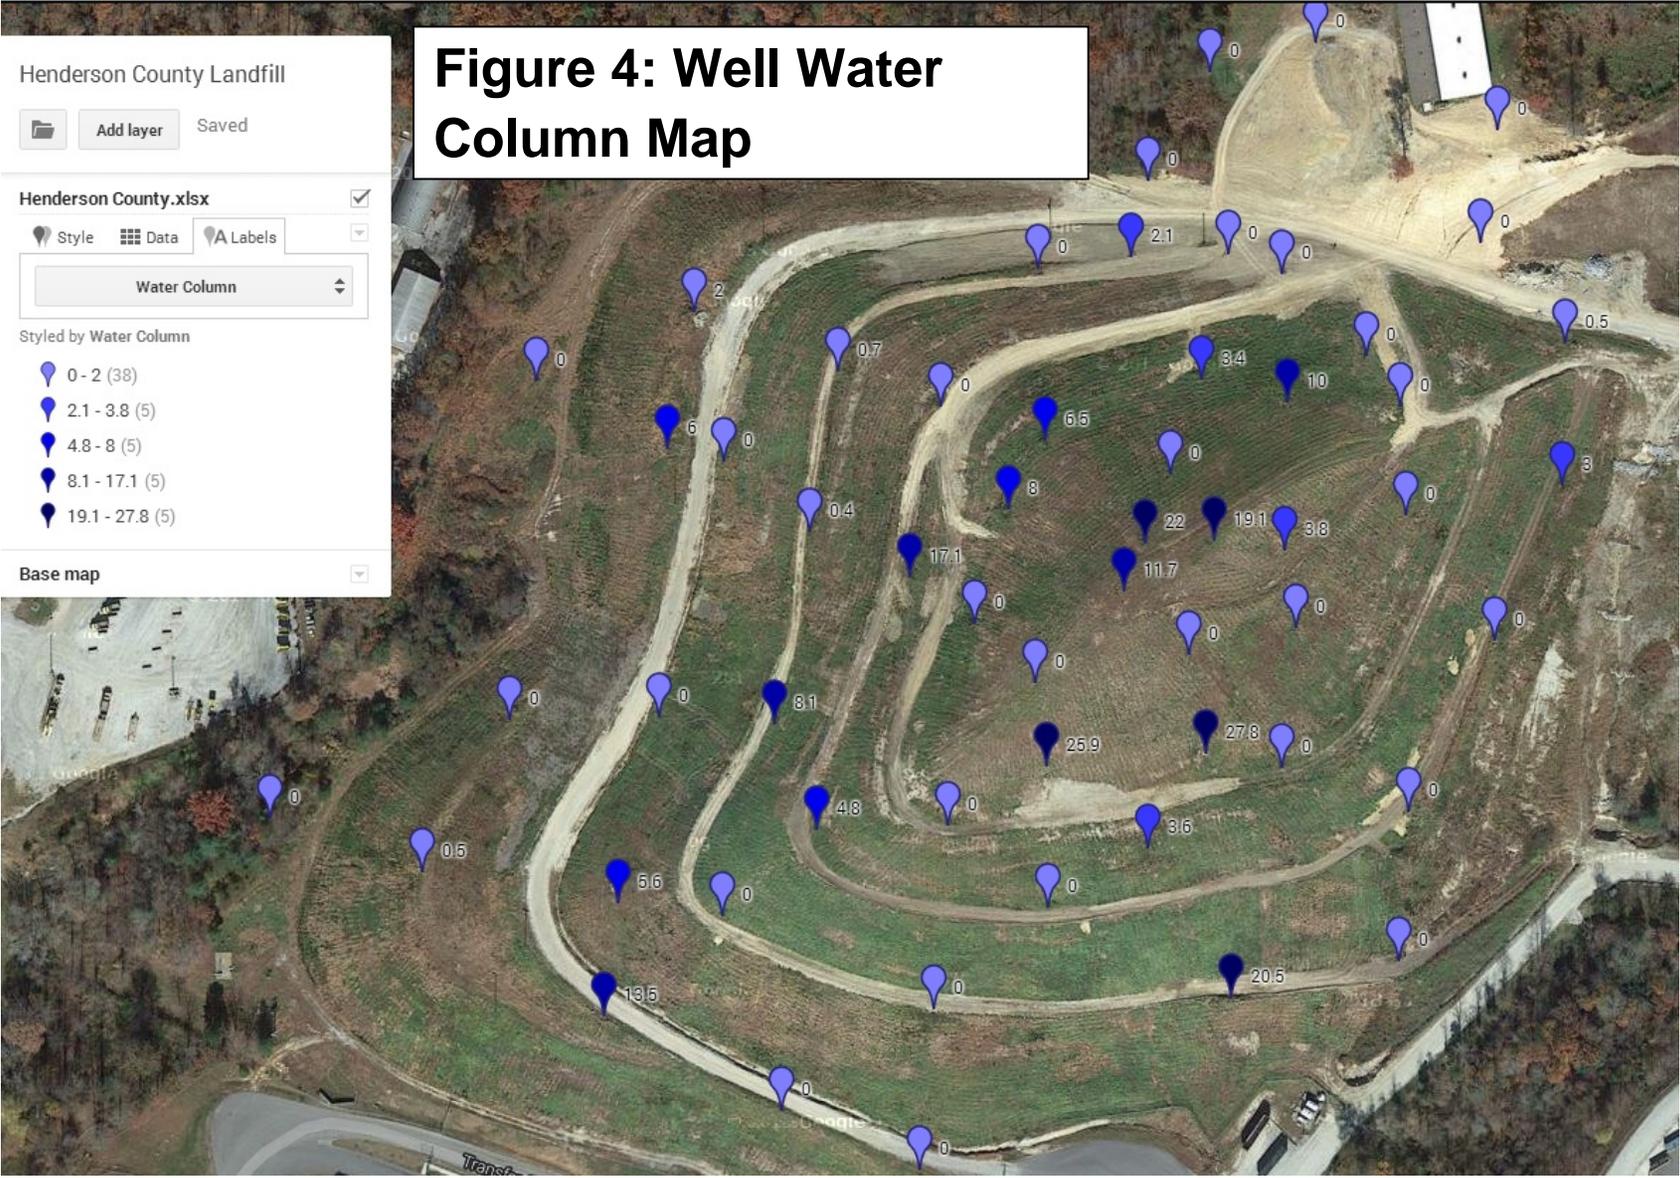
PROJECT No.	Phase	Rev	FIGURE
0839650614	500	0	4

Well water column depths are provided as an overlay of the wellfield map in Figure 4. Water column depths were calculated as the difference between depth to liquid and depth to refusal (well bottom or obstruction). The largest water columns tend to be in wells at the higher elevations and toward the center of the landfill. These data are difficult to interpret without additional information such as as-built depths, depth to screen and screen length; but based on the fact that the majority of the wells (44, or 88%) have less than 5 feet of water column it is likely that liquids are not a limiting factor on collection potential.

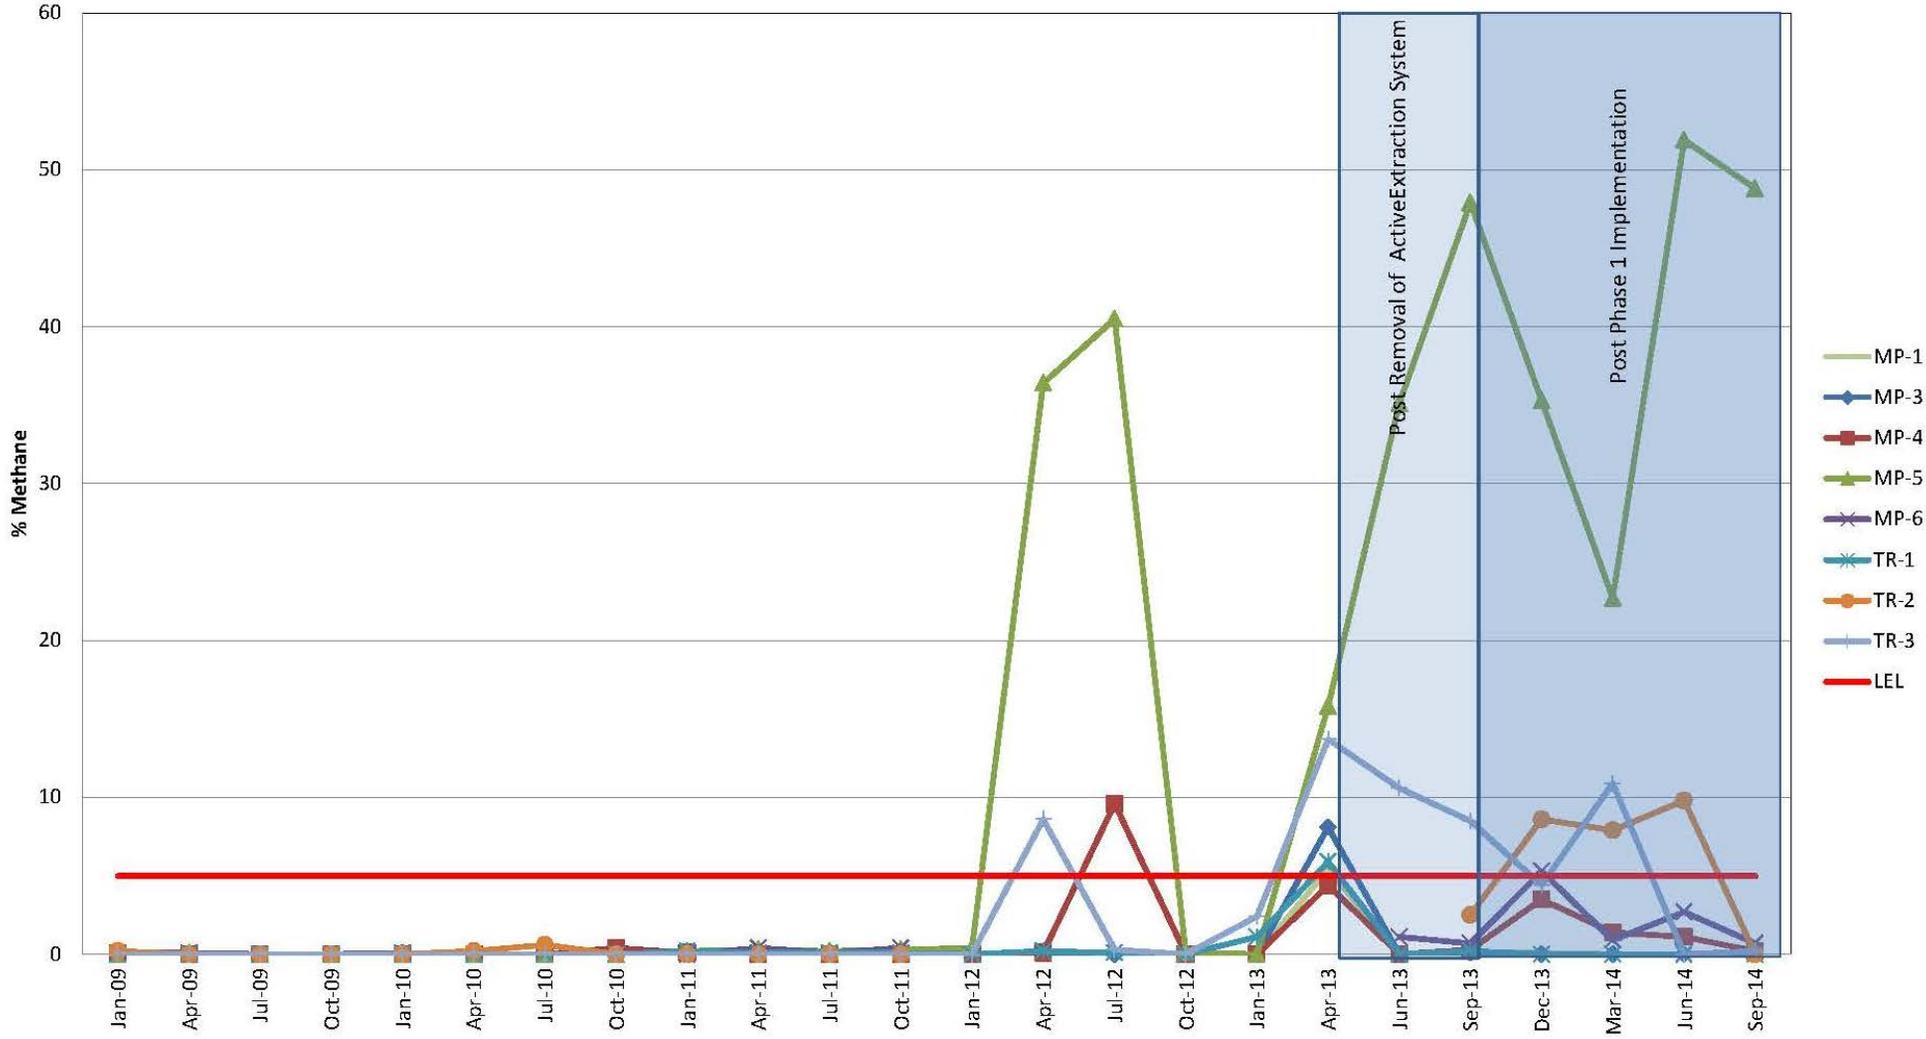
TITLE  
METHANE CONCENTRATION TREND GRAPH

Methane levels at most methane monitoring wells have been routinely at or near zero percent before and after the removal of the active LFG extraction system (Table 2 and Figure 5). The most consistent methane readings are from well MP-5, which have ranged from 15.8% and 51.9% since the active extraction system was removed in April 2013. Methane readings had ranged from 0% to 40.5% when the LFG extraction system was operational.

Well TR-3 has had methane readings that have ranged from 0% to 13.7% since the extraction system was removed with readings exceeding the LEL on four occasions during that time span. Methane

readings have been below the LEL during the last two quarterly events. Methane readings had ranged from 0% to 8.6% when the LFG extraction system was operational.

Well TR-2 has had methane readings that have ranged from 0% to 9.8% since the well was located and repaired prior to the September 2013 event with readings exceeding the LEL on three occasions during that time span. Prior to that event the well had been broken off near ground surface and could not be located. Methane was not reported in TR-2 during the most recent event in September 2014.

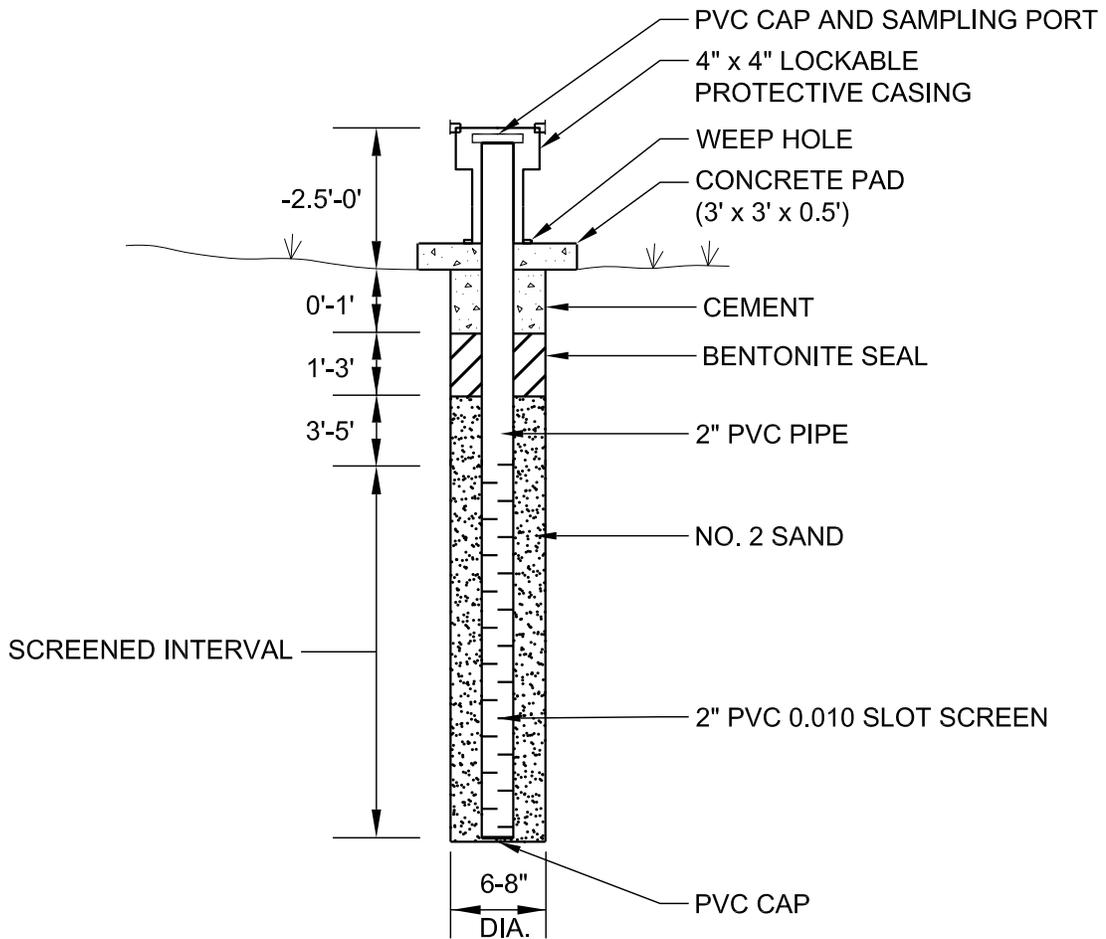
The methane monitoring wells will be constructed to a depth equivalent to the top of bedrock unless groundwater is encountered above bedrock. If groundwater is encountered above bedrock, the wells will be installed approximately 5 feet above the static water level to account for seasonal high water level fluctuations. Groundwater is expected to be encountered above bedrock at each location. The wells will be constructed of 2-inch PVC with 0.010-inch slotted screen from the bottom of the well up to 5 feet below ground surface. A coarse, clean sand will be used to fill the annular space to approximately 2 feet above the screen. An approximately 2-foot thick bentonite seal will be placed above the sand. The remaining annular space will be filled with a cement mixture. The surface completion of each gas probe will consist of a 3 feet by 3 feet by 0.5 feet concrete well apron and a locking protective casing. The top of the PVC riser will be equipped a well cap with a stopcock valve or quick connect coupling.

1. PLACE PEA GRAVEL IN ANNULAR SPACE BETWEEN PVC STICK UP AND PROTECTIVE CASING.
2. THE LANDFILL GAS MONITORING WELL WILL BE CONSTRUCTED AT THE TOP OF BEDROCK UNLESS GROUNDWATER IS ENCOUNTERED ABOVE BEDROCK.
3. IF GROUNDWATER IS ENCOUNTERED ABOVE BEDROCK, THE LANDFILL GAS MONITORING WELL WILL BE INSTALLED APPROXIMATELY 5 FEET ABOVE THE STATIC WATER LEVEL TO ACCOUNT FOR SEASONAL HIGH WATER LEVEL FLUCTUATIONS.

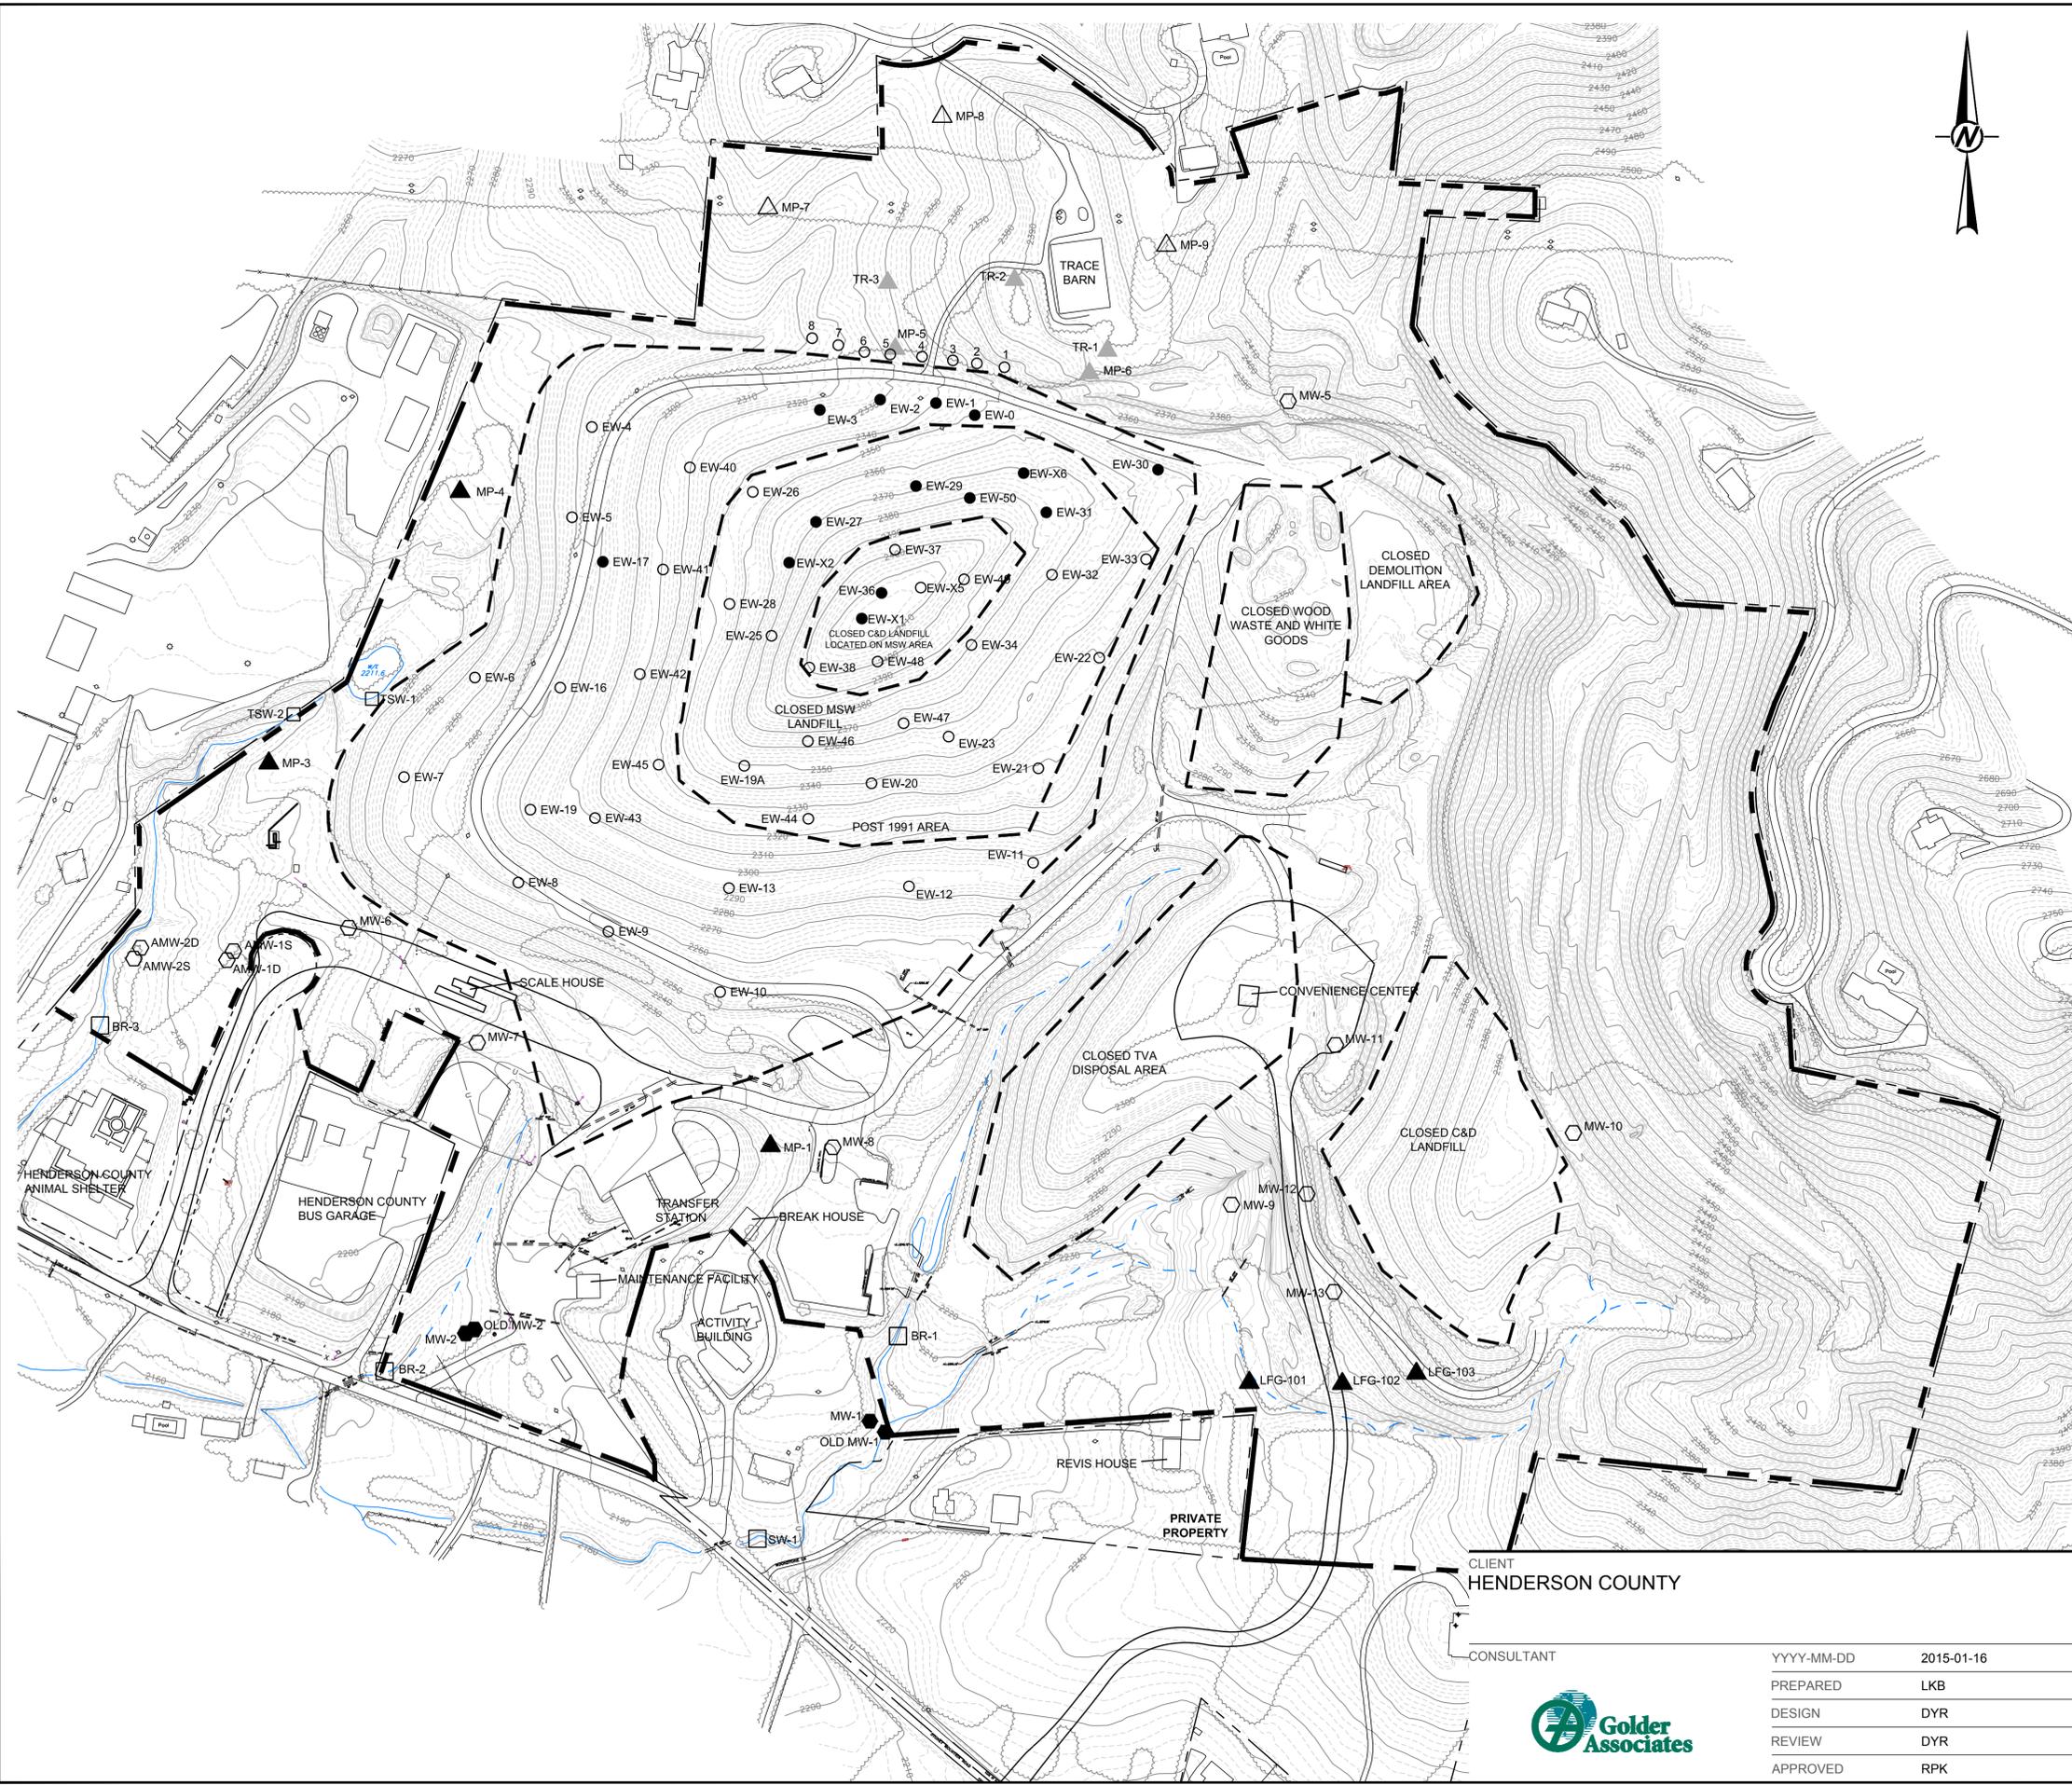
TITLE  
**LANDFILL GAS EXTRACTION SYSTEM LAYOUT AND  
PROPOSED METHANE MONITORING NETWORK**

As part of Phase 1, 14 LFG extraction wells were disconnected from the extraction header pipe and turbine vents were installed to each (Drawing 1). It is proposed that the remaining 46 vents be disconnected from the extraction header pipe and either have turbine vents installed or have the LFG extraction wells topped with 'candy canes' style passive vent pipes to allow the remaining wells to passively vent and prevent the buildup of LFG in the waste unit.

As discussed in Section 4.0, methane monitoring well MP-5 has had methane readings since the removal of the LFG extraction system that have ranged from 15.8% to 51.9%. As shown on Drawing 1, MP-5 is located in closed proximity to the edge of waste or possibly in waste and therefore, is not a viable monitoring point. This well should be removed from the compliance network and a turbine vent should be installed and allowed to passively vent to help prevent migration of methane toward the property boundary.

In addition to removing methane monitoring well MP-5 from the methane monitoring network, wells MP-6, TR-1, TR-2, and TR-3 will also be removed from the compliance network. These five methane monitoring wells will be replaced by three new wells designated as MP-7, MP-8, and MP-9. These wells will be located closer to the northern facility (compliance) boundary and further away from the waste unit as shown on Drawing 1. Wells MP-6, TR-2, and TR-3 will continue to be monitored as assessment monitoring points during the quarterly events to help determine if remediation efforts are helping reduce methane concentrations, but will not be part of the compliance monitoring network. Well TR-1 will be abandoned due to its close proximity to MP-6.

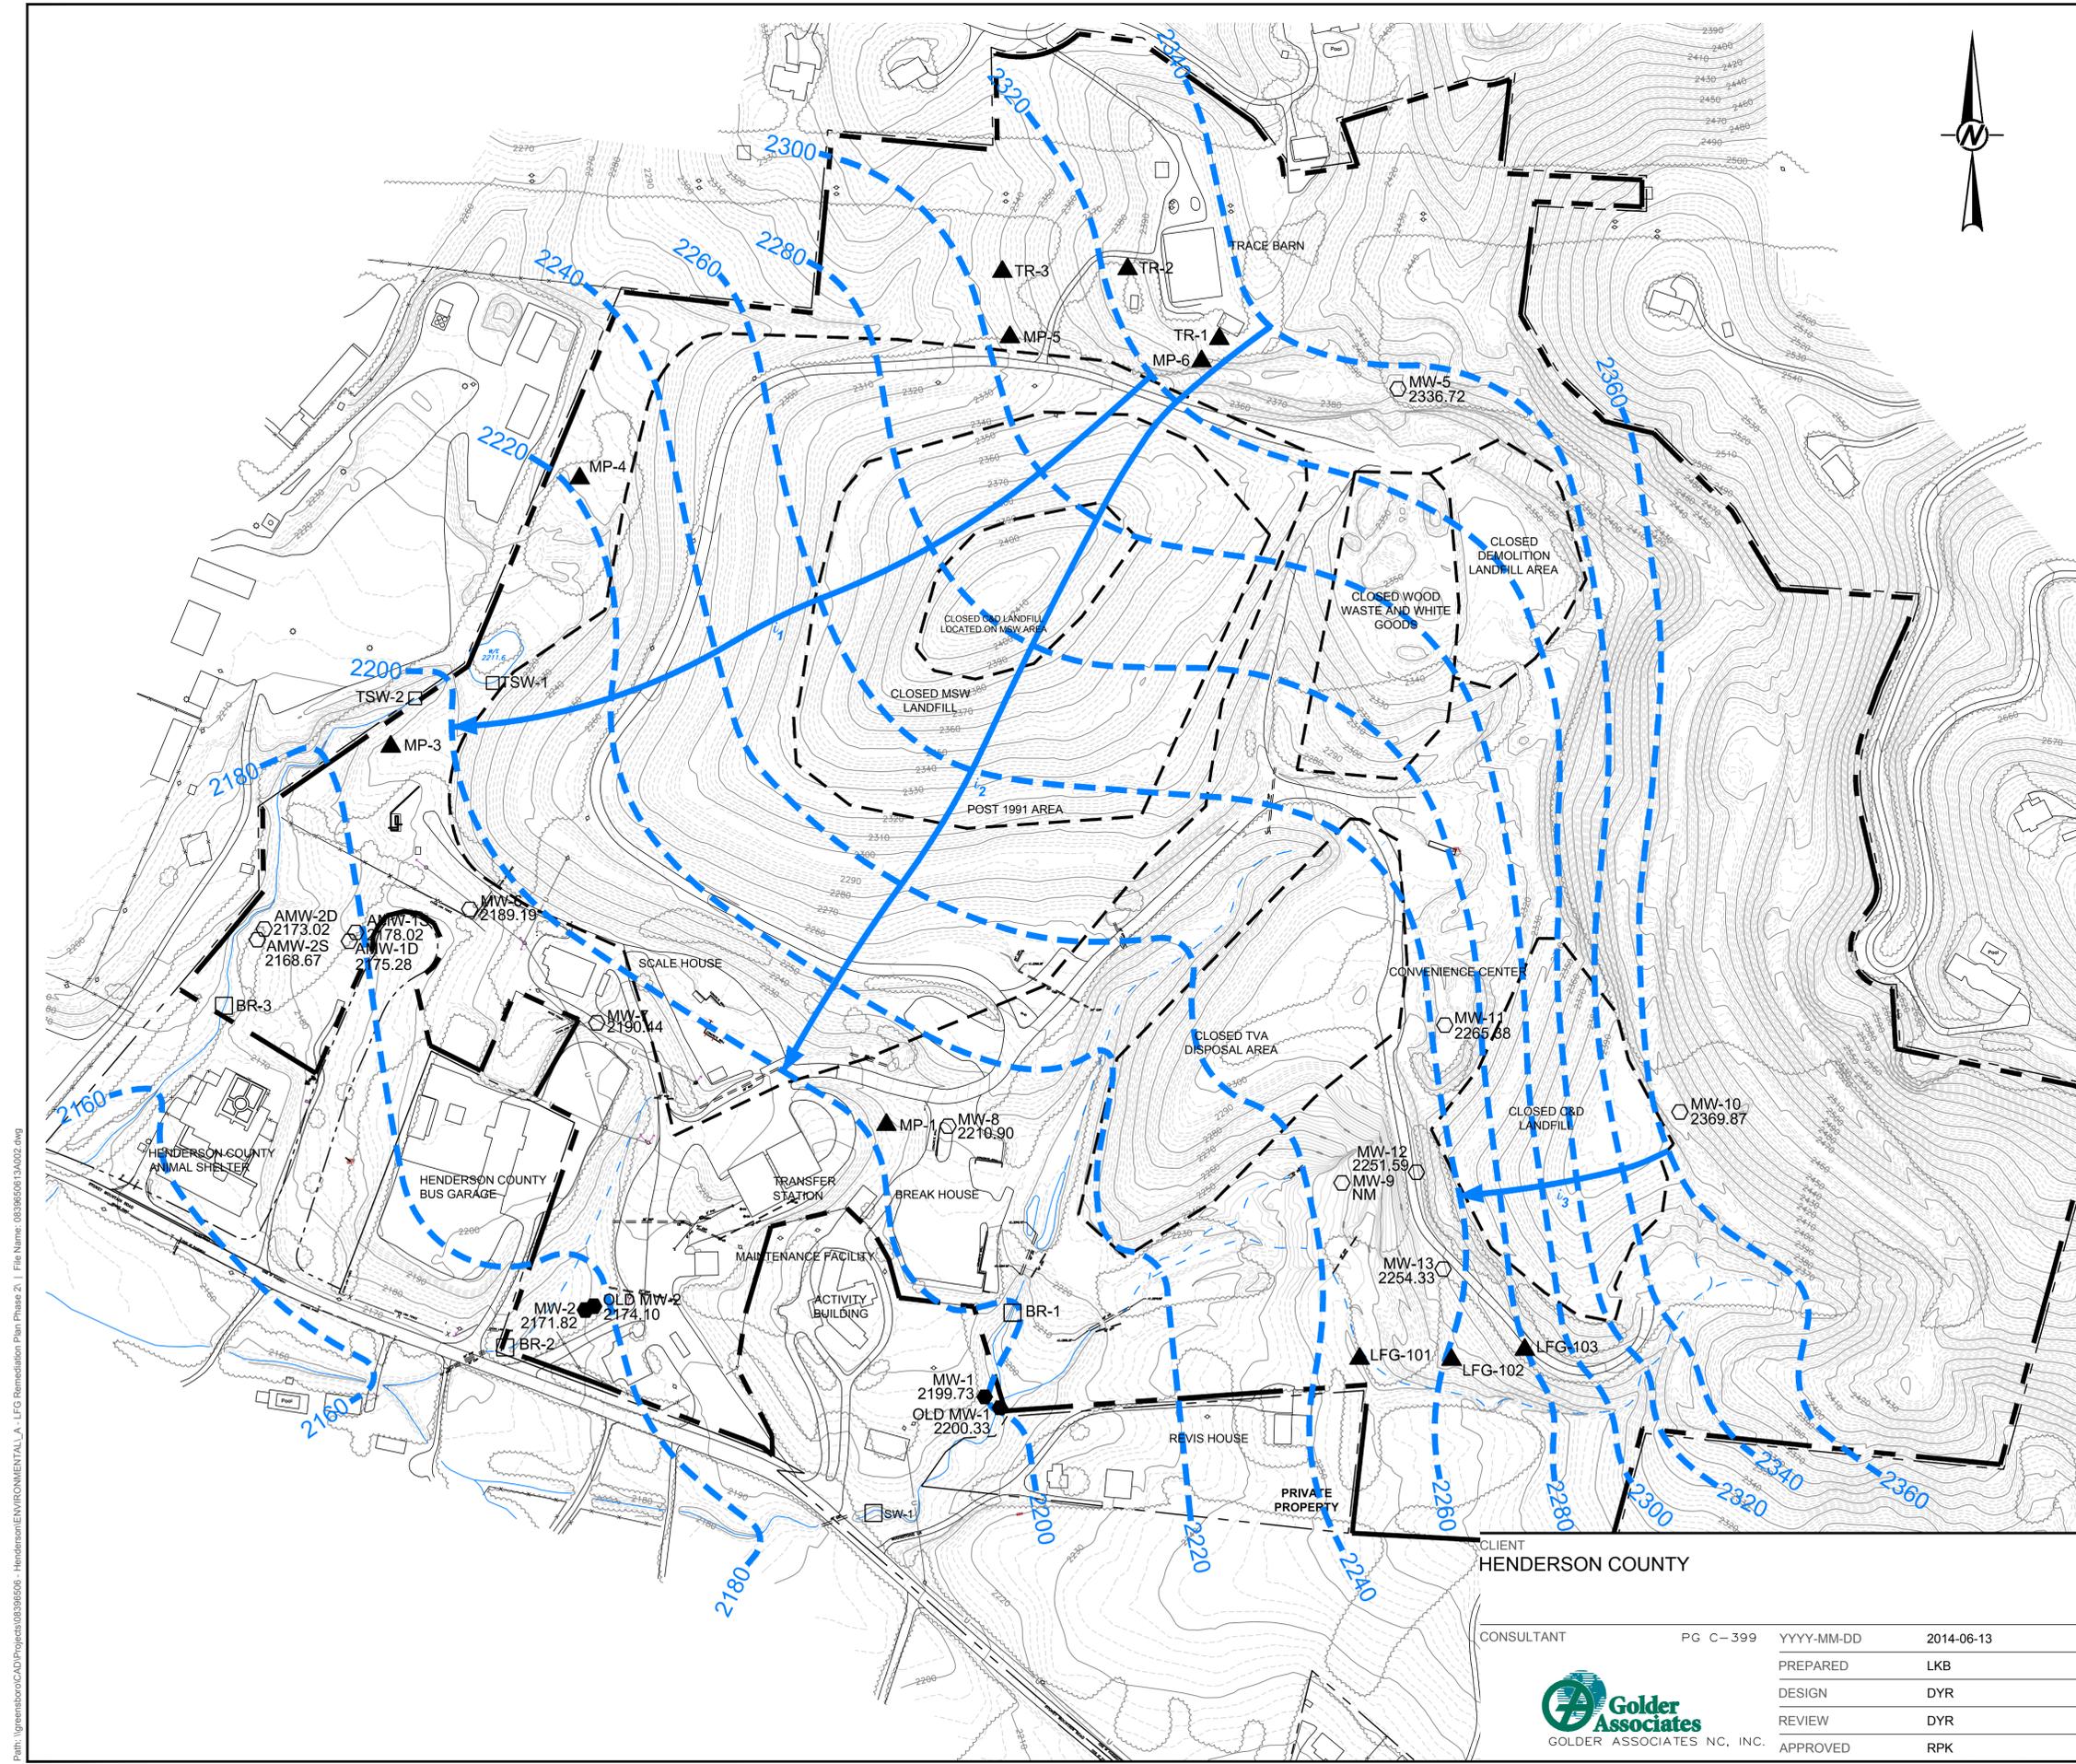
PROJECT HENDERSON COUNTY CLOSED MSW AND C&D LANDFILL PERMIT # 45-01			
TITLE <b>GROUNDWATER SURFACE CONTOUR MAP</b> SEPTEMBER			
PROJECT No. 0839650614	PHASE 100	Rev. 0	DRAWING 2

Relatively little information is known about the depth to bedrock and groundwater at the proposed locations of the landfill gas monitoring wells. Depth to bedrock at each of the locations is assumed to range between 40 and 70 feet below ground surface, based on available boring logs for groundwater monitoring wells at the facility. Depth to groundwater for each proposed location was estimated using the groundwater surface contours provided on Drawing 2. A summary of depth to bedrock and groundwater estimates along with proposed depths and screened intervals of the proposed landfill gas monitoring wells are provided on Table 3. A diagram of a typical landfill gas monitoring well is provided as Figure 6. The wells are estimated to range between 30 to 45 feet below ground surface, but actual depths will be dependent on field conditions.

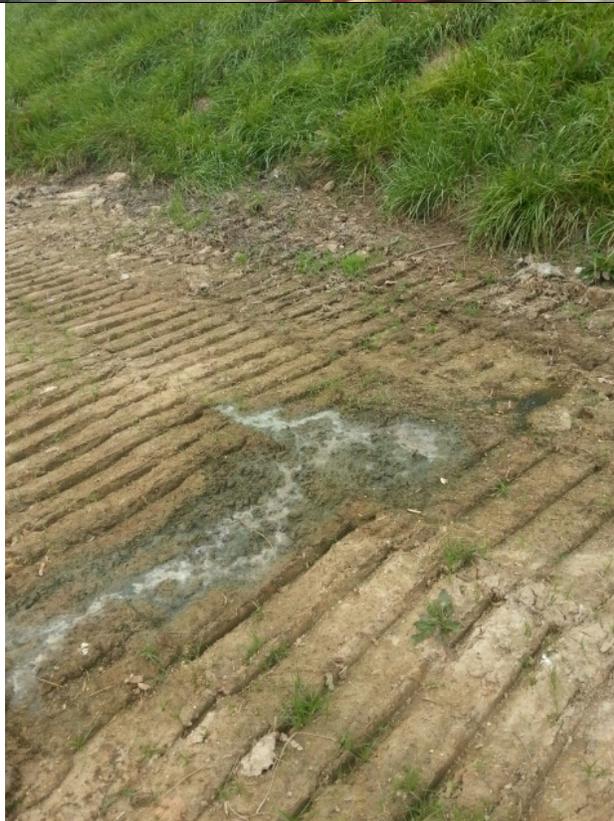
**PHOTO  
62**

Surface  
Breakout

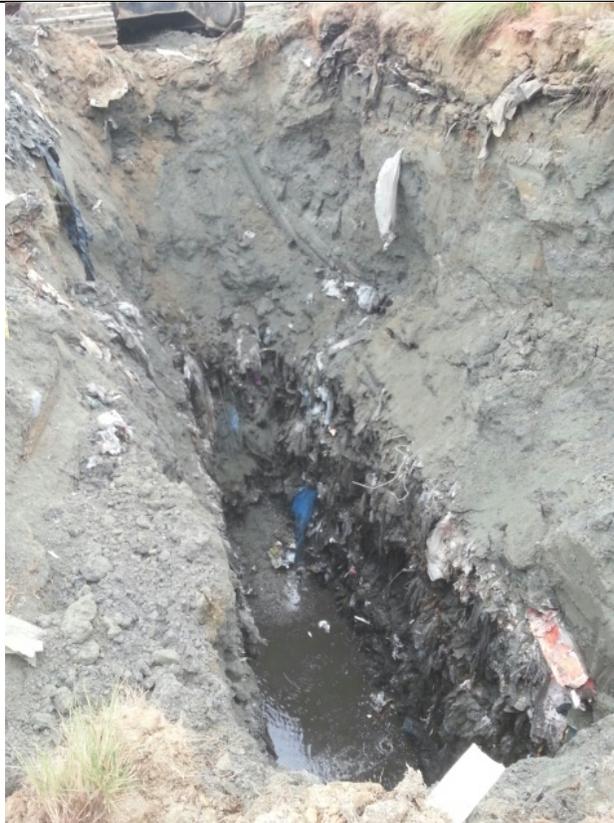
**PHOTO  
63**

Excavati  
on for  
Surface  
Breakout

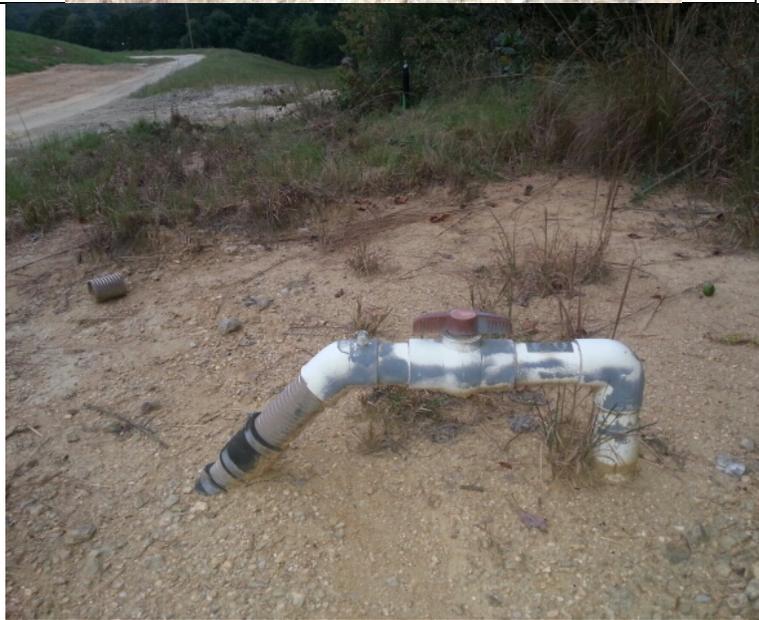
**PHOTO  
64**

SVE  
Point  
Near  
MP-05
